**Mechanism and Root Cause of L-1 Blade Failure
and
Assessment of Cycle Chemistry
at
Xcel's Comanche Unit 3**

Xcel Energy Corporation
MDC 9500 Interstate 76
Henderson, Colorado 80640. USA

Structural Integrity Associates, Inc.
San Jose, California 95318. USA

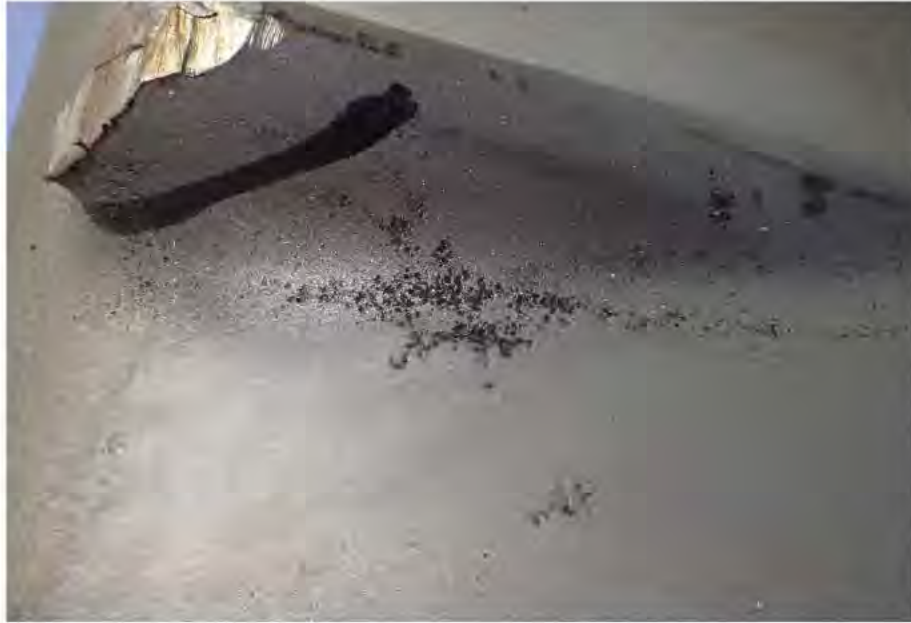
In summary, the metallurgical analyses confirm the mechanism as pit-induced SCC and a high density of pits in a location parallel to the snubber/blade interface. This is most significant in this deterministic mechanism and root cause analysis conducted by SI.

Figure 1. Showing a line of concentrated pitting parallel to the snubber.

Inspection by 3 Angles (29th January 2020) of all the L-1 blades after shot blasting indicated that “pitting was found on all blades, mostly around the snubbers”. This is a most important observation which indicates that the LP turbine was not protected during the multiple long (> 3 day) shutdown periods. 1 – 1.5 in crack-like indications were also observed on the discharge side of all snubbers, with cracks on all blades on the admission side towards the blade roots. Pitting (and erosion) was also observed on all L-0 blades as well as foreign object damage. The pitting on the L-0 blades supports the lack of any shutdown protection. It has not been possible to create a quantitative geography of pitting but the observations in this section and in Section 2.1 are thought to clearly illustrate the susceptibility on the blade surface parallel and close to the snubber.

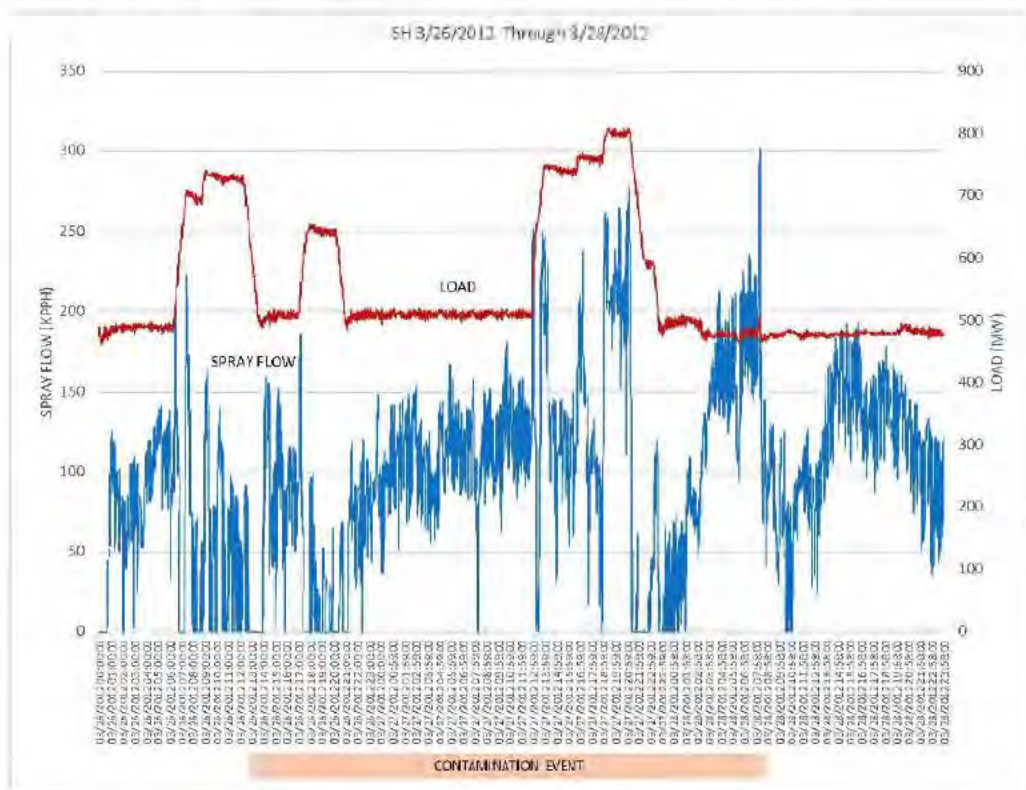
The plots in Figures 2 and 3 show that unit load had just decreased to 489 MW from 733 MW when the contamination event started at 13:00 hrs. on 26th March 2012. The plots also show that the superheater and reheater attenuators were in service prior to the contamination event. Two periods of increased load occurred during the contamination event. The first began at 17:00 on 26th March 2012 to a maximum load of 654 MW and lasting 4 hours and 11 minutes. The second began at 12:49 hrs. on 27th March 2012, reaching a maximum load of 809 MW and lasting 11 hours and 10 minutes.

Attenuator spray flow plots in Figures 2 and 3 show that the superheater attenuator operated the majority of the time and the reheater attenuator operated near-continuously during the contamination event.

Figure 2 – Unit load and superheater attenuator spray water flow before, during and after the March 2012 condenser leak event

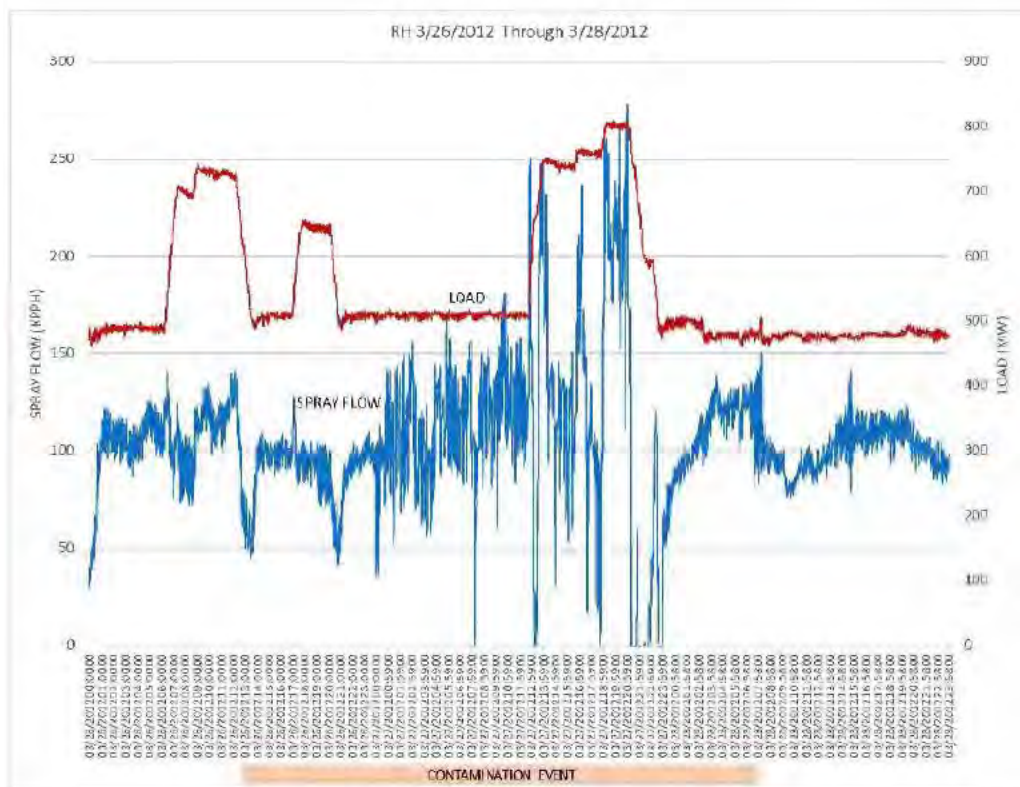
Figure 3 – Unit load and reheater attemperator spray water flow before, during and after the March 2012 condenser leak event

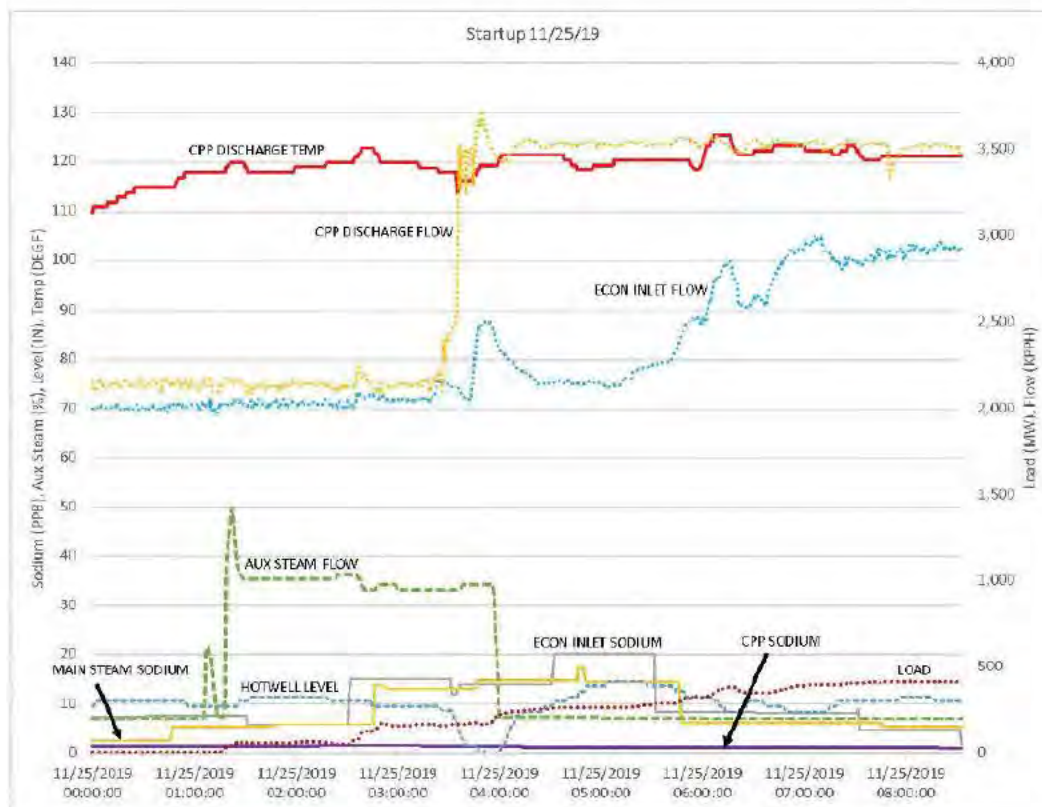
Figure 4 – Startup on 25th November 2019 when sparging steam was supplied and the condensate polishers were bypassed.

The plot shows that the EI and MS sodium levels were slightly elevated at unit startup but were further elevated due to auxiliary steam flow during the next six hours to about 20 and 15 ppb, respectively. It can be seen that the condensate polisher was partially by-passed until about 3:30 on the 25th November 2019 but the condensate polisher (CPP) sodium remained within limits (< 2 ppb) throughout. SI also reviewed the chemistry data in detail for other startups (for example: 7th December 2018, 12 and 20th July 2019) but as reported in Section 3.2.3 the sodium analyzer was out of service. Figure 4 however illustrates that the auxiliary steam can be a source of contamination for the steam supply to the Comanche Unit 3 turbine. Clearly an alternate supply for sparging steam is required.
