Comanche 3 QCP - Major Outage

TURBINE ROTOR INSPECTION

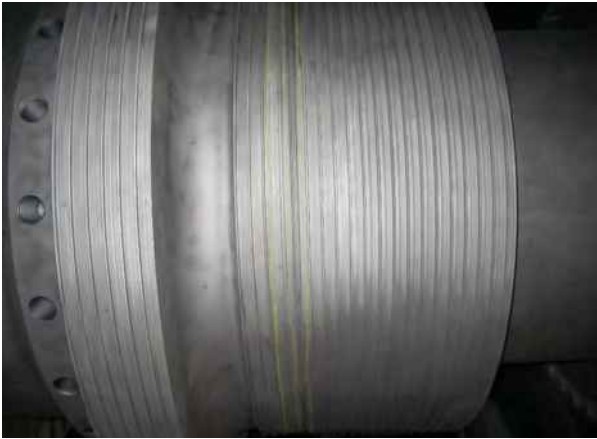
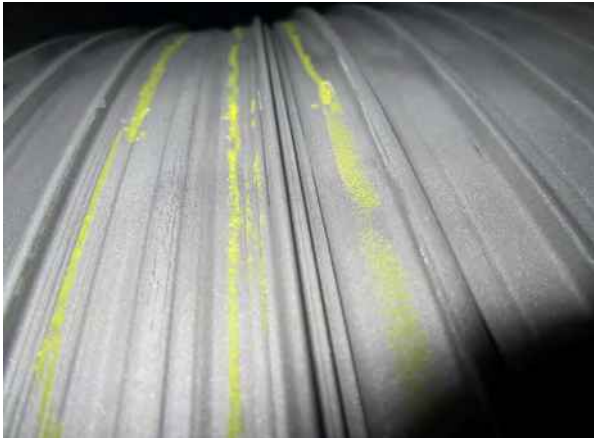
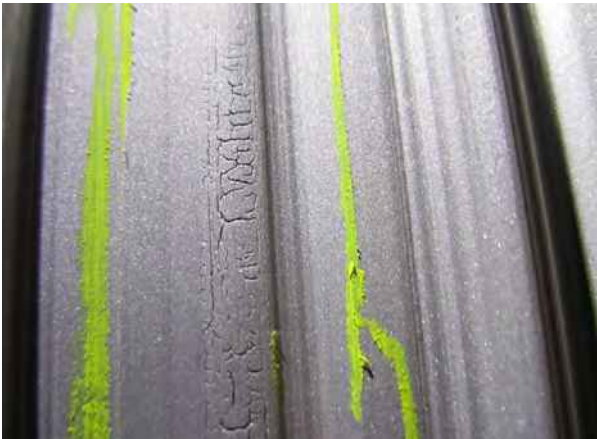
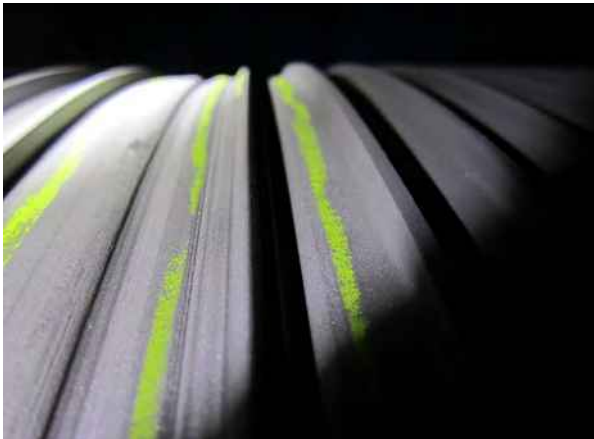
CUSTOMER:		FCSS	
PO #:	4900073380	SURFACE CONDITION:	Oxide Blasted
MATERIAL DESCRIPTION:		Comanche Unit 3 HPIP VT Results Page 1	
Stage		Description	
1 Dummy Ring Castellations		<ul style="list-style-type: none"> • Deep groove around entire body. • (1) set of castellations missing

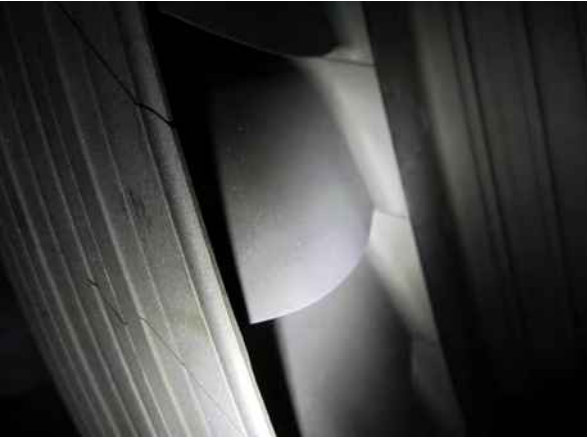
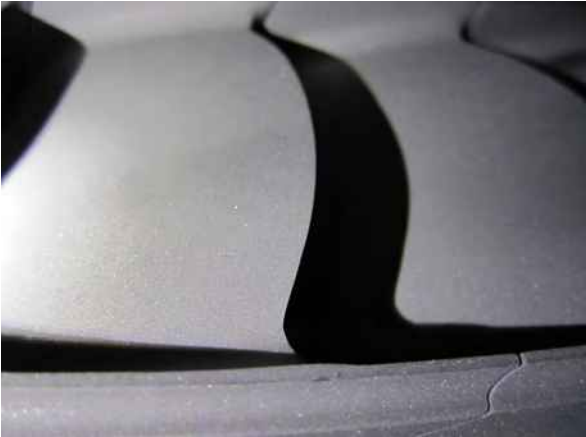
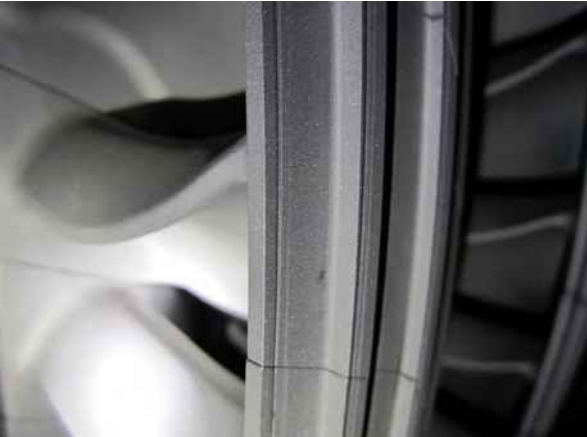
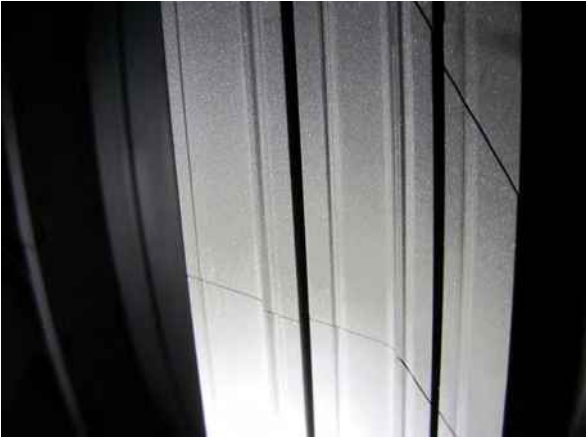
CUSTOMER:		FCSS	
PO #:	4900073380	SURFACE CONDITION:	Oxide Blasted
MATERIAL DESCRIPTION:		Comanche Unit 3 HPIP VT Results Page 6	
Stage	Description		
5	<ul style="list-style-type: none"> • Light foreign object damage to leading edge • Rubbing on all shrouds

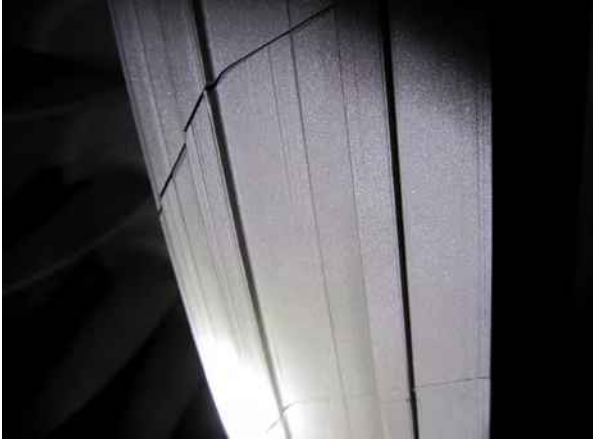
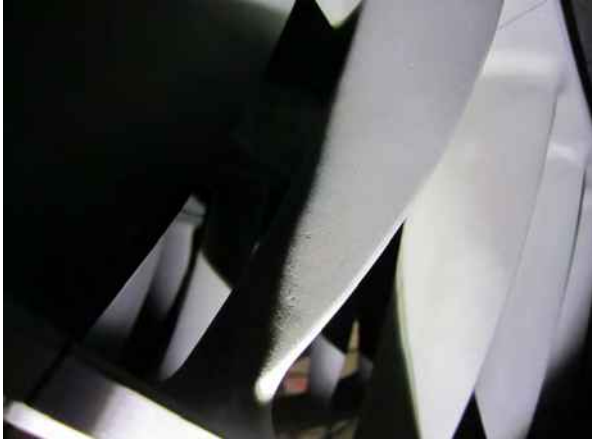
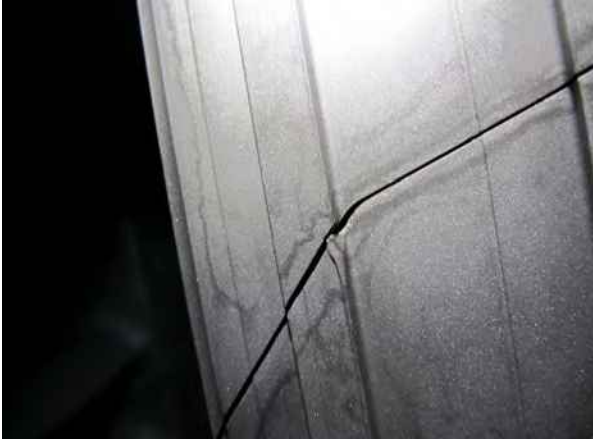
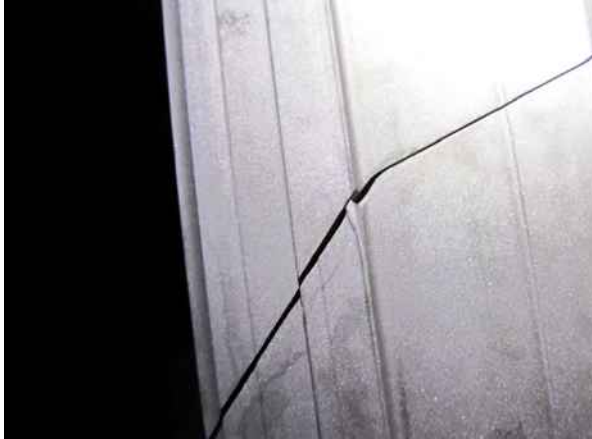
CUSTOMER:		FCSS	
PO #:	4900073380	SURFACE CONDITION:	Oxide Blasted
MATERIAL DESCRIPTION:		Comanche Unit 3 HPIP VT Results Page 14	
Stage		Description	
13	<ul style="list-style-type: none"> • Rubbing on all shrouds. • Light foreign object damage to leading edge.

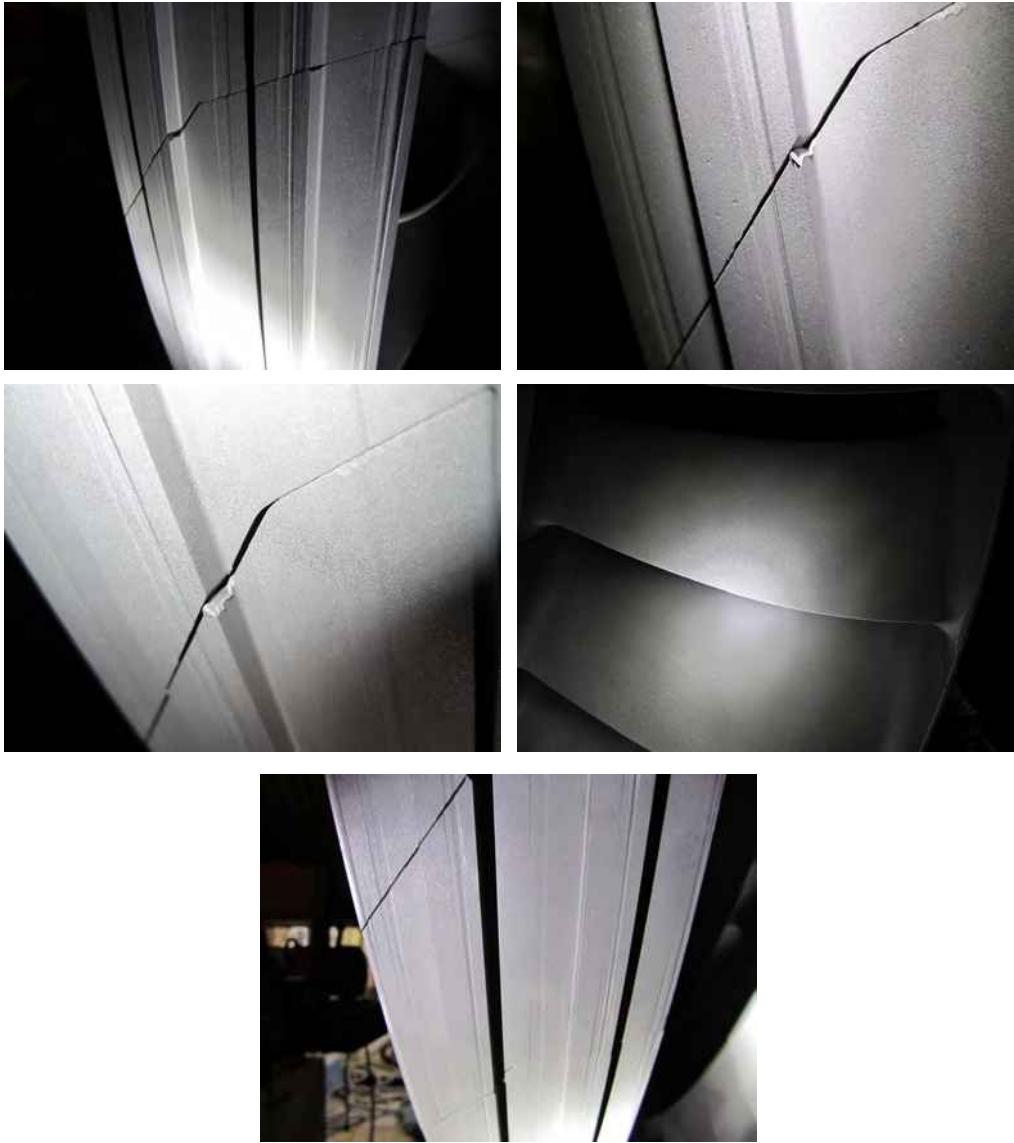
CUSTOMER: FCSS	
PO #: 4900073380	SURFACE CONDITION: Oxide Blasted
MATERIAL DESCRIPTION: Comanche Unit 3 HPIP VT Results Page 16	
Stage	Description
15	<ul style="list-style-type: none"> • Rubbing on all shrouds. • Erosion/mechanical damage to shroud. • Light foreign object damage to leading edge.

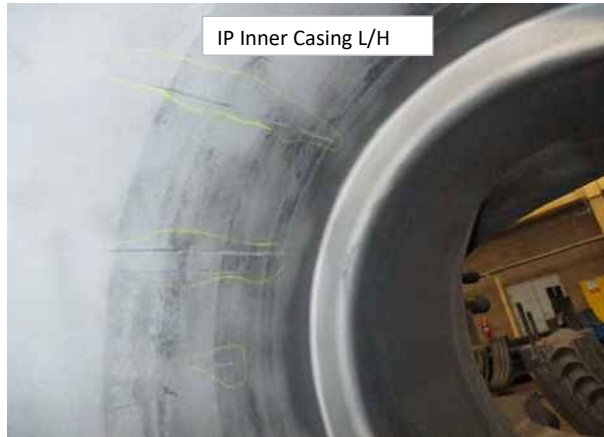
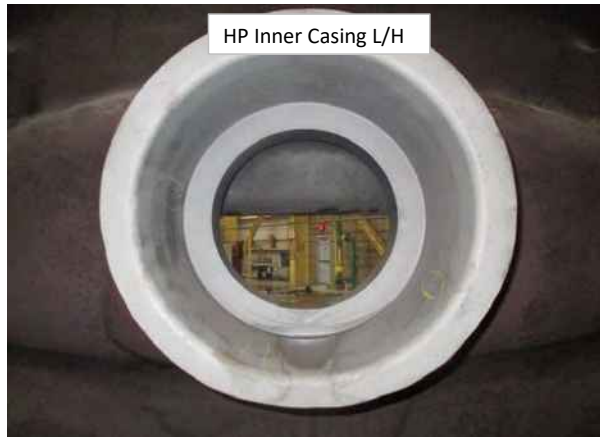
- HP minor mechanical damage steam inlet
- IP mechanical damage in steam inlet
- IP damaged threads on studs #L71, L72 and R71

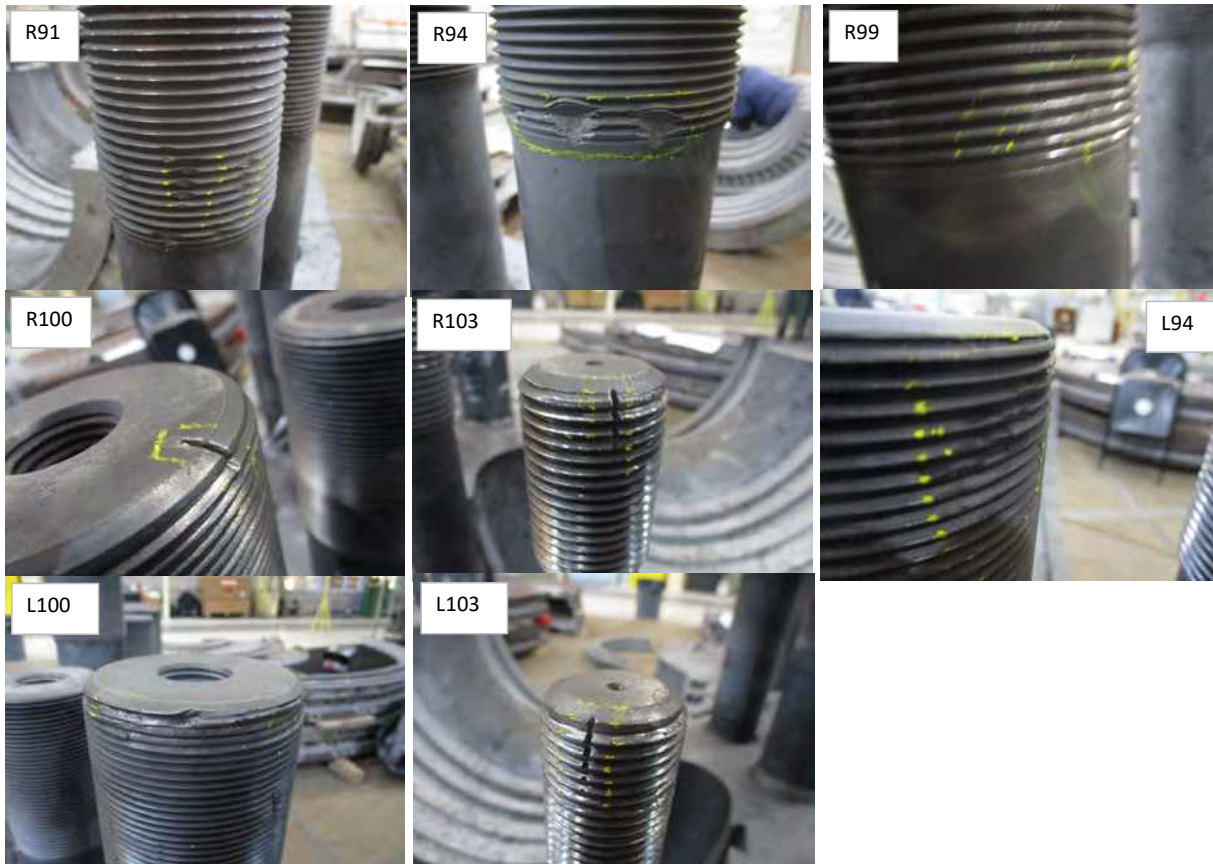
- Damaged studs: #R91, R94, R99, R100, R103, L94, L100, L103

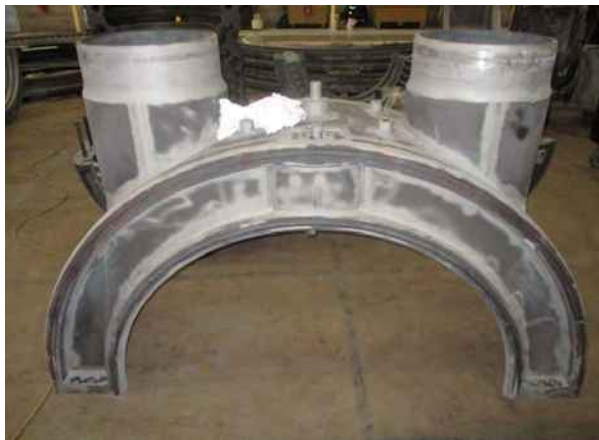
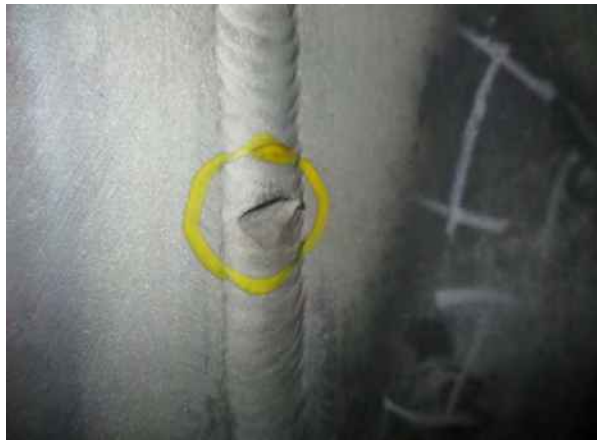
- U/H: in one location material missing from weld
- L/H: no reportable indications

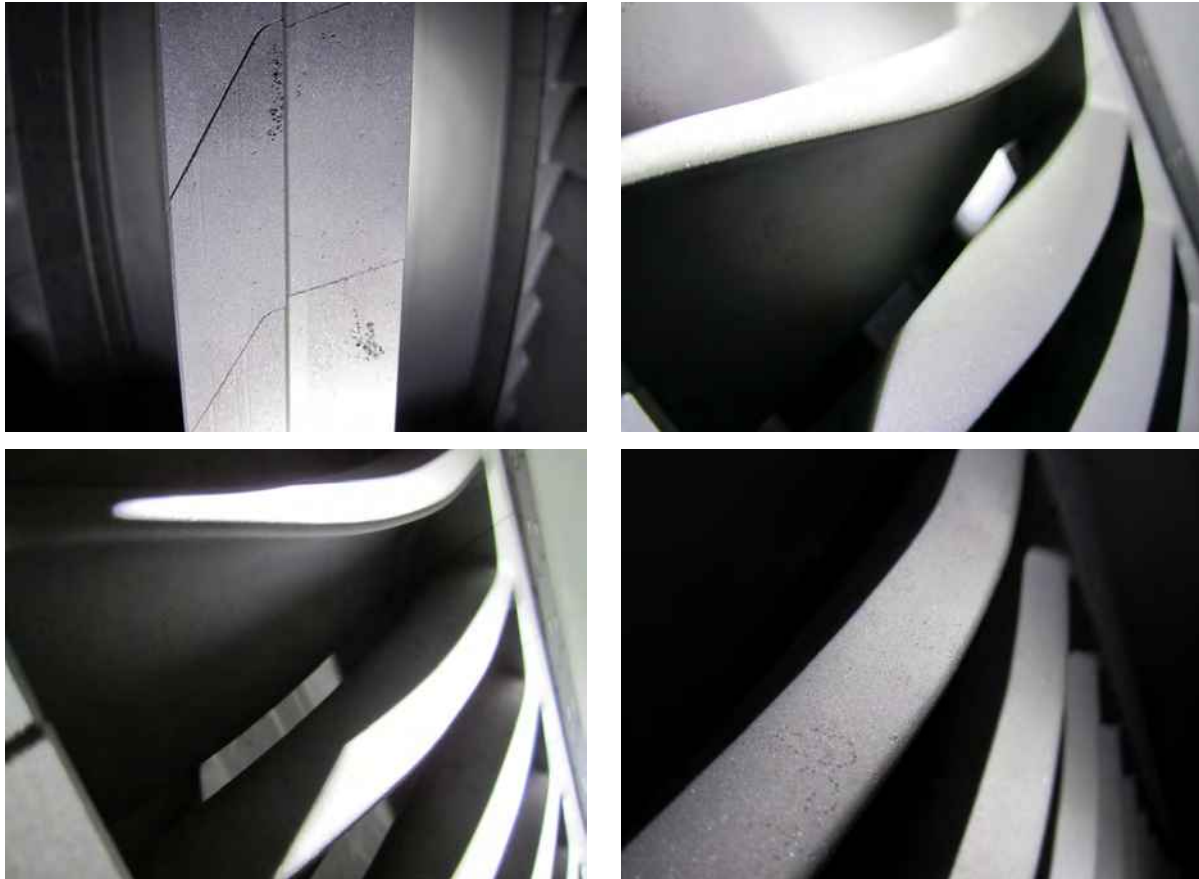
CUSTOMER:		FCSS	
PO #:	4900073380	SURFACE CONDITION:	Oxide Blasted
MATERIAL DESCRIPTION:		Comanche Unit 3 LPA VT Results Page 10	
Stage		Description	
L-3 G	• Erosion/pitting present

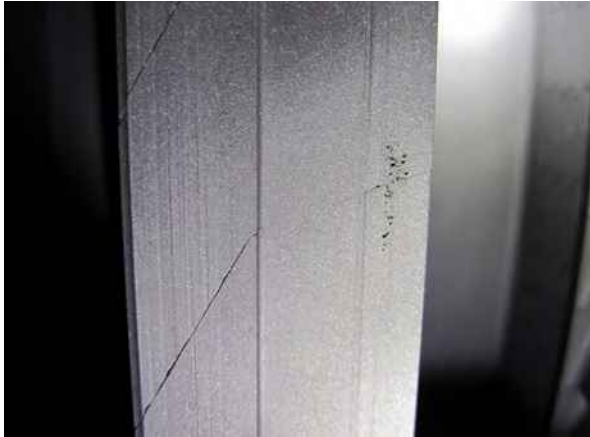
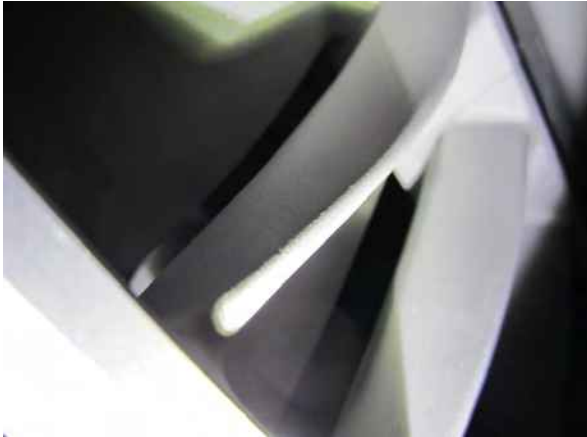
CUSTOMER:		FCSS	
PO #:	4900073380	SURFACE CONDITION:	Oxide Blasted
MATERIAL DESCRIPTION:		Comanche Unit 3 LPA VT Results Page 11	
Stage	Description		
L-4 G	<ul style="list-style-type: none"> • Light foreign object damage found on leading edges. • Pitting found on all blades.

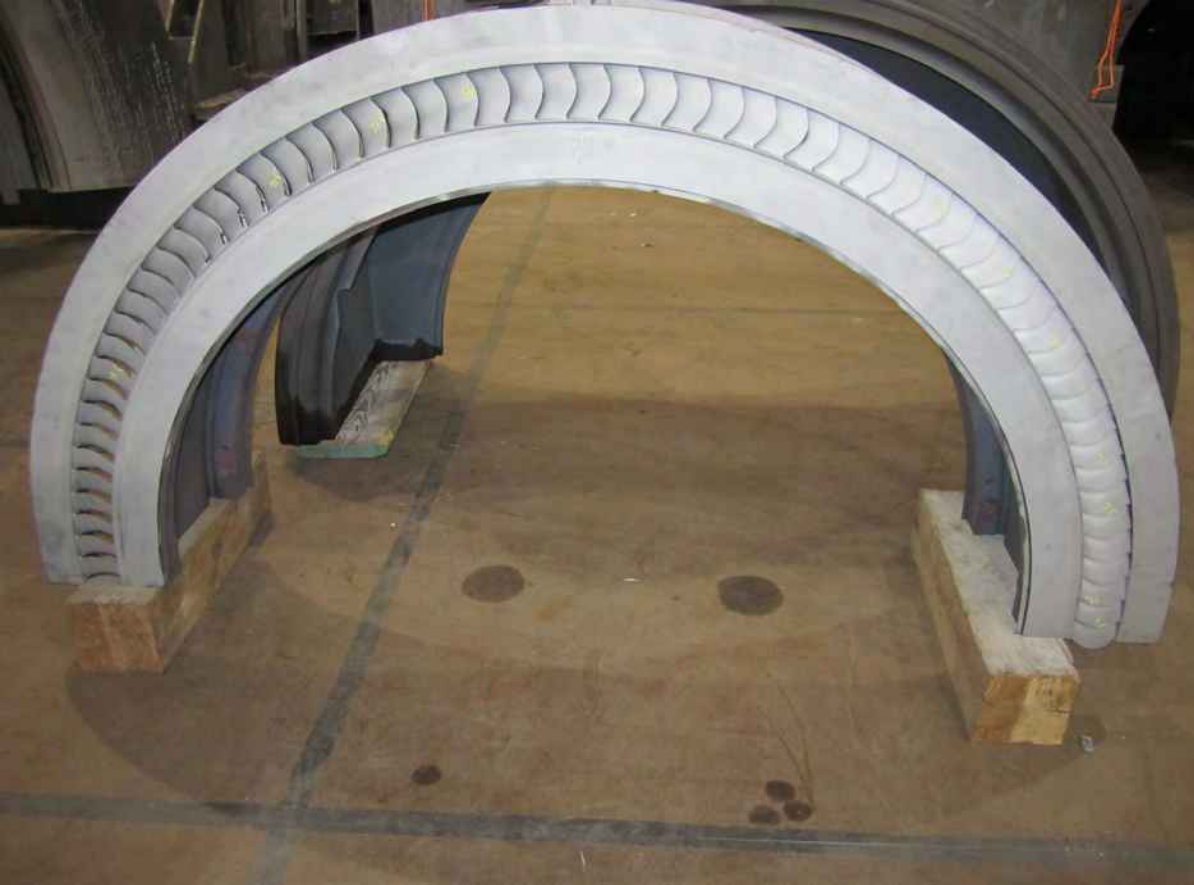
CUSTOMER:		FCSS	
PO #:	4900073380	SURFACE CONDITION:	Oxide Blasted
MATERIAL DESCRIPTION:		LPA Stationary Components	
Stage	Description		
1TU	<ul style="list-style-type: none"> Foreign object damage found on the following blades: 2,3,7,9,11,16,19,34,37,41 and 51.

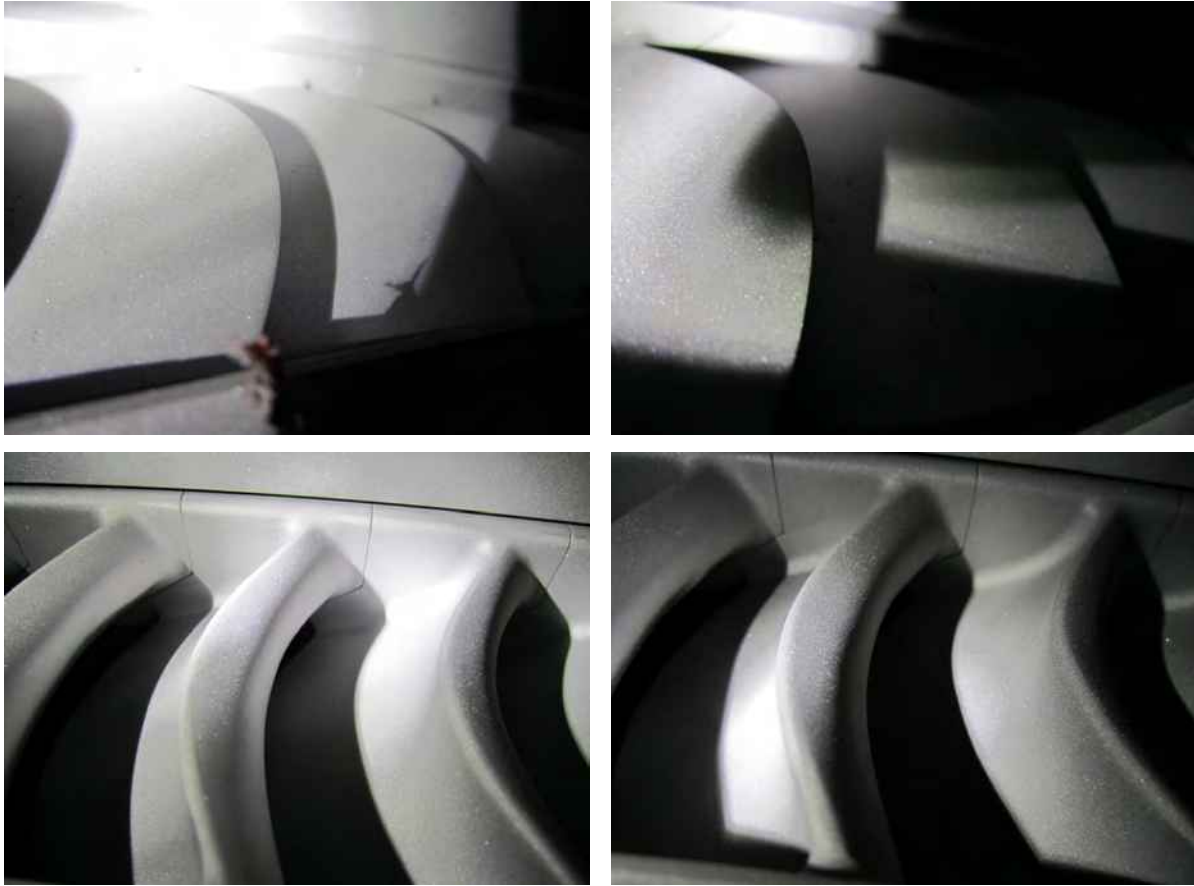
CUSTOMER:		FCSS	
PO #:	4900073380	SURFACE CONDITION:	Oxide Blasted
MATERIAL DESCRIPTION:		LPA Stationary Components	
Stage	Description		
2TU	• Lite pitting on all surfaces.

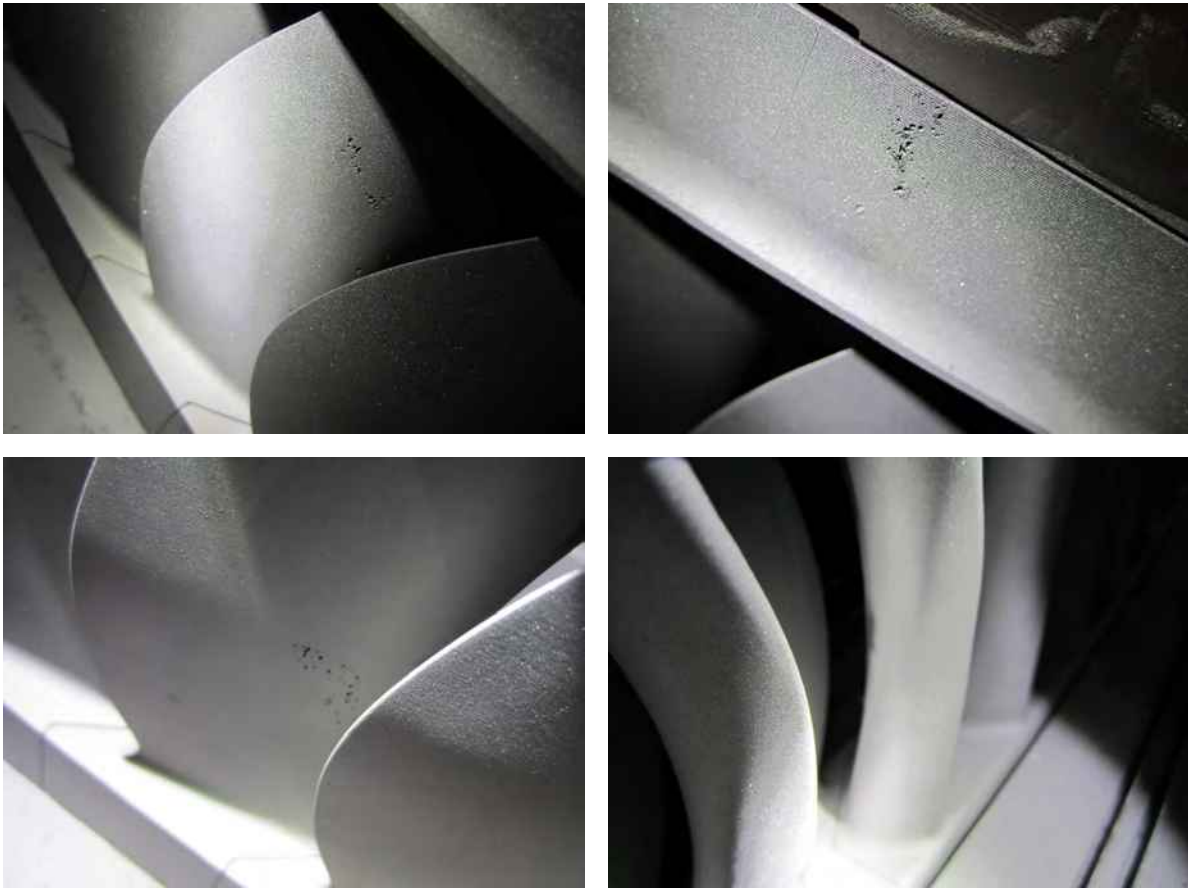
CUSTOMER:		FCSS	
PO #:	4900073380	SURFACE CONDITION:	Oxide Blasted
MATERIAL DESCRIPTION:		LPA Stationary Components	
Stage		Description	
2TL	<ul style="list-style-type: none"> Pitting on all surfaces.

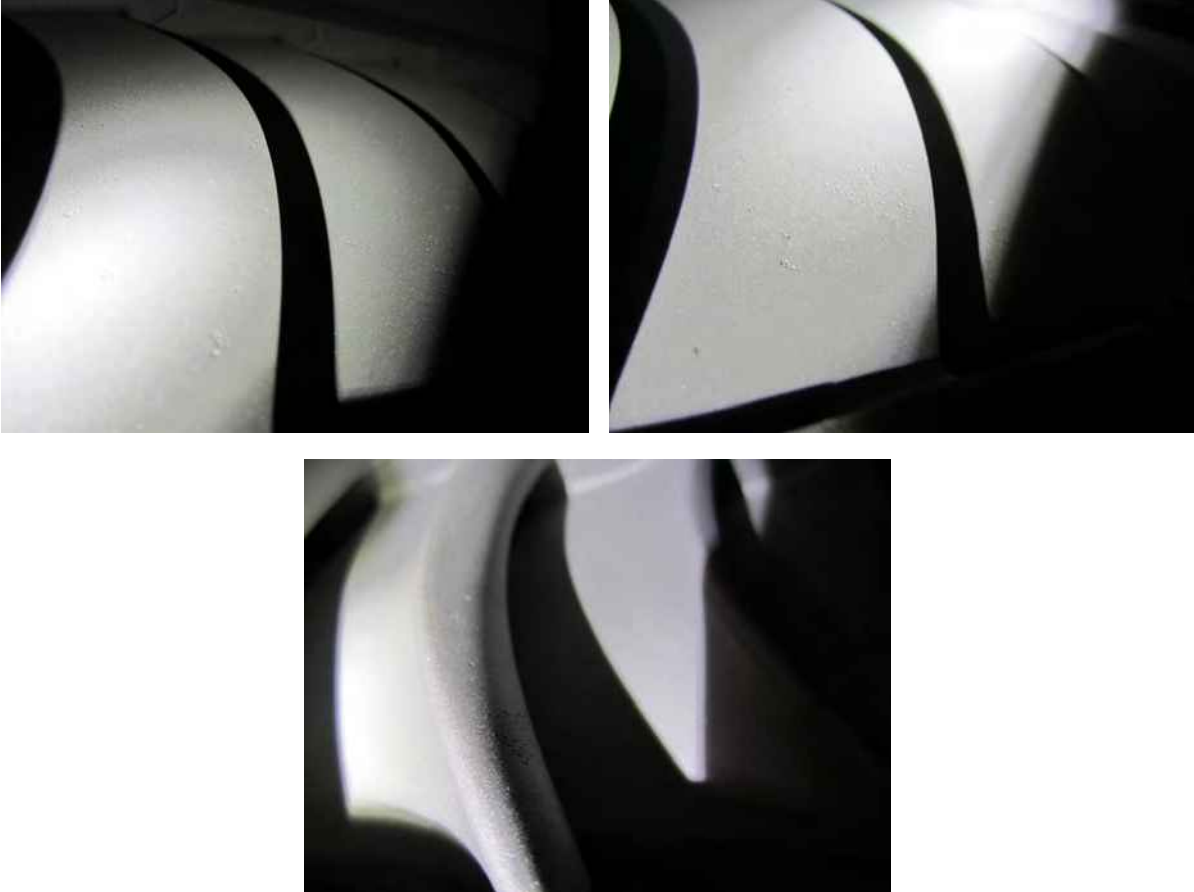
CUSTOMER:		FCSS	
PO #:	4900073380	SURFACE CONDITION:	Oxide Blasted
MATERIAL DESCRIPTION:		LPA Stationary Components	
Stage	Description		
3GU	<ul style="list-style-type: none"> Moderate pitting on all surfaces.

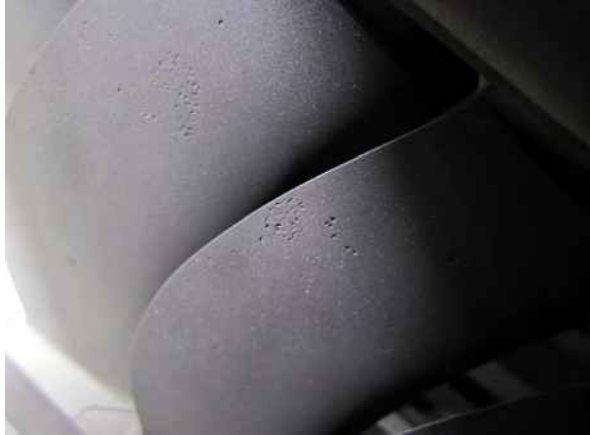
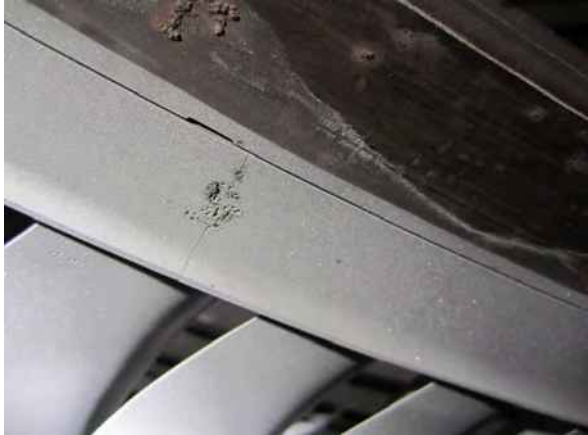
CUSTOMER:		FCSS	
PO #:	4900073380	SURFACE CONDITION:	Oxide Blasted
MATERIAL DESCRIPTION:		LPA Stationary Components	
Stage	Description		
3TL	<ul style="list-style-type: none"> Pitting on all surfaces.

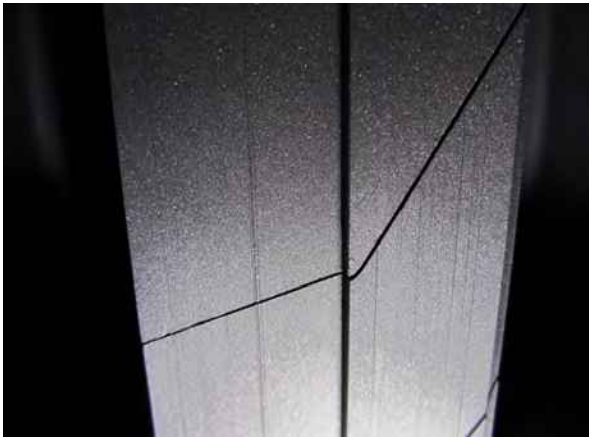
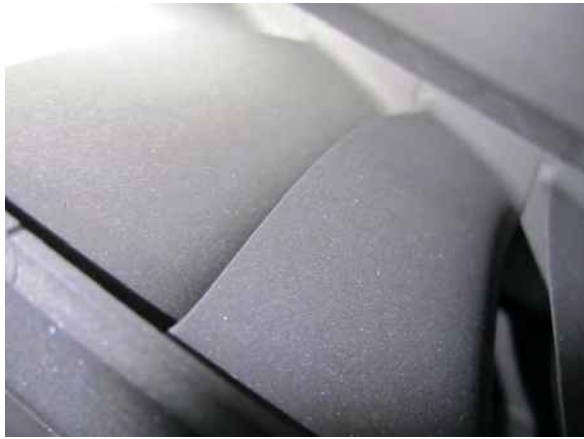
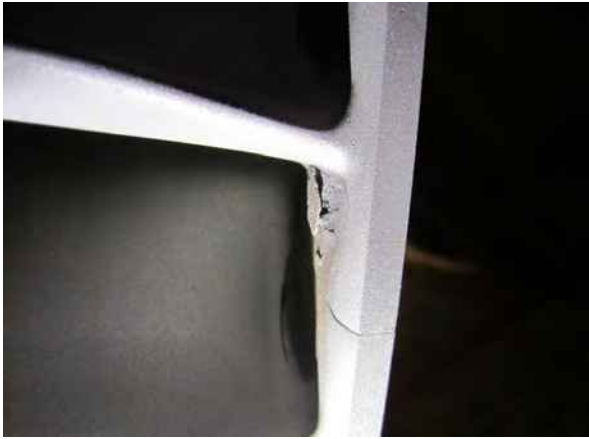
CUSTOMER:		FCSS	
PO #: 4900073380		SURFACE CONDITION: Oxide Blasted	
MATERIAL DESCRIPTION:		Comanche Unit 3 LPB VT Results Page 1	
Stage		Description	
L-4 G	<ul style="list-style-type: none"> Erosion/pitting present Light foreign object damage present. Deposits under covers.

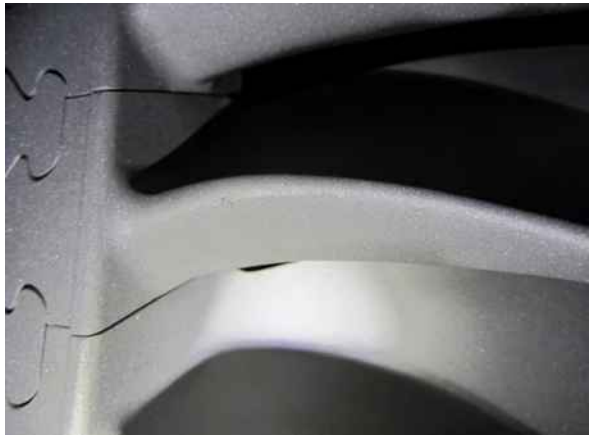
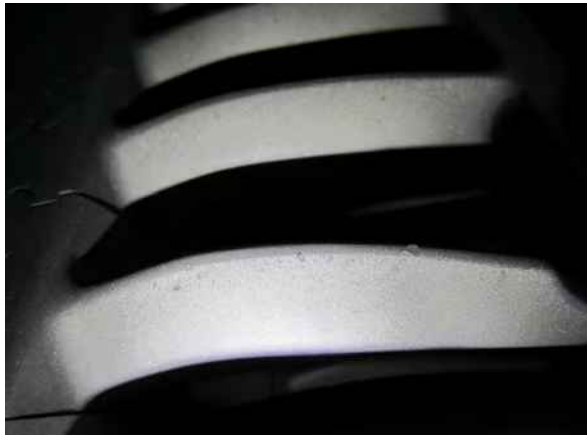
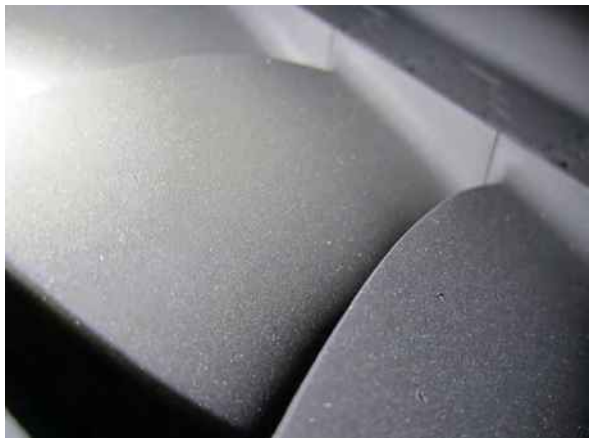
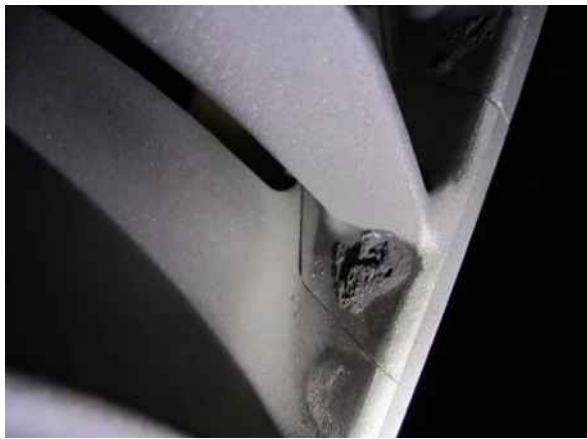
CUSTOMER:		FCSS	
PO #: 4900073380		SURFACE CONDITION: Oxide Blasted	
MATERIAL DESCRIPTION:		Comanche Unit 3 LPB VT Results Page 1	
Stage		Description	
L-5 G		<ul style="list-style-type: none"> Erosion/pitting present Light foreign object damage present. Deposits under covers.

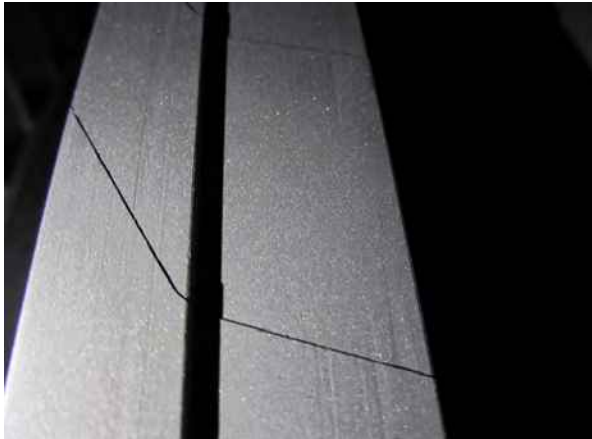
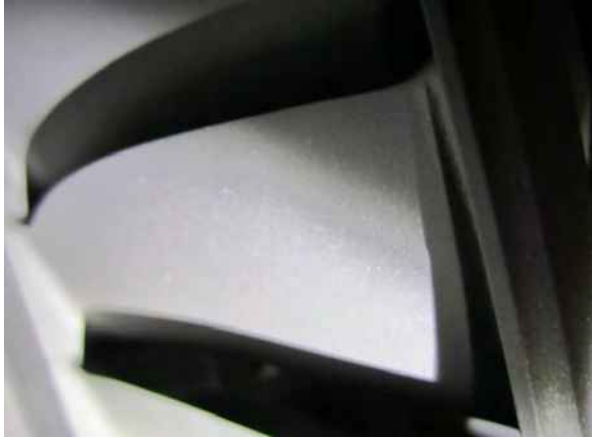
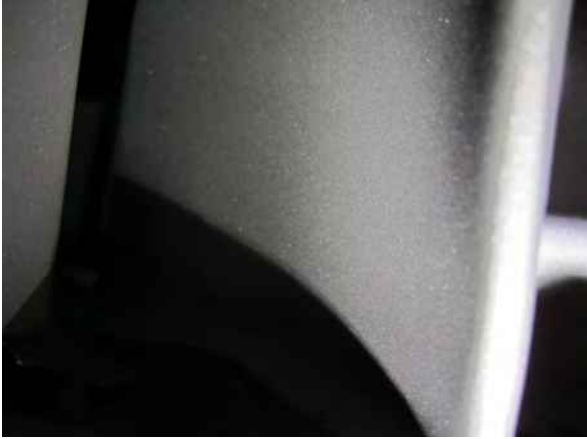
CUSTOMER:		FCSS	
PO #: 4900073380		SURFACE CONDITION: Oxide Blasted	
MATERIAL DESCRIPTION:		Comanche Unit 3 LPB VT Results Page 1	
Stage		Description	
L-4 T		<ul style="list-style-type: none"> Erosion/pitting present Light foreign object damage present. Deposits under covers.

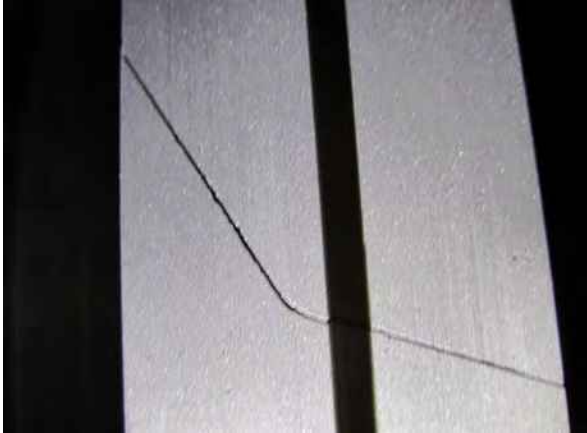
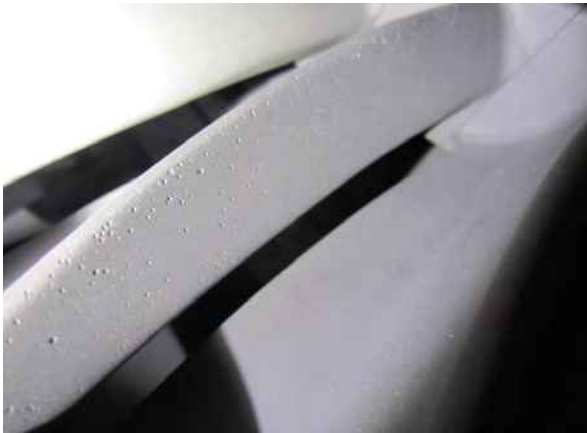
CUSTOMER:		FCSS	
PO #: 4900073380		SURFACE CONDITION: Oxide Blasted	
MATERIAL DESCRIPTION:		Comanche Unit 3 LPB VT Results Page 1	
Stage		Description	
L-3 T		<ul style="list-style-type: none"> Erosion/pitting present Light foreign object damage present. Deposits under covers.

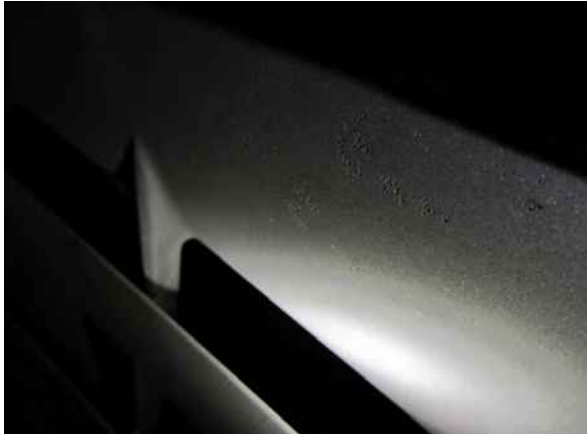
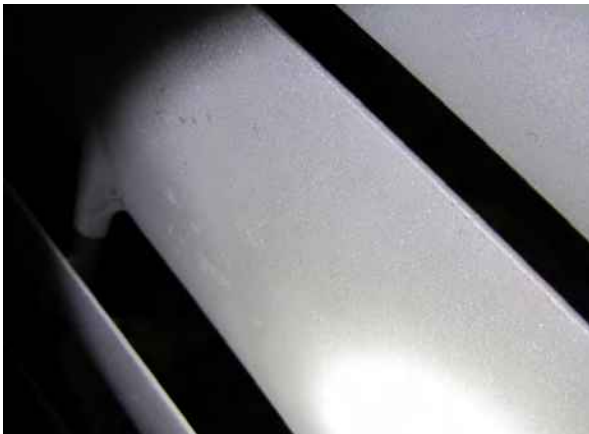
CUSTOMER:		FCSS	
PO #:	4900073380	SURFACE CONDITION:	Oxide Blasted
MATERIAL DESCRIPTION:		Comanche Unit 3 LPB VT Results Page 1	
Stage	Description		
L-I T	• Pitting found on all blades. Mostly around snubbers and on the admission side.

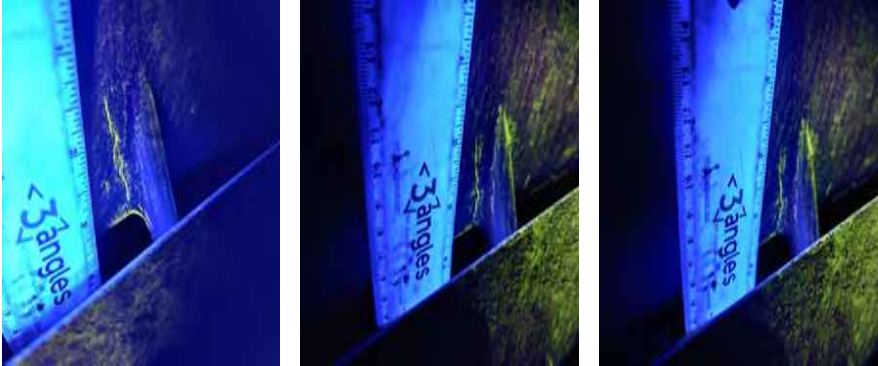
CUSTOMER:		FCSS	
PO #: 4900073380		SURFACE CONDITION: Oxide Blasted	
MATERIAL DESCRIPTION:		Comanche Unit 3 LPB MT Results Page 1	
Stage		Description	
L-1 G	<ul style="list-style-type: none"> 1-1.5" crack-like indications on discharge side of all snubbers. Multiple crack-like indications found on all blades on admission side towards root in corrosion areas Examples shown below

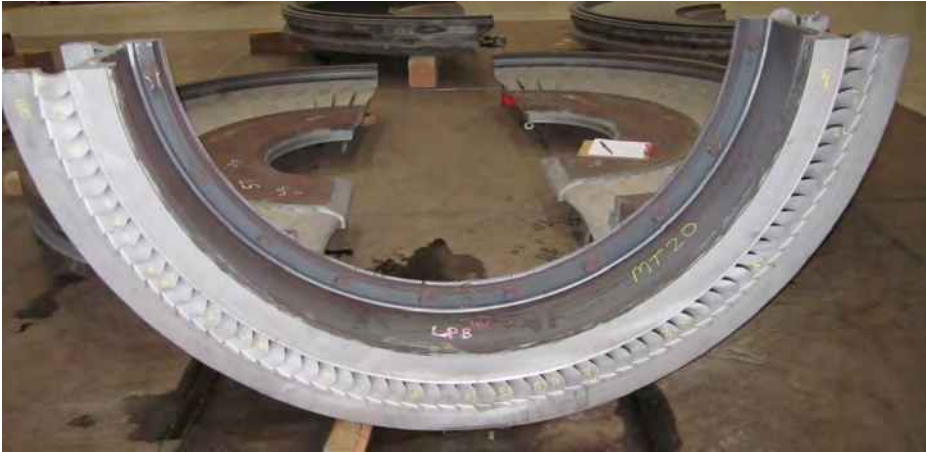
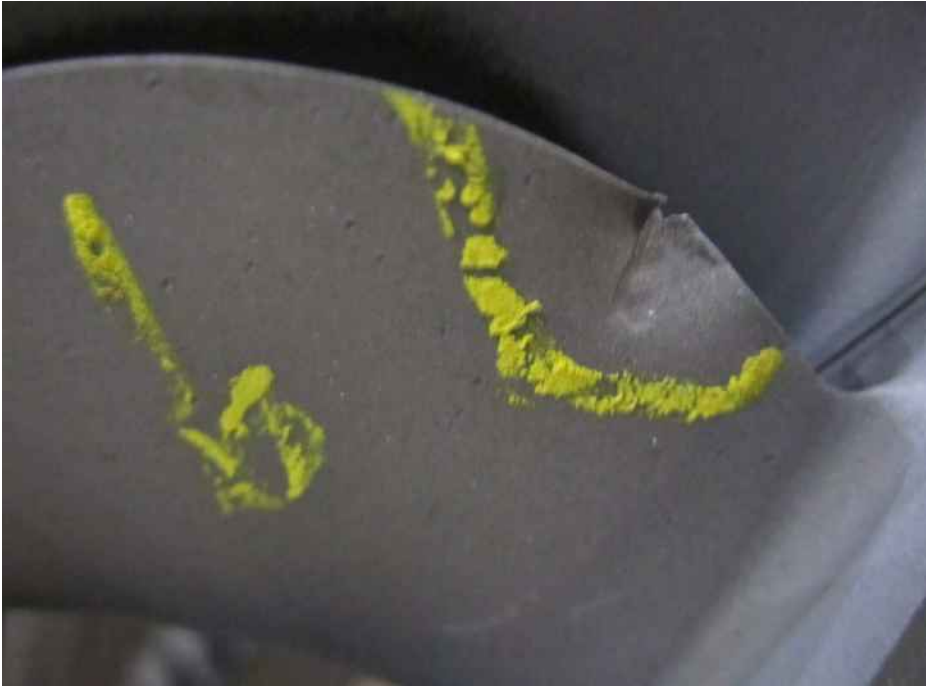
CUSTOMER:		FCSS	
PO #: 4900073380		SURFACE CONDITION: Oxide Blasted	
MATERIAL DESCRIPTION:		LPB Stationary Components	
Stage	Description		
1GU	<ul style="list-style-type: none"> Partitions 6: 1/16" Tear in trailing edge Partitions: 4,6,14,19,20,25,27,28,30,32,35,40,44,45,47,50,51,53-55,58,60-61: Foreign object damage in trailing edge.

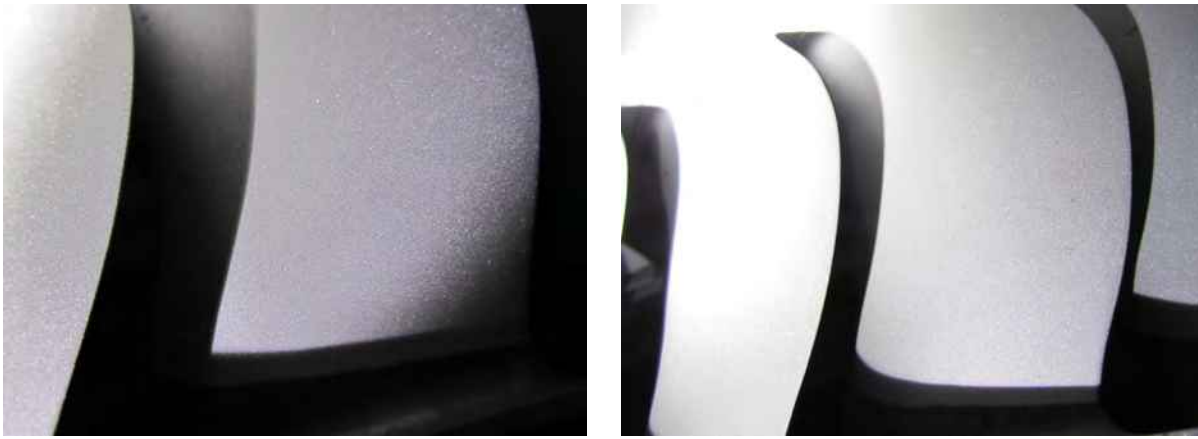
CUSTOMER:		FCSS	
PO #:	4900073380	SURFACE CONDITION:	Oxide Blasted
MATERIAL DESCRIPTION:		LPB Stationary Components	
Stage	Description		
2TU	<ul style="list-style-type: none"> • Damage to spill strips. • Erosion/pitting of blade surfaces.

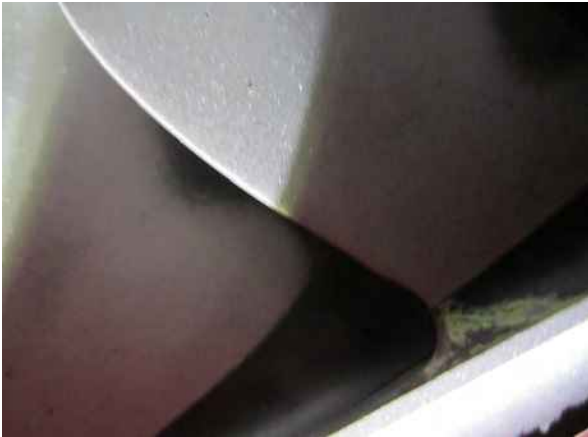
CUSTOMER:		FCSS	
PO #: 4900073380		SURFACE CONDITION: Oxide Blasted	
MATERIAL DESCRIPTION:		LPB Stationary Components	
Stage	Description		
2GU	<ul style="list-style-type: none"> • Blade 21: foreign object damage on trailing edge. • Erosion/pitting of blade surfaces. • Minor foreign object damage on trailing edge.

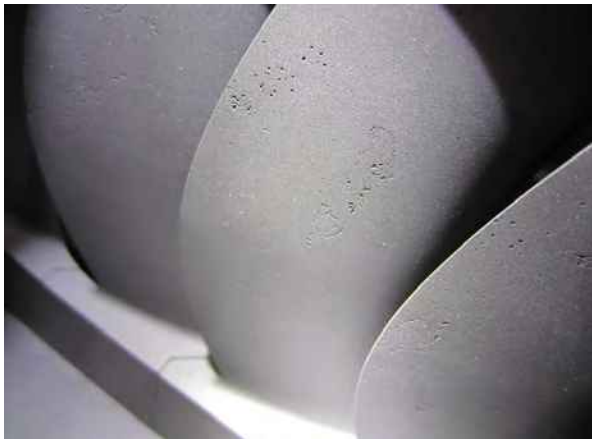
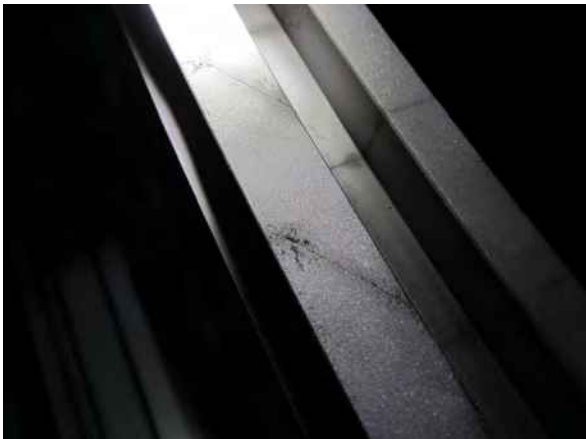
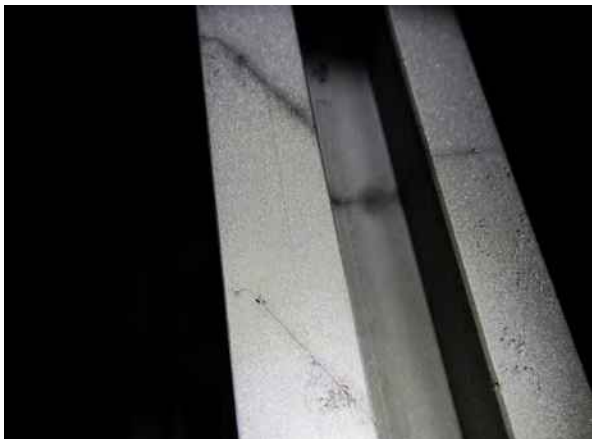
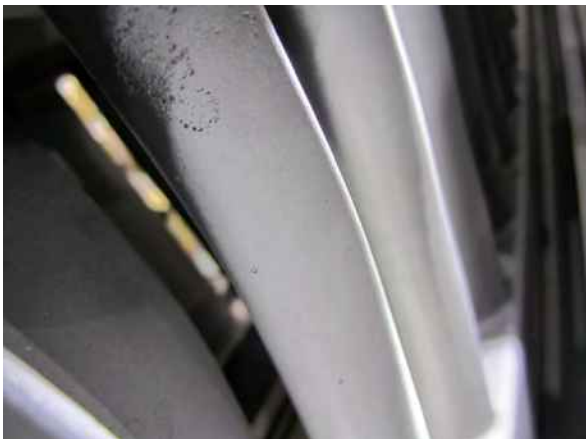
CUSTOMER:		FCSS	
PO #: 4900073380		SURFACE CONDITION: Oxide Blasted	
MATERIAL DESCRIPTION:		LPB Stationary Components	
Stage	Description		
3TL	<ul style="list-style-type: none"> • Thinning of trailing edges. • Erosion/pitting of blade surfaces.

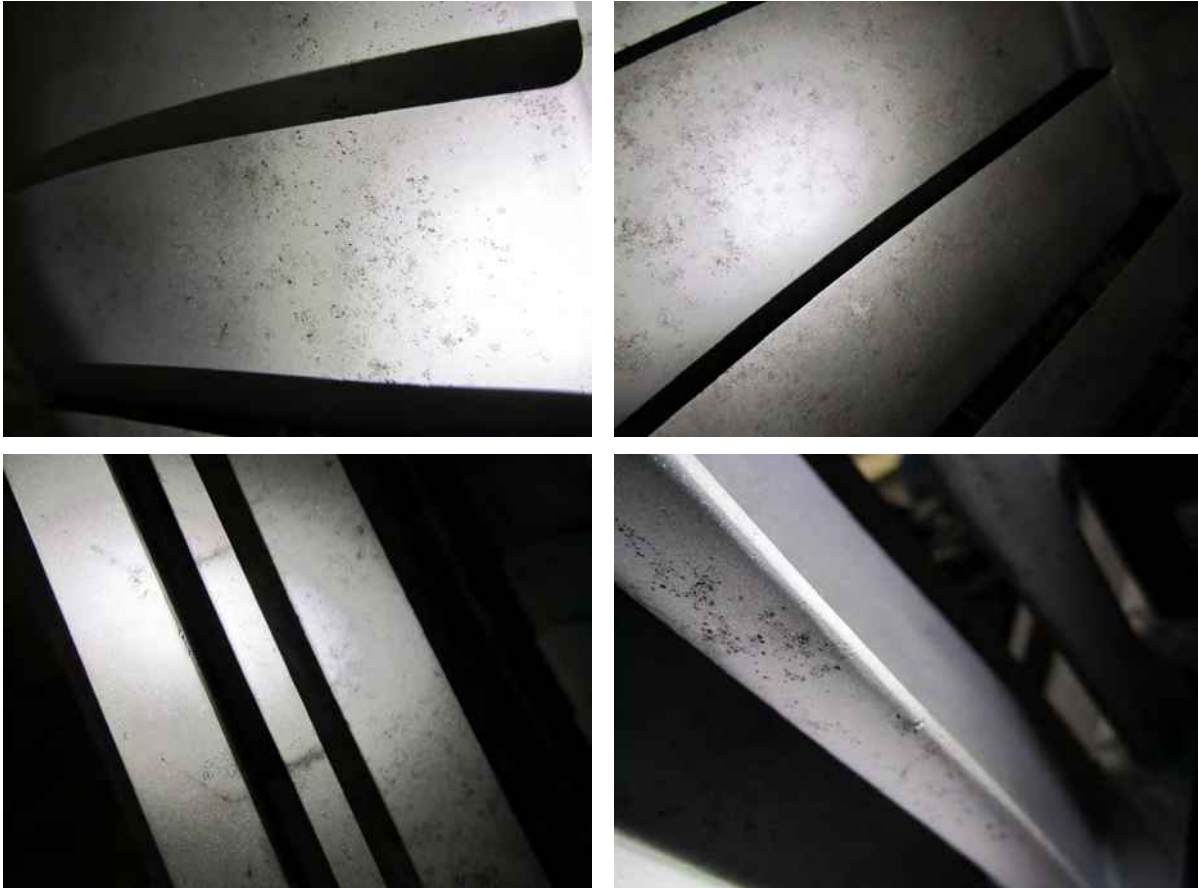
CUSTOMER:		FCSS	
PO #:	4900073380	SURFACE CONDITION:	Oxide Blasted
MATERIAL DESCRIPTION:		LPB Stationary Components	
Stage	Description		
4TL	<ul style="list-style-type: none"> • Thinning of trailing edges. • Erosion/pitting of blade surfaces.

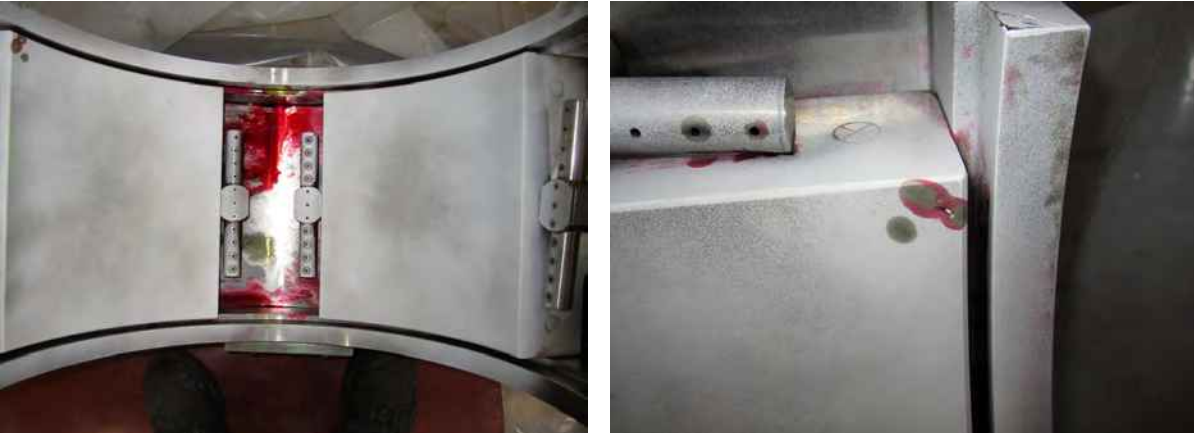
CUSTOMER:		FCSS	
PO #:	4900073380	SURFACE CONDITION:	In Service / Cleaned
MATERIAL DESCRIPTION:		Unit #3 Bearings	
Stage	Description		
T2U	<ul style="list-style-type: none"> • 3/16" oval indication found in babbit • Porosity found on surface.
