Comanche 3 QCP - Major Outage

TURBINE ROTOR INSPECTION

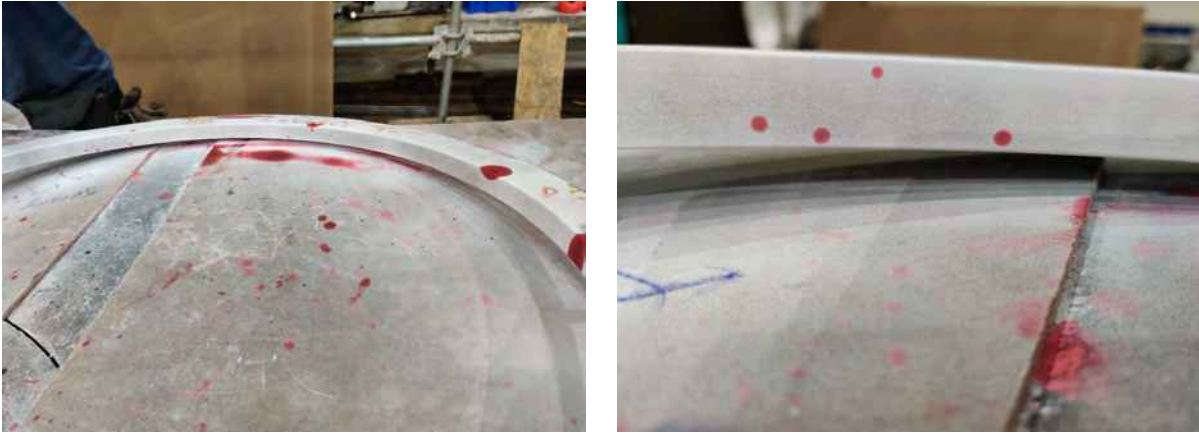
CUSTOMER:		FCSS	
PO #:	4900073380	SURFACE CONDITION:	In Service / Cleaned
MATERIAL DESCRIPTION:		Unit #3 Bearing Seal Rings Findings	
Stage	Description		
T7TL	<ul style="list-style-type: none"> (9) spots of porosity found on ID babbitt face.

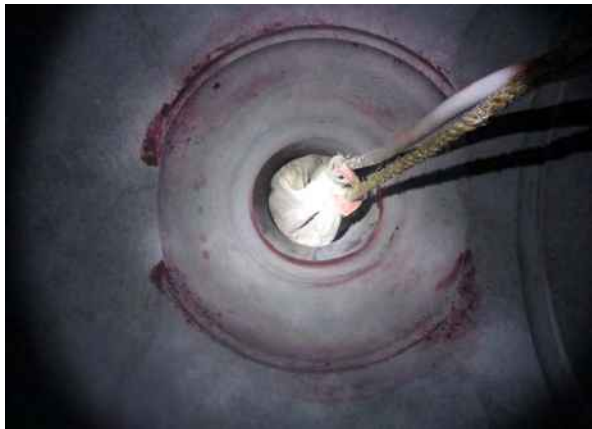
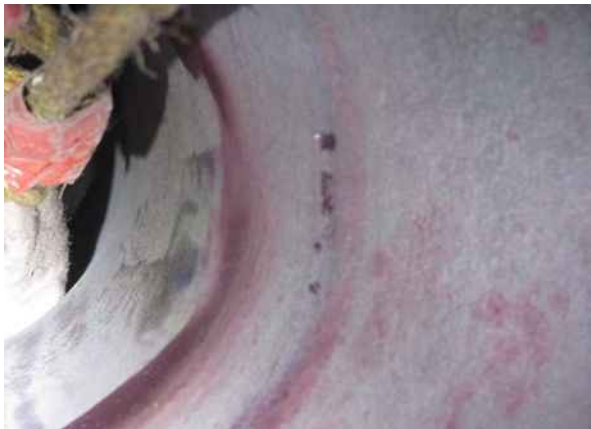
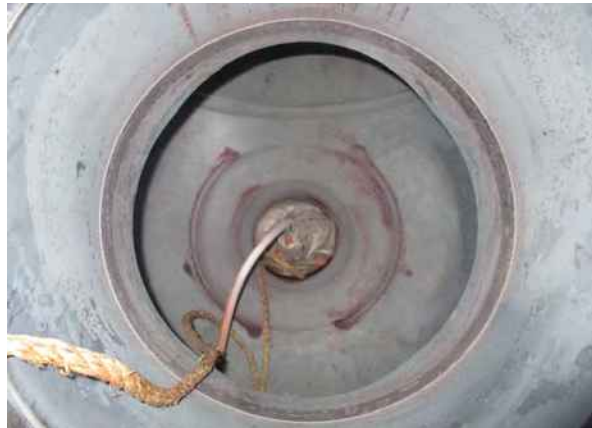
CUSTOMER:		FCSS	
PO #:	4900073380	SURFACE CONDITION:	In Service / Cleaned
MATERIAL DESCRIPTION:		Governor Valves Seats and Corners	
		Description	
<ul style="list-style-type: none"> • R/S #2 indication on the seat • L/S #1 indication corner of the seat

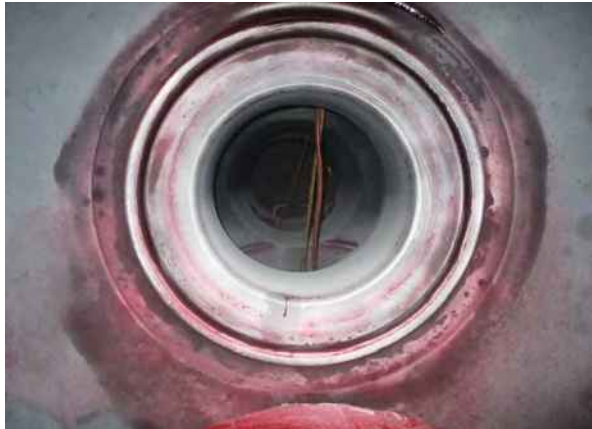
CUSTOMER:		FCSS	
PO #:	4900073380	SURFACE CONDITION:	In Service / Cleaned
MATERIAL DESCRIPTION: Throttle Valves R/S and L/S Seats, Seal Welds, Strainer Grooves and Swirl Dams			
Description			
	<ul style="list-style-type: none"> R/S Seat: Cracklike indication through the seat

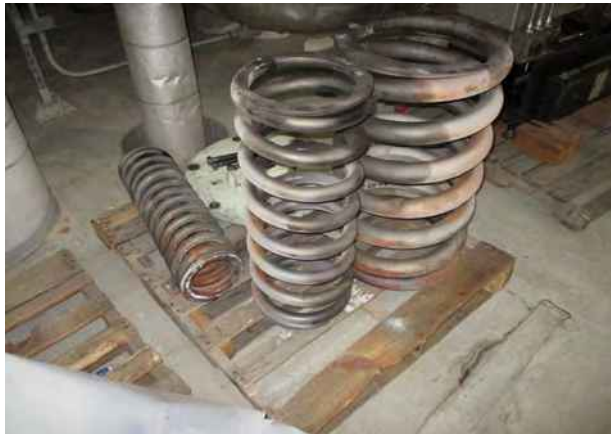
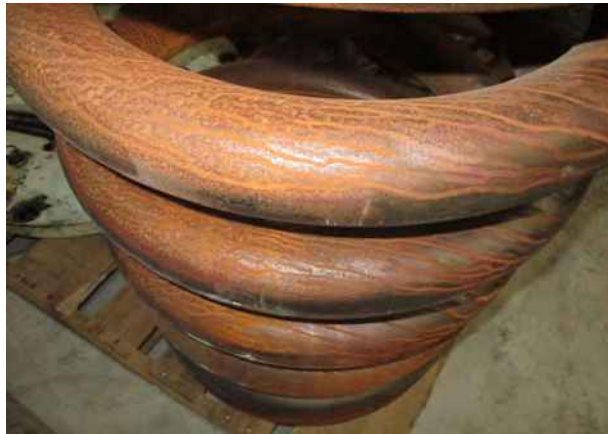
- General corrosion on all springs

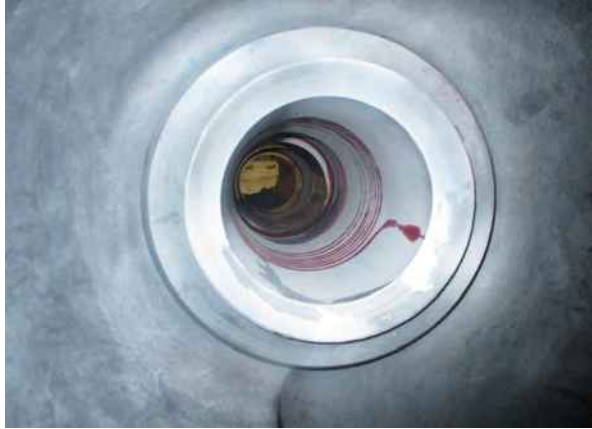
CUSTOMER:		FCSS	
PO #:	4900073380	SURFACE CONDITION:	In Service / Cleaned
MATERIAL DESCRIPTION: Throttle Valves R/S and L/S Seats, Seal Welds, Strainer Grooves and Swirl Dams			
Description			
	<ul style="list-style-type: none"> R/S Bushing: Cracklike indication spiraling from seat into the bushing
