STAFF REPORT

PROCEEDING NO. 20I-0437E

IN THE MATTER OF THE INVESTIGATION INTO THE HISTORY AND CONTINUING OPERATIONS OF THE PUBLIC SERVICE COMPANY OF COLORADO COMANCHE UNIT 3 GENERATING STATION PURSUANT TO DECISION NO. C20-0505.

March 1, 2021

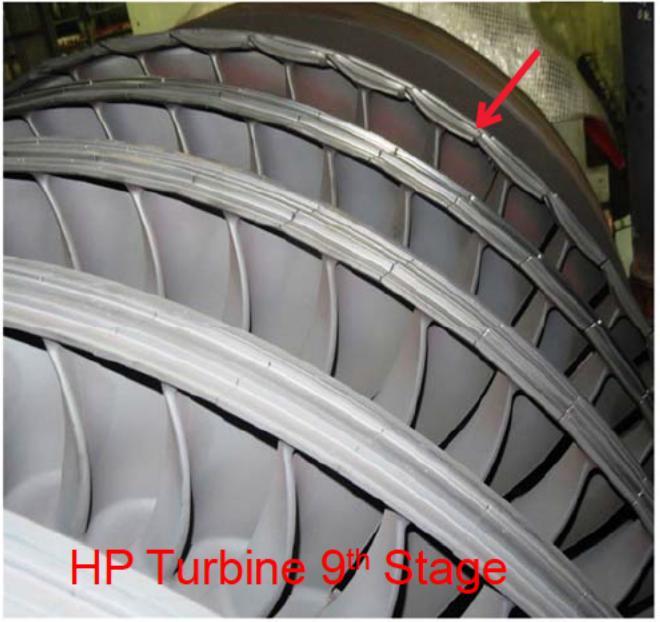
The detailed inspection and analysis of the condition of the turbine suggested that the high pressure turbine shaft and turbine casing was bowed from water induction into the turbine during two events in January and September of 2018. It's likely that damage occurred when the bowed shaft was rotated on the turning gear and during unit startup. Damage also likely occurred during a third event in December of 2018, a startup with excessive vibration from high eccentricity.¹⁰ An example of the damage is shown in the figure below.¹¹

Figure 5. HP turbine damage at 9th stage.

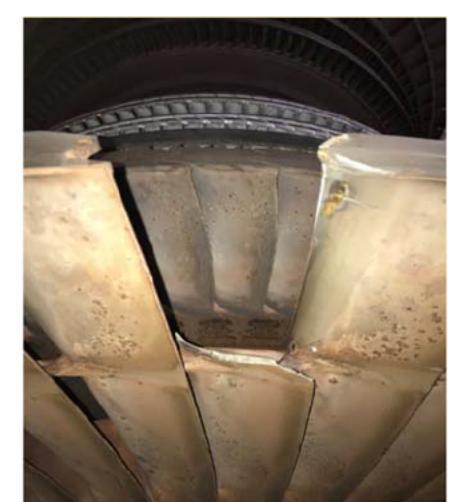
The Company also engaged the services of Structural Integrity Associates (SI) to investigate the mechanism and root cause of the L-1 turbine blade failure shown in Figure 5 below, and to assess the steam cycle chemistry for Comanche 3.¹⁹

Figure 6. Missing turbine blade of L-1 section of LH.²⁰

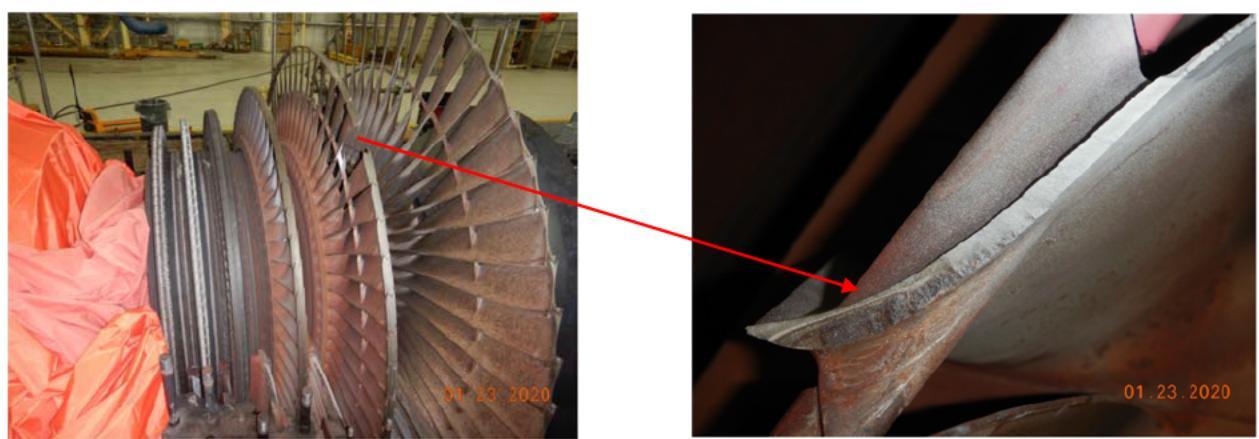
The company also engaged a consultant to assess whether steam cycle chemistry contributed to the blade damage show in the figures below.²¹

Figure 7. Blade damage.

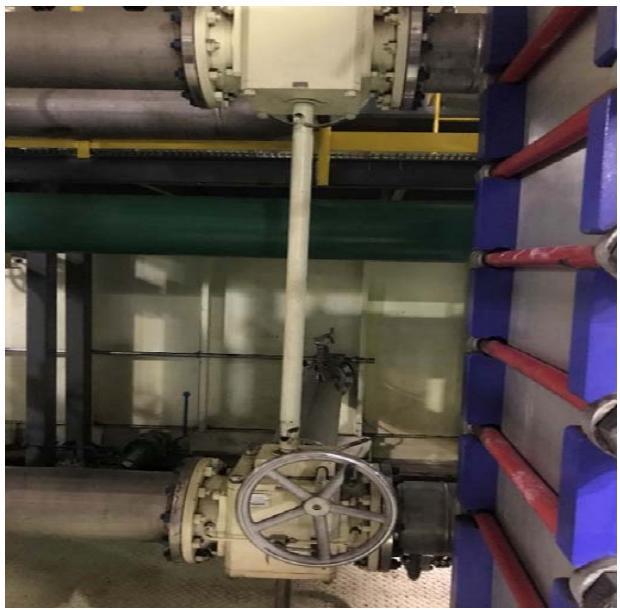
Consistent with best design practices, most large turbines having TLO systems have two heat exchangers and two lube oil strainers. The piping and valve configurations required to provide this redundancy is complex to design and costly to install. On the Comanche 3 turbine, the original piping designers chose to employ a singular unique valve assembly called a TLO Cooler 6-Way Transfer Valve which is shown below:

Figure 10. TLO cooler 6-way transfer value. 37

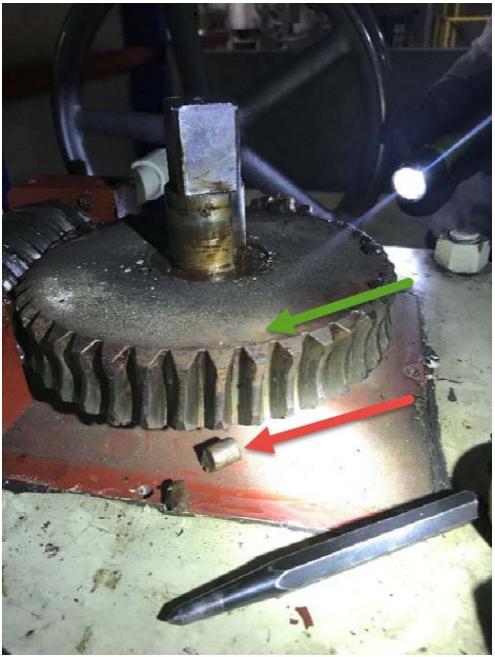
The Technical Improvement Team evaluated the TLO Cooler 6-way Transfer Valve and identified equipment damage based on design flaws in the valve's actuator. Specifically, the design for the valve master actuator worm gear stop pin (dowel pin) was determined inadequate (i.e., the original carbon steel material and 10mm pin size was undersized) and, as a result, sheared off at some unknown point in time during prior operation.³⁹

Figure 11. Stop pin (red arrow) found under gear (green arrow). 40

Because the stop pin was sheared, the actuator was able to rotate the valve's in-stream element (i.e., ball or plug) to a position which eliminated all TLO flow to the turbine bearings. To inspect or repair stop pin, the valve actuator

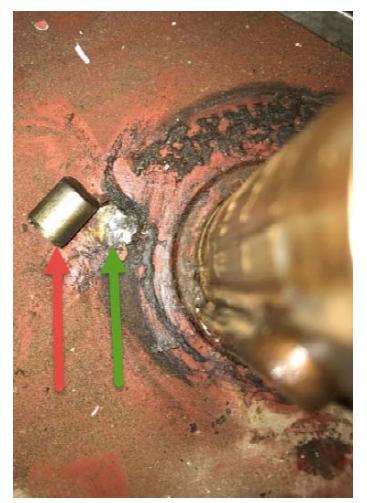
must be disassembled as this stop pin is located underneath actuator gear. Because of location of the pin below the gear, the valve would have to be out of service (i.e. under lockout tag out control) to inspect and repair the pin. The valve could only be out of service if the turbine lube oil system was out of service. Upon disassembly of the valve, the sheared stop pin was discovered laying loose under the gear. Figure 10(a) shows the broken stop pin (red arrow) and the sheared off section of stop pin (green arrow) in the valve body. Figure 10(b) shows the underside of the gear shows circular collar (green) with a 180degree collar section (red) which butts against the stop pin to prevent overtravel.

Figure 12 (a) Gear removed.⁴¹

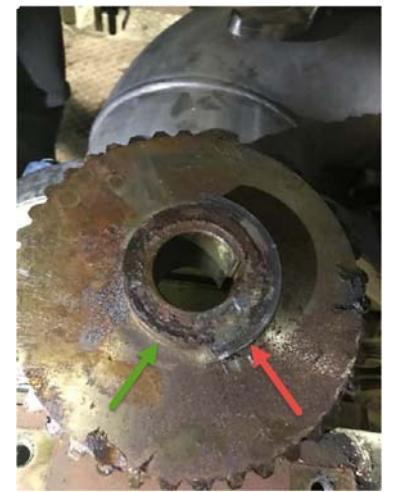
Figure 10(b) *Underside of gear.*⁴²

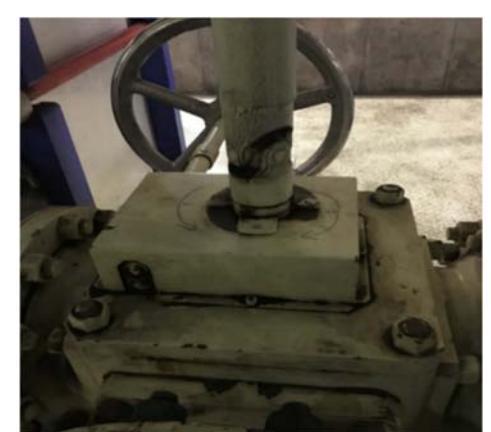
• *TLO Cooler 6-Way Valve Master Valve Actuator Design.* The master actuator did not have adequate visual indication of the relative position of its in-stream element as shown below.

Figure 13. Sharpie inscribed 6-way transfer valve position indication as found. 43

The Technical Improvement Team corrected the inadequate visual indication position on the valve actuator by replacing the existing square shroud, with a rounded "nub" indicator and no signage, with a circular plat and "notched" indicator with plastic labeling as show below.

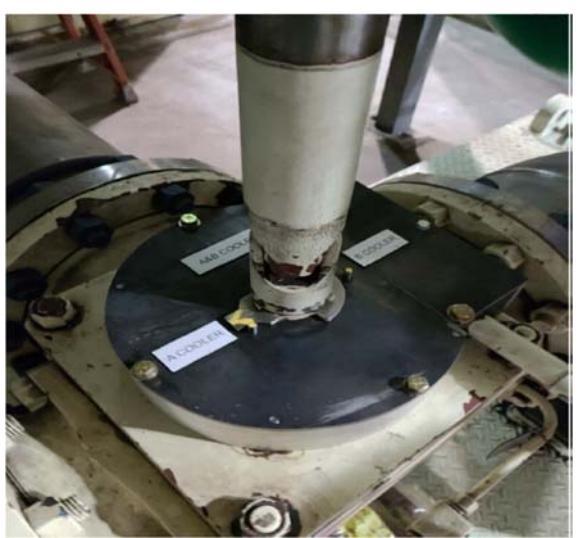
Figure 14. 6-way valve position indicator as modified.

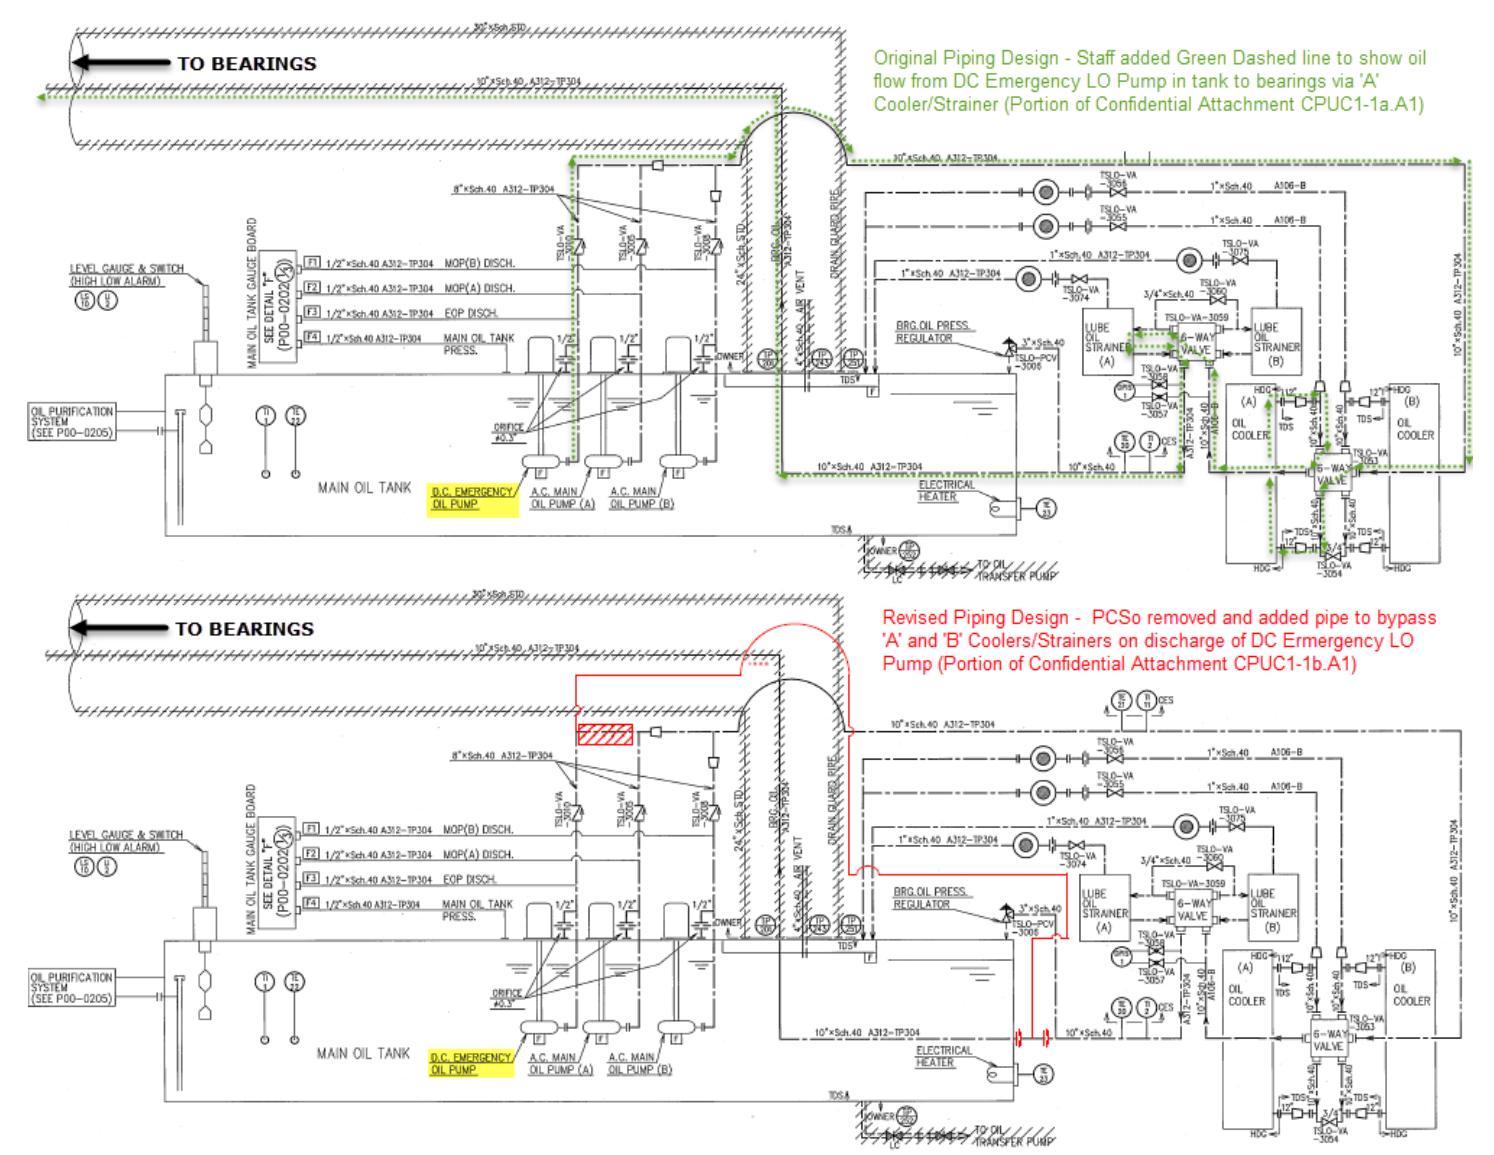
• *TLO Cooler TLO Backup Source*. The TLO Cooler 6-Way Valve was the single point of failure for the June 2, 2020 incident. When the valve stop pin failed, it allowed plant personnel to position valve such that it isolated TLO flow to critical turbine components and also isolated TLO flow from the emergency backup TLO pump.

Figure 15. Original P&ID of lube oil system (top) vs. revised P&ID (bottom).

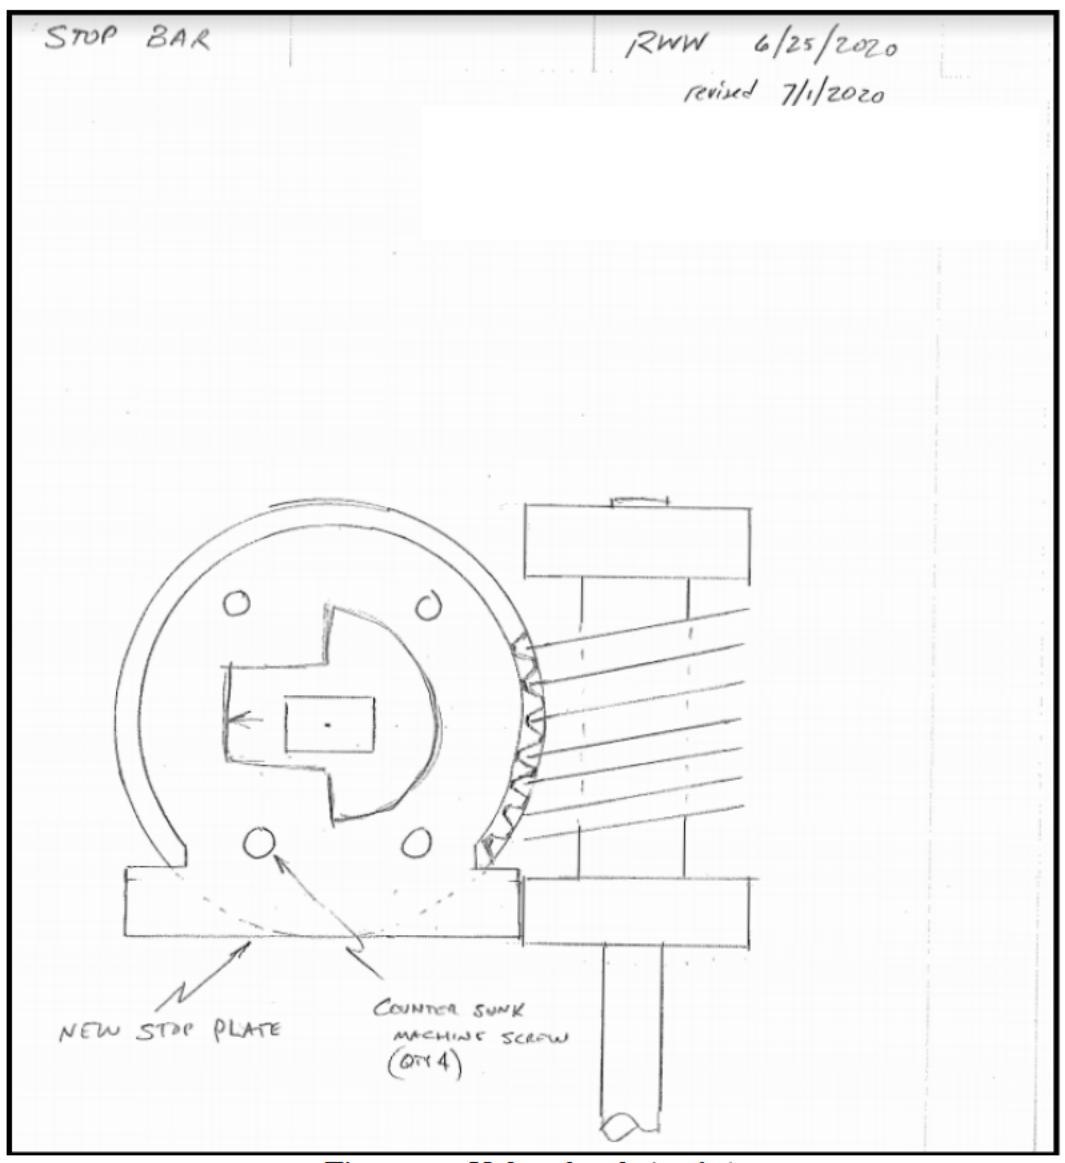
Figure 16. Value sketch (1 of 2).

It was noted that the drawings were created and signed by the Technical Improvement Team Lead, who also happens to be the Plant's Manager of Reliability. There was no secondary or independent signature that demonstrated that the design was reviewed or verified. As is apparent by the single signature, design changes appear to have been made also without independent verification. There was no indication of the materials used for the modifications to the valve. There is no discussion of why modifications were made necessary (e.g. the result of a previous incident or identified by a SPOF analysis). There is no indication of what service standard was used, nor was there any indication that the drawings were filed or input into the plant's drawing system for future reference or traceability.

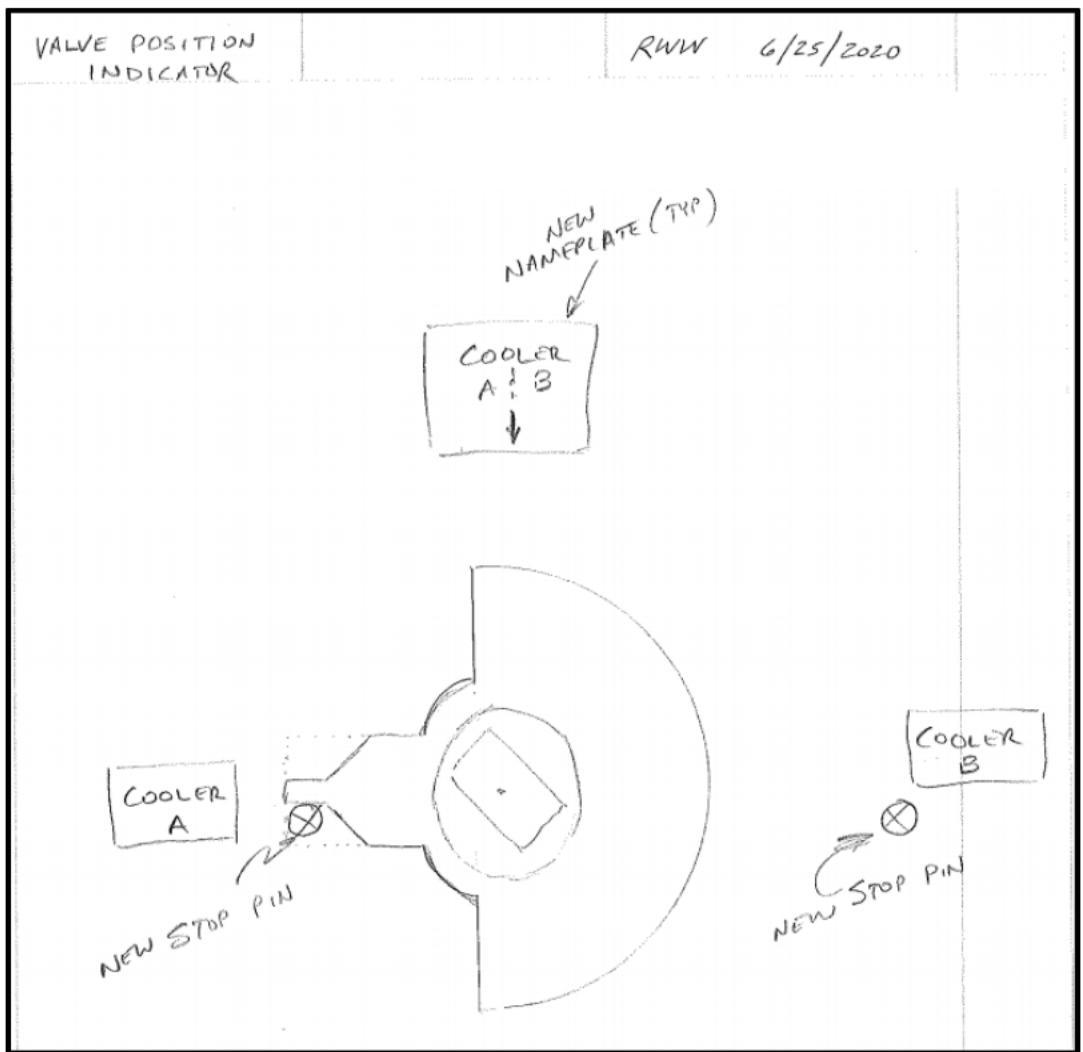
Figure 17. Valve sketch (2 of 2).

While this is may be a minor design change, it is essential to create a record of what modifications were made and why.
