Report on Comanche Unit 3 High Pressure Turbine Blade Damage

Prepared by Fleet Engineering

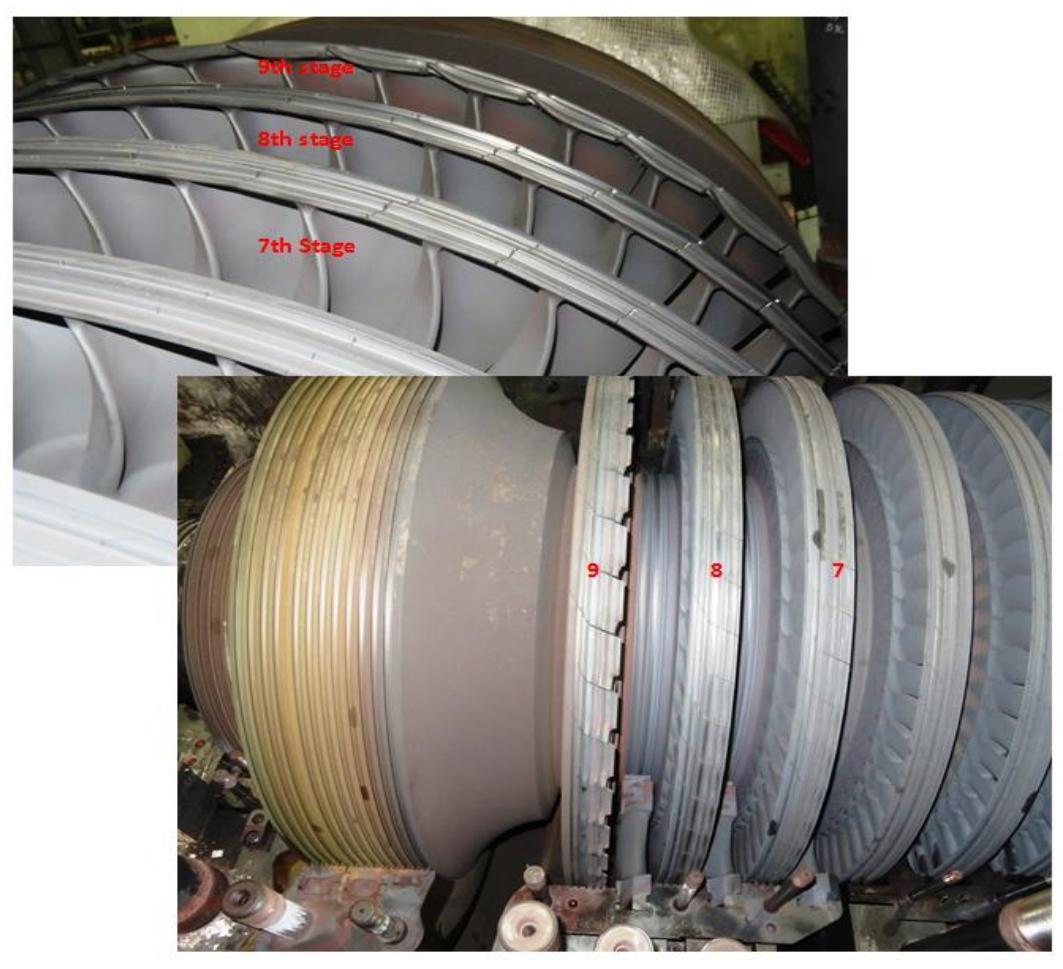
Inspection of the HP Turbine revealed rubbing on the rotating blade shrouds of stages 2 through 9 with work hardening of the shrouds from heating on stages 7, 8, and 9. A corner section of the shroud was missing on the stage 9 blades. Stationary seal damage was significant in the lower portion of the casing.

Hardness of the rotating blade shrouds ranged from 47.7 HRC to 50.6 HRC compared to the standard blade hardness of 30 HRC to 35 HRC. After removal of 0.010 inches of blade material, hardness increased by as much as 10%. Since the hardness could not be removed by machining, the rotating blades for stages 7, 8, and 9 required replacement, along with the seal strips. Replacement blades were sourced through the Ethos Energy Group.

The pictures below show the altered shapes of the stage 9 rotating blade shrouds.

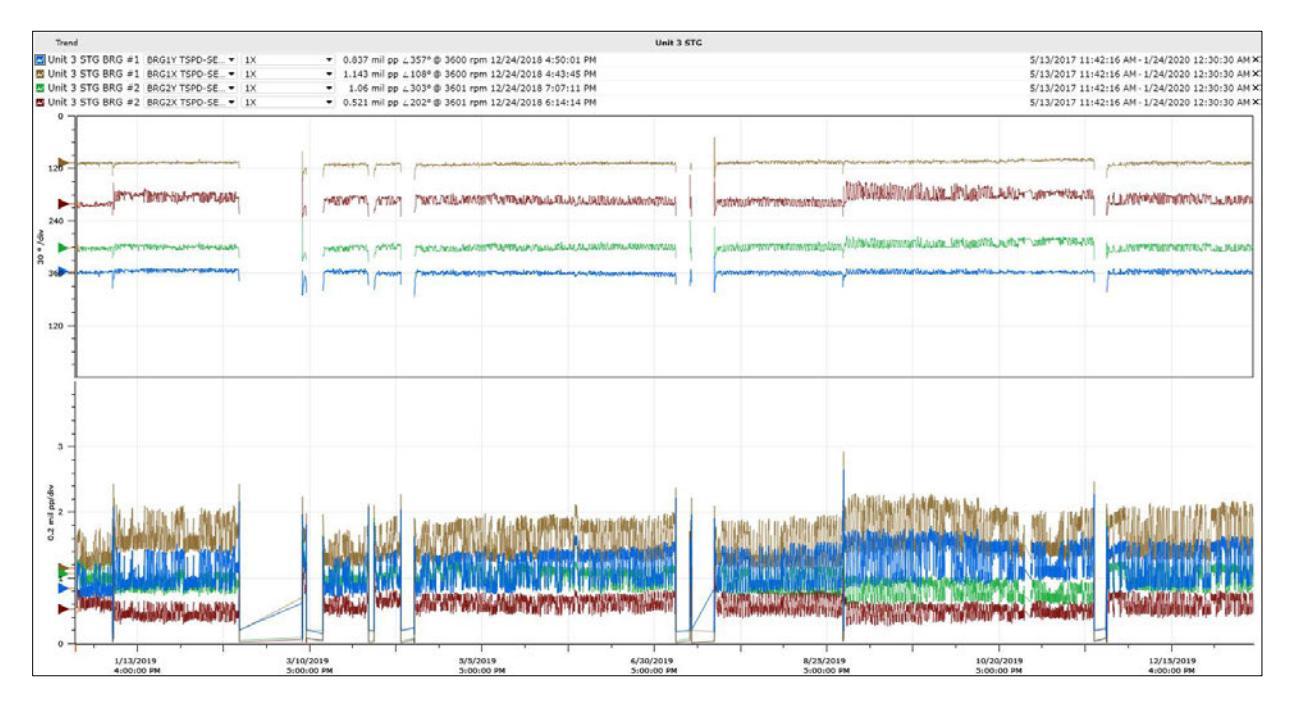
Bearing 1 and 2 vibration and phase trends were reviewed for step changes. As seen in the example below, in 2019, there were no large amplitude nor phase step changes that would indicate balance shifts. Temporary high amplitude excursions, as could occur while the rotor was rubbing, were also not found while the machine was online. High amplitude vibration occurred on Bearings 1 and 2 during several startups in 2018. The significant startup vibration events will be discussed further in Contributing Events.

Figure 1: 1X running speed vibration amplitude and phase through 2019

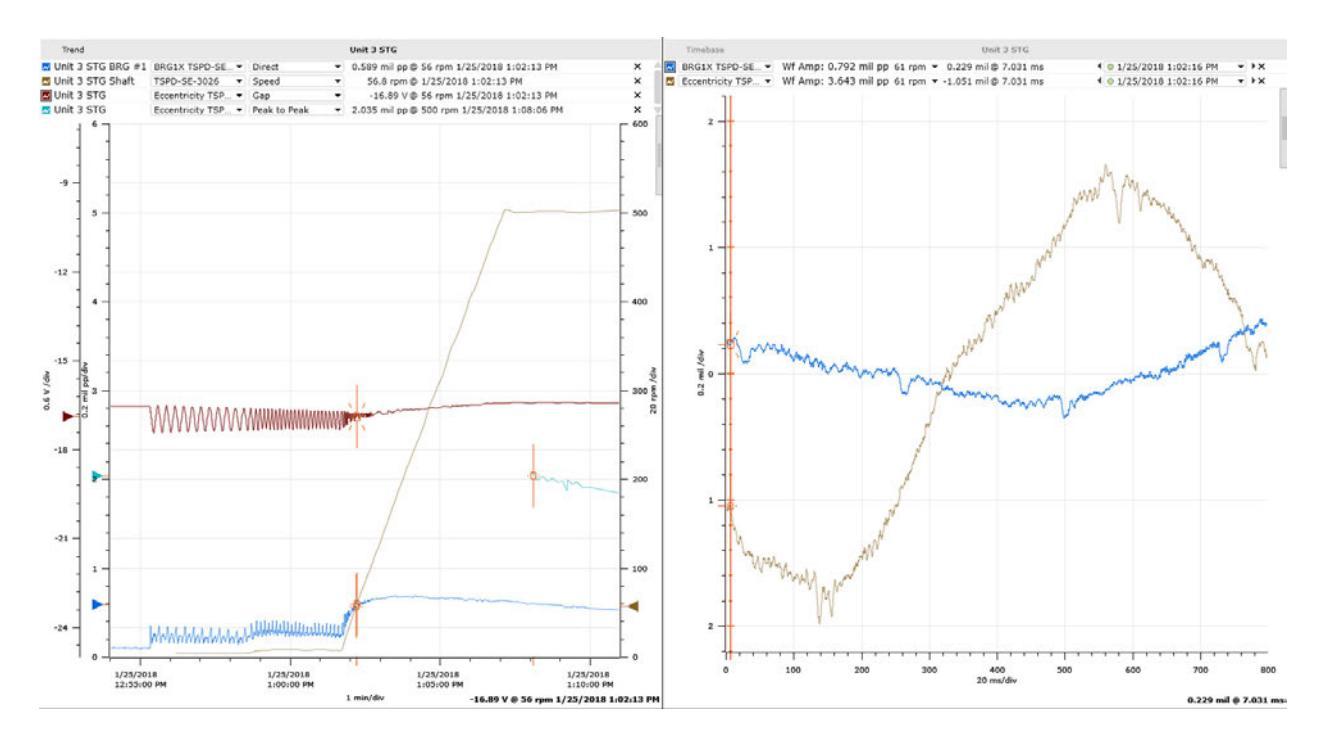
High eccentricity will cause high HP/IP Turbine vibration during turbine roll up. As the example in Figure 2 shows, high eccentricity was present for several startups when the high eccentricity alarm did not initiate.

Figure 2: January 25, 2018 rotor eccentricity waveform (right) can be used to verify that eccentricity was over 3.5 mils, alarm 2.95 mils, while out of range for calculated value that initiates the high eccentricity alarm.

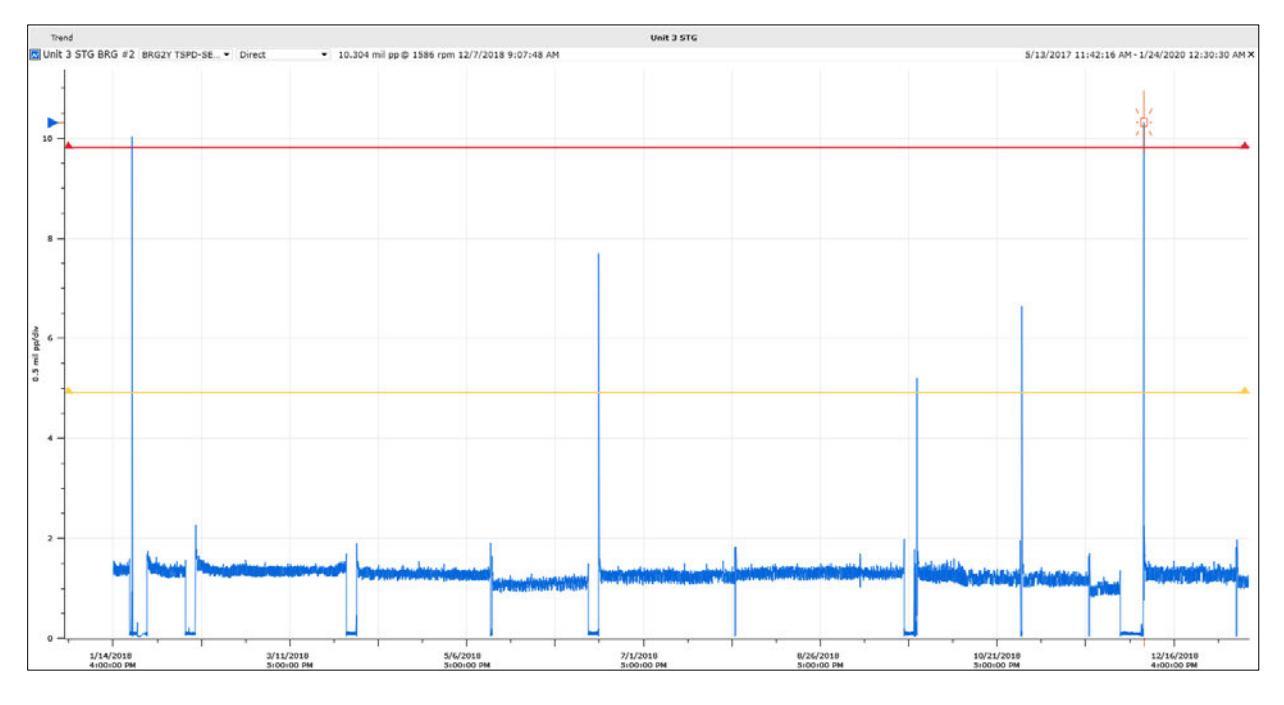
After the turbine was removed from service and had been on turning gear for 18 hours, there was a sudden drop in lower casing temperature which caused a differential temperature of 396 °F between the top and bottom of the HP Turbine casing. As the casing differential temperature increased, the vibration increased, up to 10 mils at Bearing 1 and Bearing 2. The turbine stayed on turning gear through this event. Vibration of this magnitude on turning gear is an indication of a significant rub

The turbine started up several days later after the turbine casing differential temperature was normal, on 1/25/2018, after sitting off of turning gear for 1 hour. The rotor ran between 500 - 1000 RPM for 1.25 hours. At low speeds it is difficult to detect potentially destructive rubs because vibration amplitude measured at the journals is very low.

Figure 3: This 2018 Bearing 2 vibration trend shows several startup vibration events and one turning gear vibration event in January.

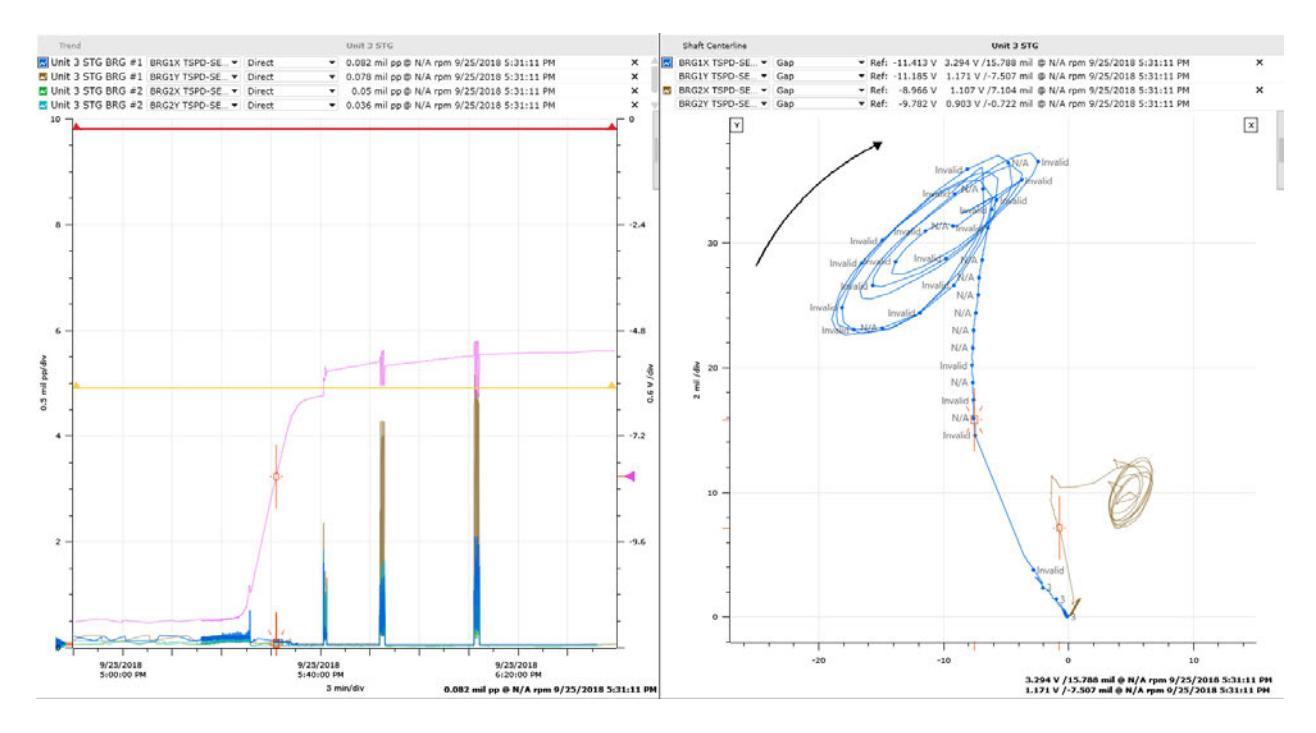
In September of 2018, the HP Turbine developed a 266 °F casing temperature differential after a unit shutdown in which an automatic turbine drain valve did not operate. The shaft centerline rose 36 mils at Bearing 1 during the casing temperature differential. The turbine rotor showed a significant bow as it rotated until the turning gear motor tripped on overload.

Figure 2: This shaft centerline plot(right) from 9/25/2018 shows shaft position rising from (0,0) point at bottom of bearing to +36 mils at BRG1 and +14 at BRG2. The "orbits" at the top of bearing 1 are 1X turning gear speed, essentially measuring 12 mils of rotor bow.

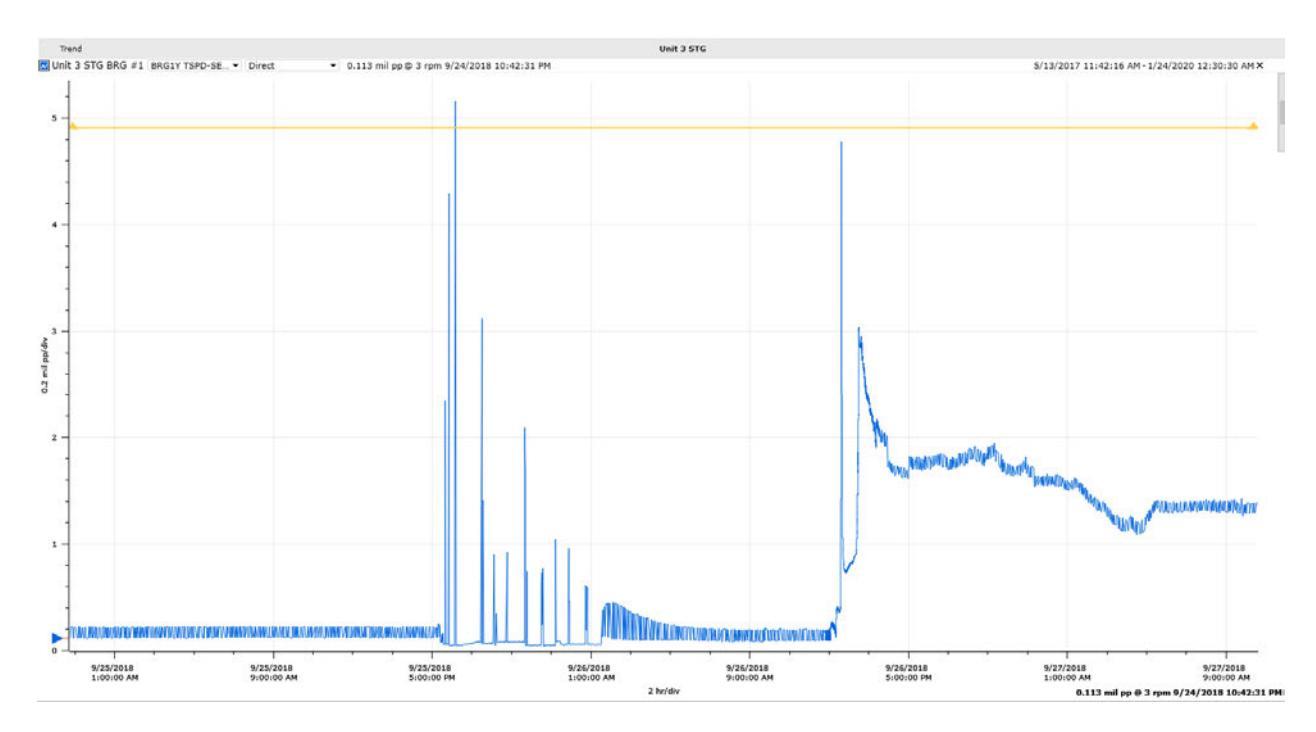
A 120 °F casing temperature differential was still measurable when the turbine was rolled during startup. During the turbine roll the HP/IP Turbine first critical speed reached 6 mils. Unlike the other turbine rolls with high vibration, this turbine roll was not preceded by time off of turning gear. This suggests that the high vibration during the turbine roll was more likely the result of a rub, rather than just high eccentricity. Bearing metal temperatures also slightly rose at Bearing 1 and 2 by 4-5 °F when online.

Figure 3: Bearing vibration amplitude in September 2018 as the unit rubbed on turning gear. Vibration peak during startup is at first critical speed of the HPIP rotor.

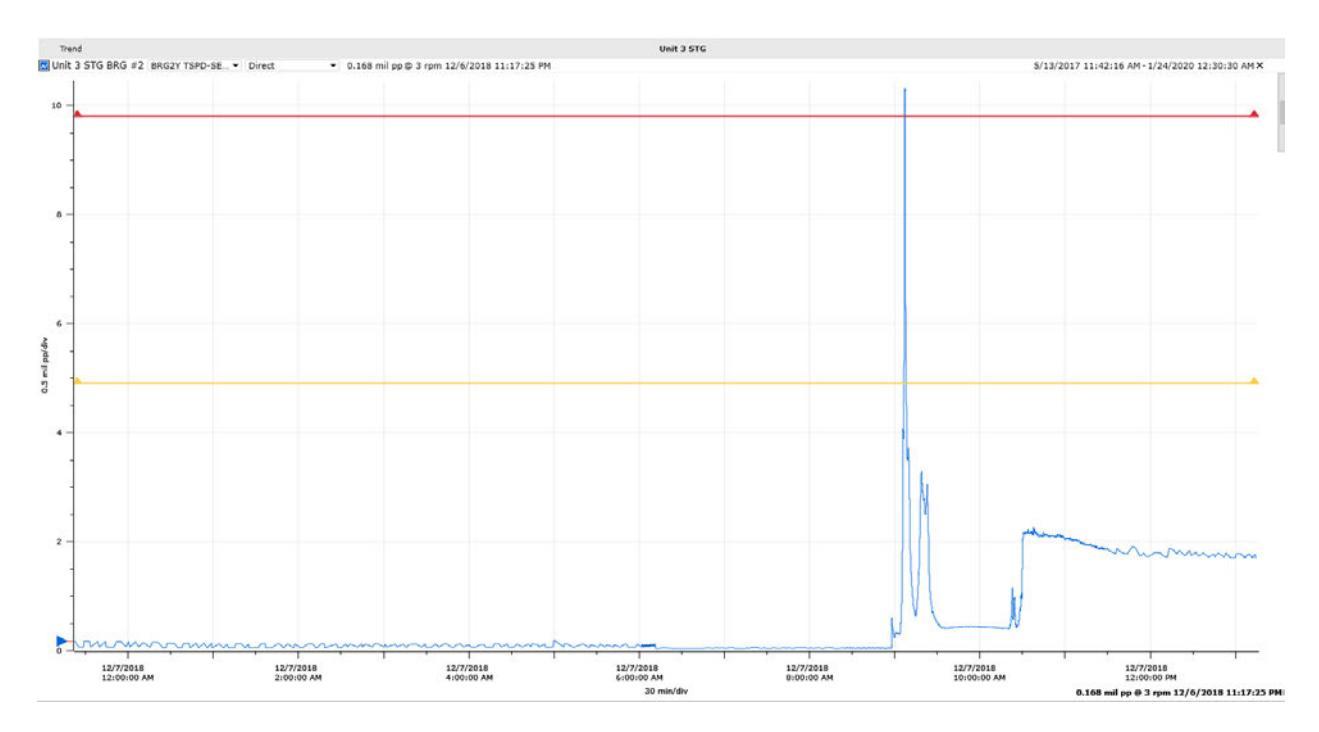
After a seven-day outage the rotor sat at rest for 2.5 hours before turbine roll. The turbine was rolled with no indication of the high eccentricity and tripped at 9.8 mils vibration at 1600 RPM. After one trip and a second attempt to roll up to 2400 RPM, the machine sat at 500 RPM for 50 minutes. At low speeds it is difficult to detect potentially destructive rubs because vibration measured at the journals is very low.

Figure 4: December 2018 startup including reaching trip level of 9.8 mils.

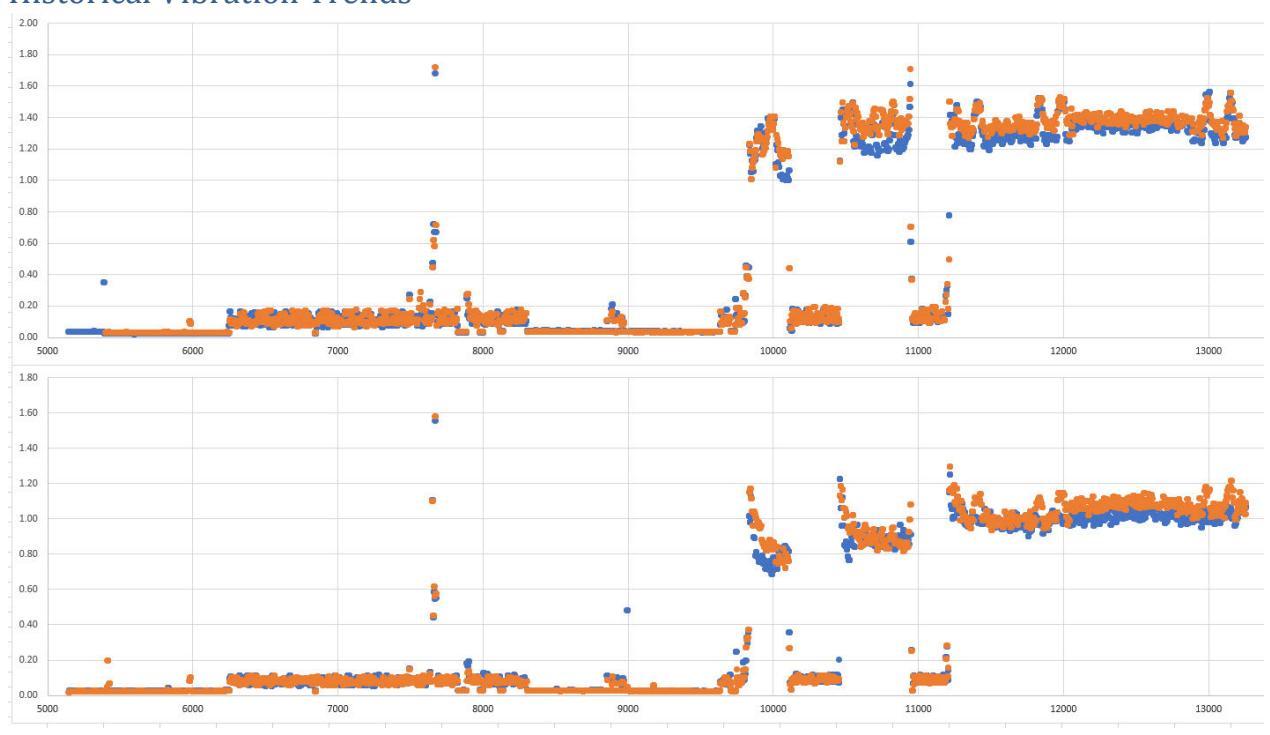
Figure 5: October - Dec 2011 Vibration data for 1X and 1Y(top) and 2X and 2Y(bottom). Overall vibration peaked at 1.8 mils.

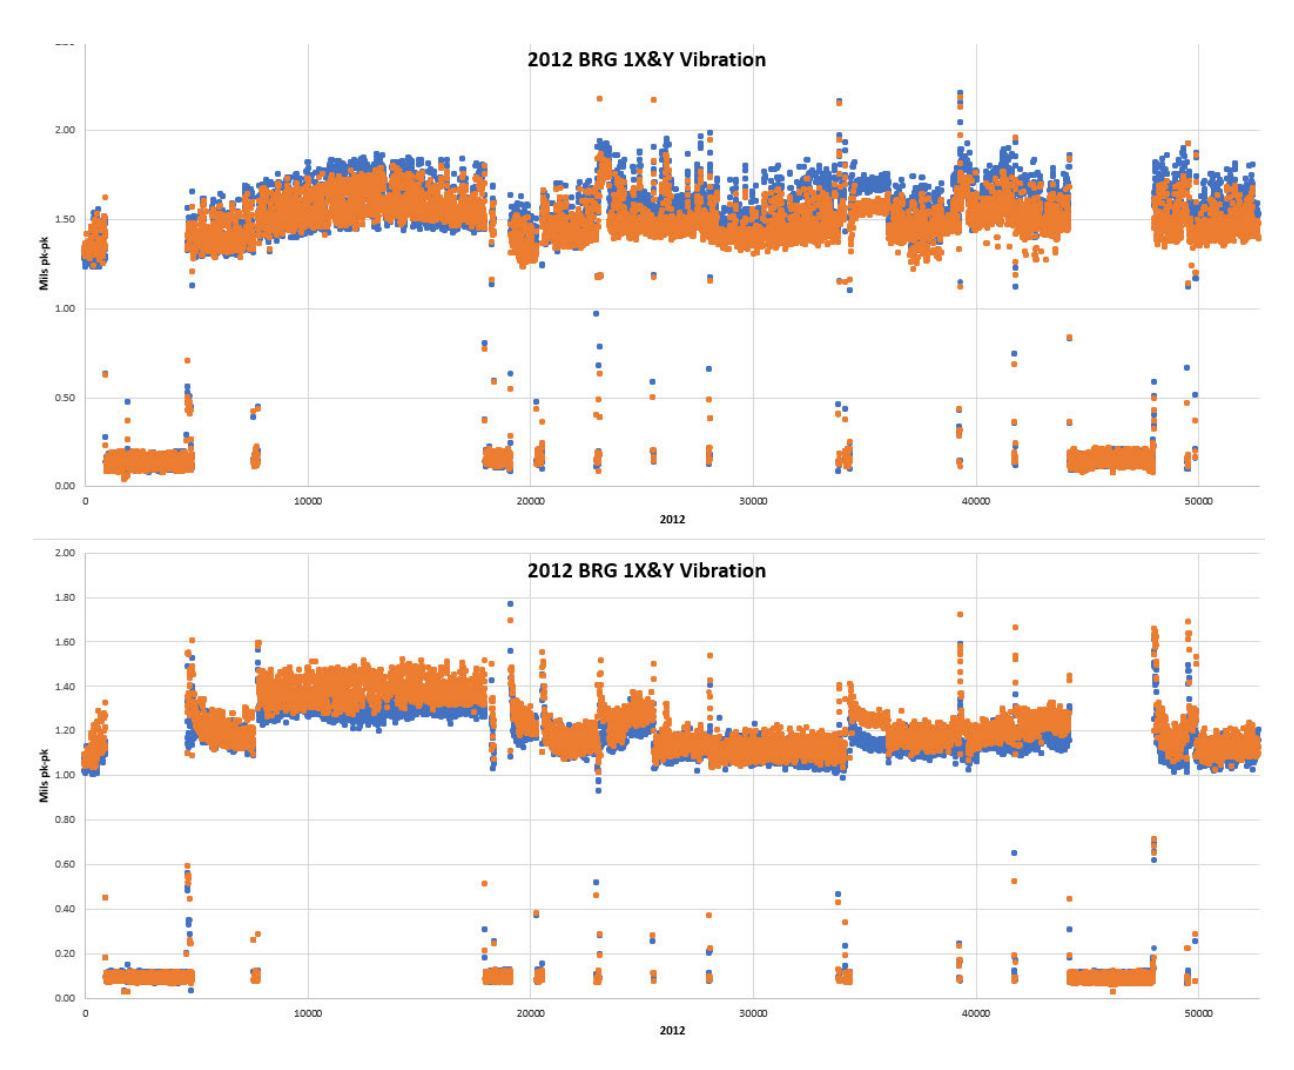
Figure 6: Vibration Trends BRG 1 & 2 2012. Running vibration below 2 mils, transient peaking at 2.25 mils

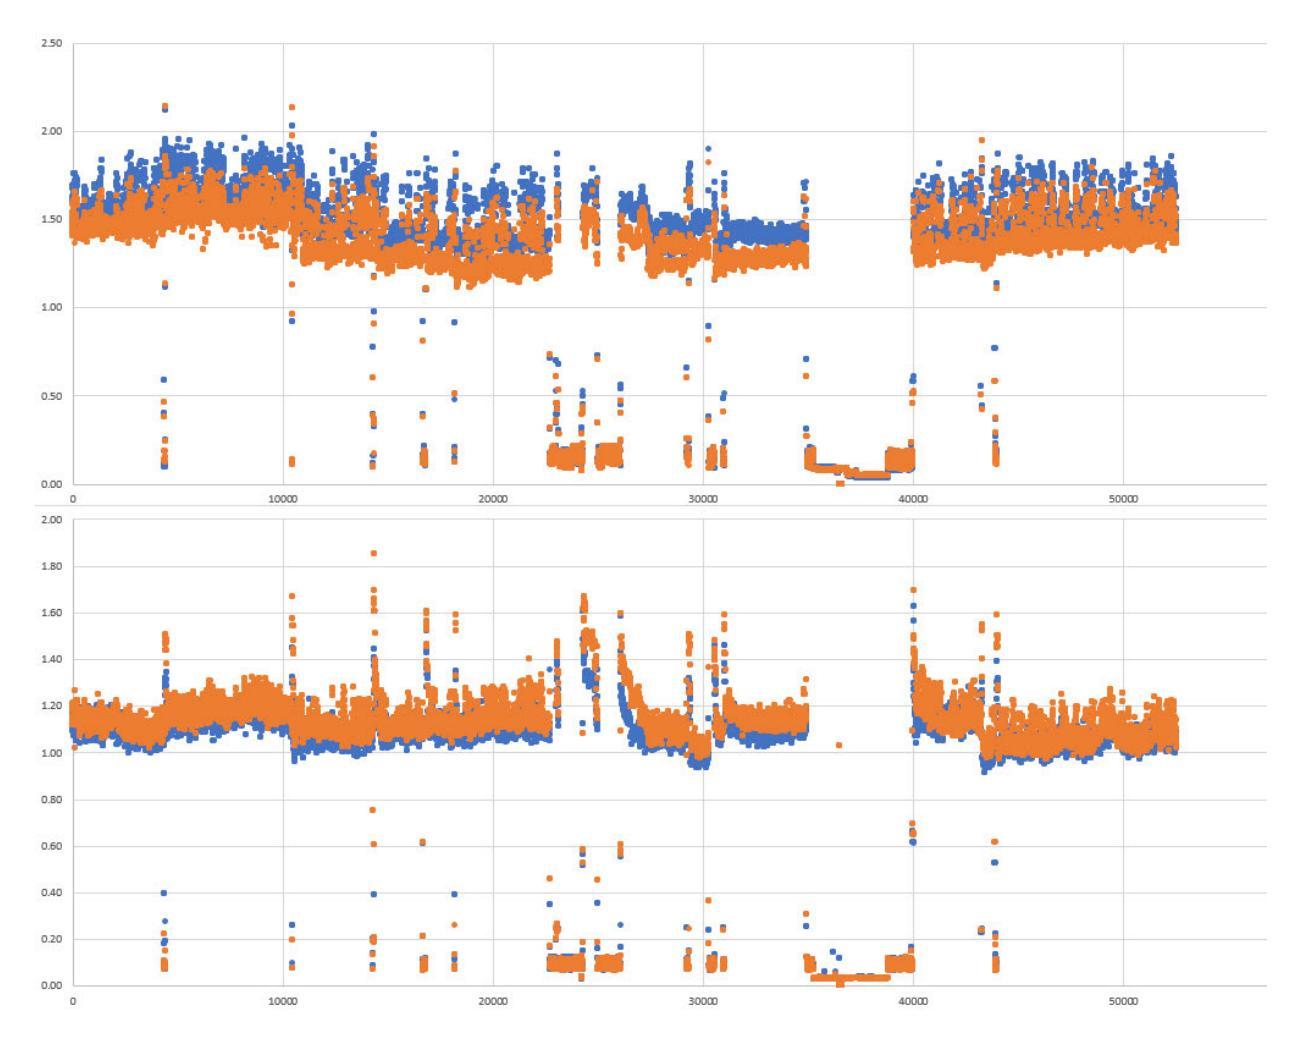
Figure 7: 2013 BRG 1(top) and BRG 2(bottom). Many starts but overall vibration levels remained steady.

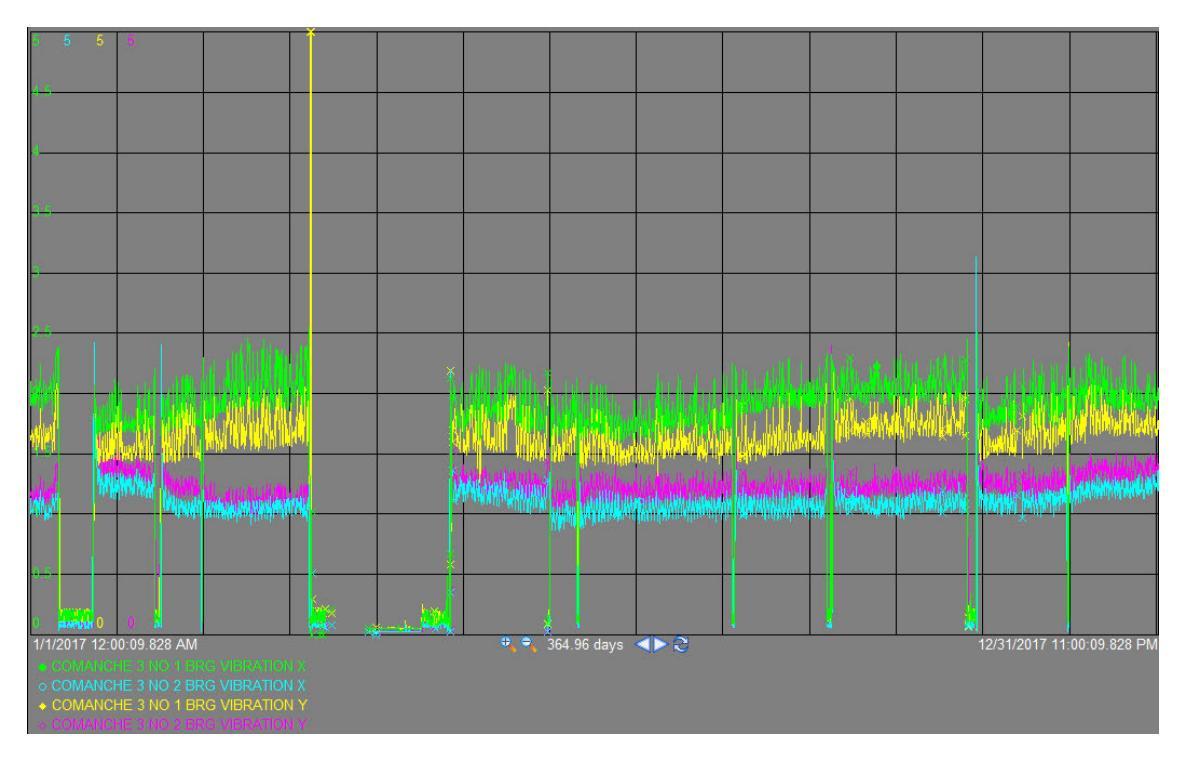
Figure 11: 2017 overall vibration for BRG 1 & 2. Peak after shutdown is instrumentation related.

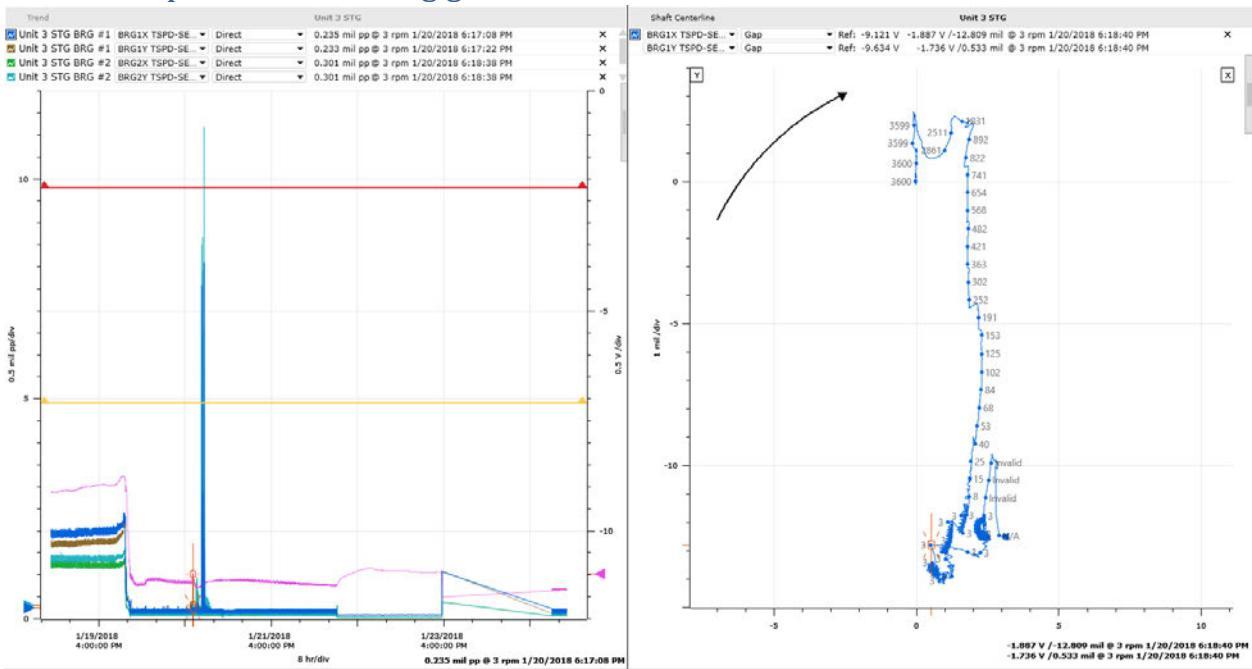
Figure 14: 1/20/18 Casing delta T event. High 37 Hz vibration amplitude every TG revolution began when Delta T increased. Vibration occured without raising shaft CL. There was a 2 mil move to the right when vibration increased, consistant with the direction a rub at the bottom of the case would push the rotor. The shaft CL measurement temporarily rose about 2 mils when the unit was taken off TG. Shaft CL plot shows normal drop of 14 mils during coast down.

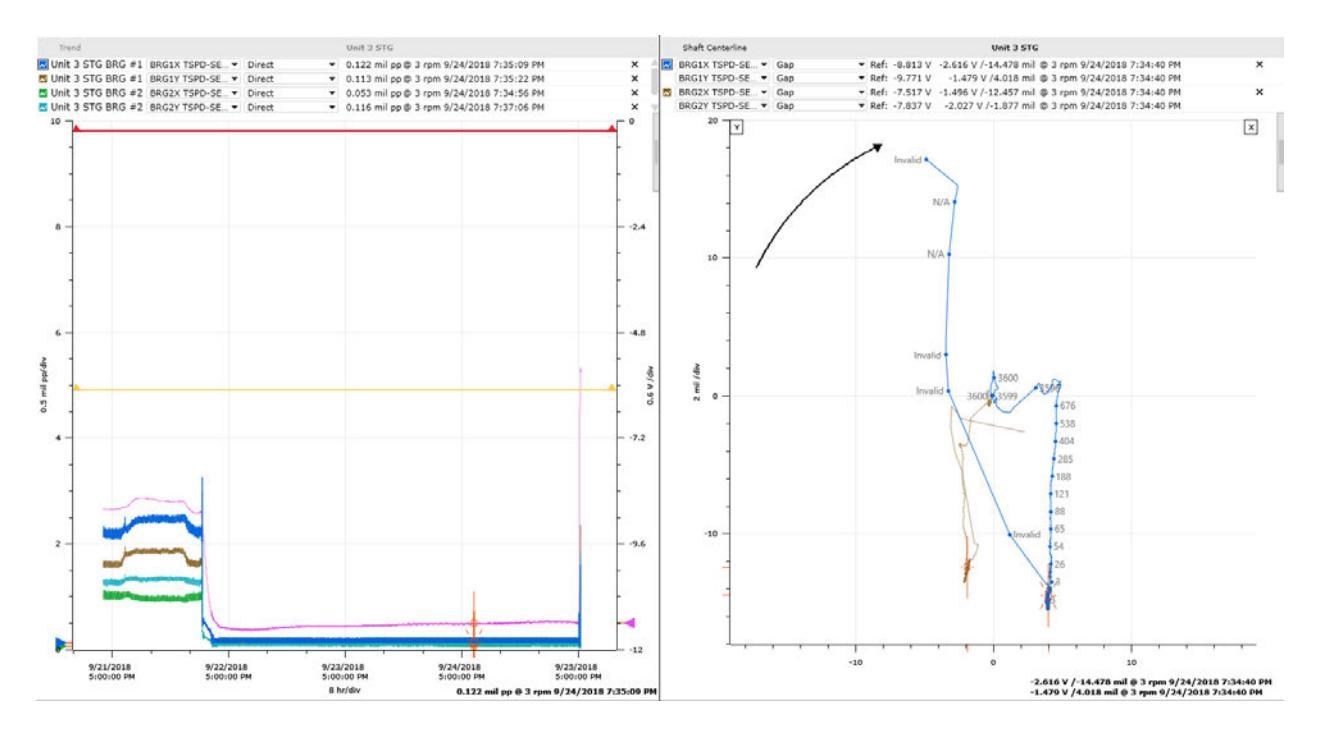
Figure 15: 9/25/18 Casing Delta T event. Shaft CL plot shows running position at (0,0) and coast down drop to (4,-14) for BRG 1 and to (-2, -12) for BRG 2. TG position was steady for 3 days until significant rise to +17 mils at BRG1 and -1 and BRG2

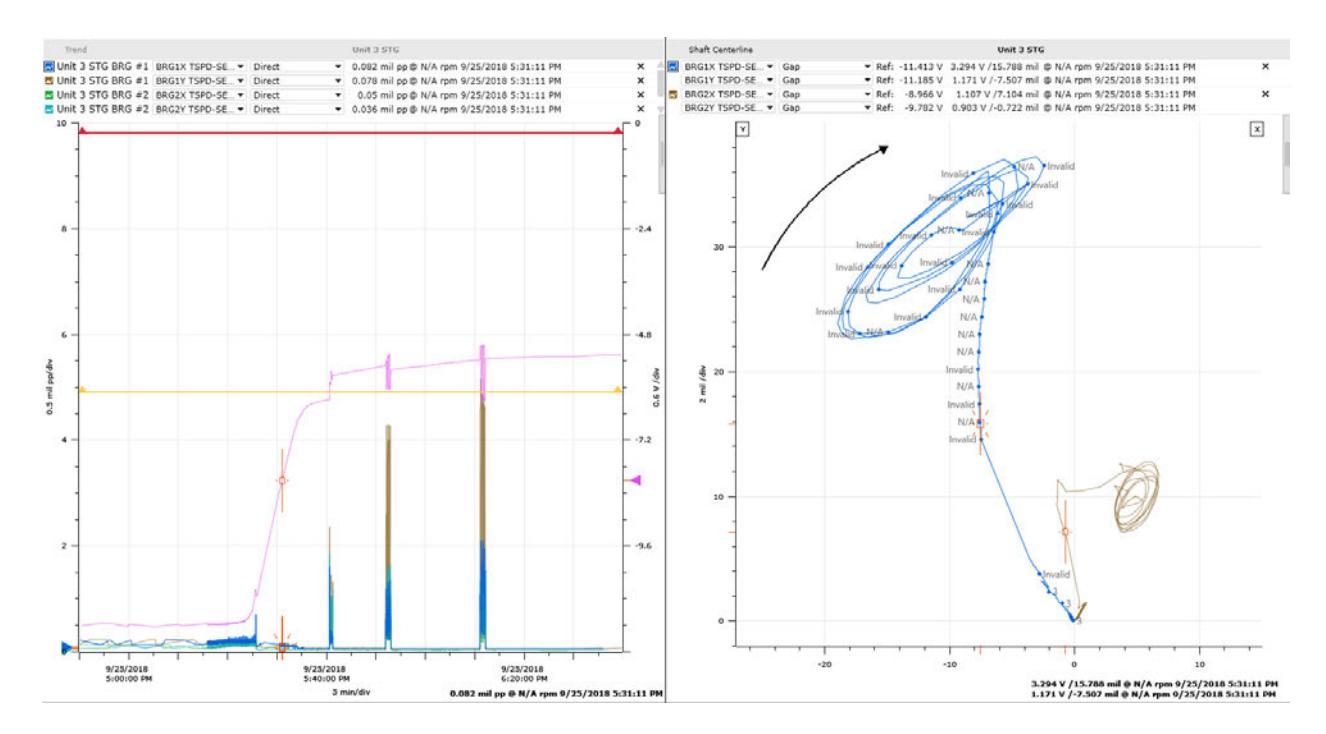
Figure 16: Shaft CL plot shows shaft position rising from new 0,0 point at bottom of bearing to +36 ils at BRG1 and +14 at BRG2. The "orbits" at the top of BRG1 are 1X TG speed, essentially measuring 12 mils of rotor bow. No 37 Hz vibration was measured during the 9/25/18 event.

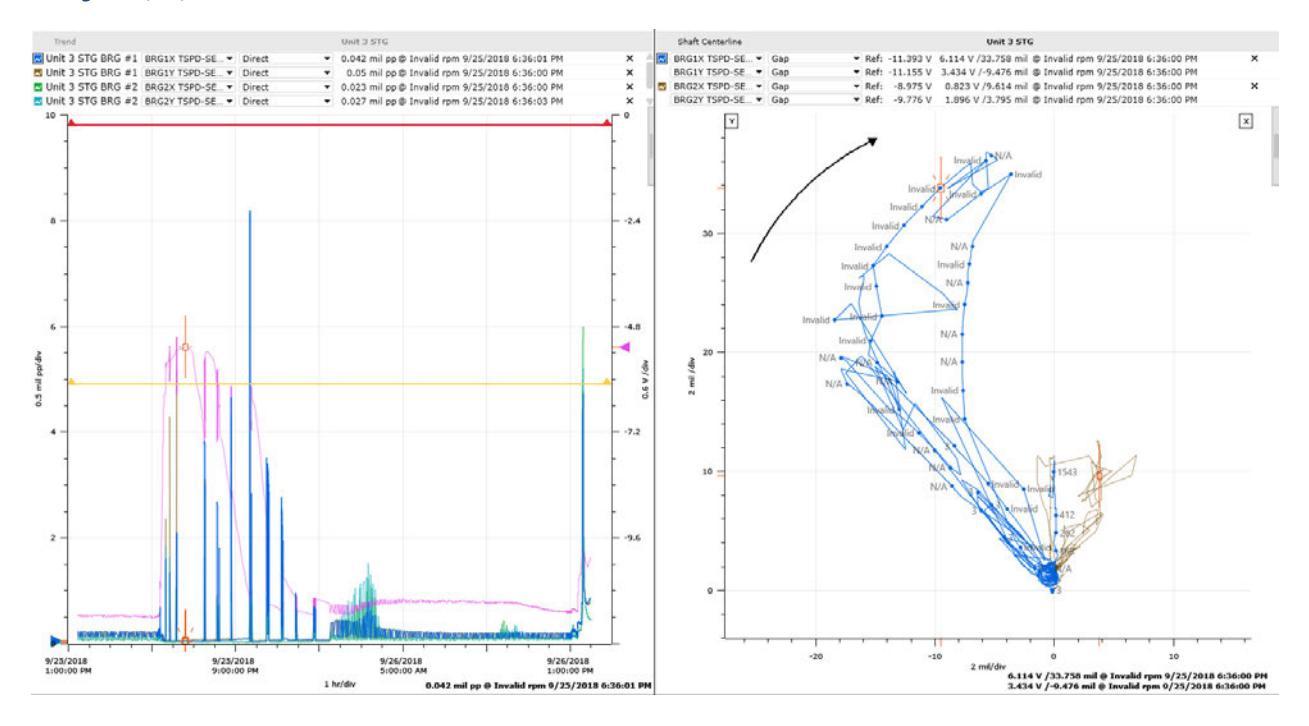
Figure 17: 9/25/18 event. Probe gap voltage shows a high shaft position for about 6 hours, from 5PM to 11PM. PI indicates there was still an HP casing Delta T of about 215F when shaft position returned to normal and the unit was able to stay on TG.

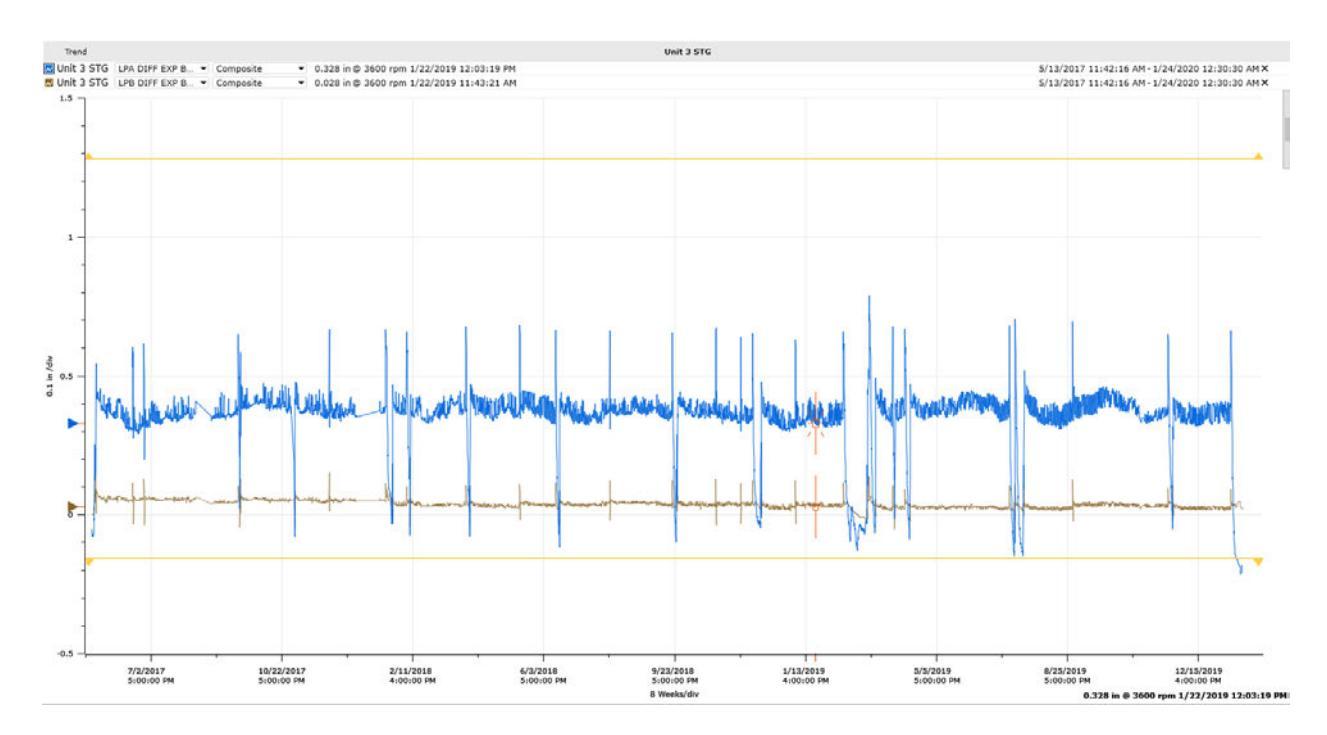
Figure 18: Differential expansion maximum of 0.75 inches and remains constant over historical trend.

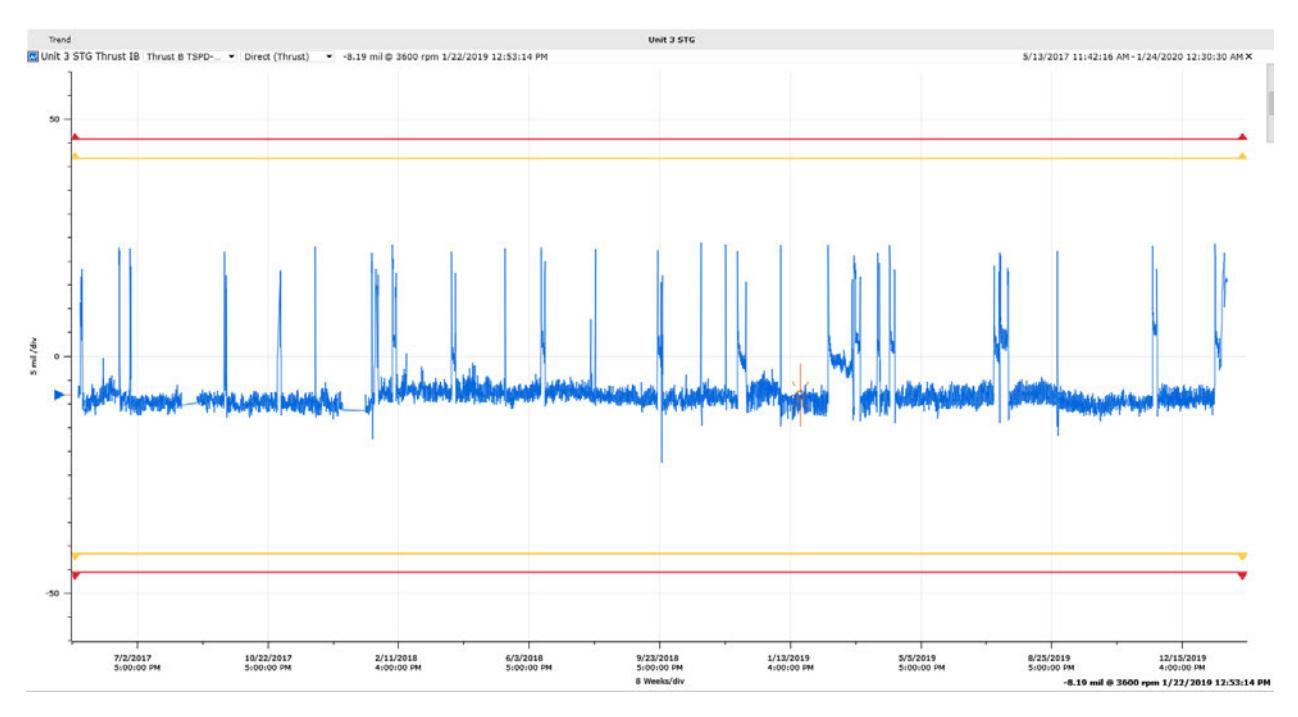
Figure 19: Thrust position indicates a total thrust of 35 mils.
