Comanche Unit 3 -Spring 2020 Outage

Full Train Major, Main Steam Valves & Generator

COMANCHE (CO) Steam Turbine ESN: SY0093272 Generator ESN: SY0350139 Job Start Date: 13 Jan 2020 Oracle Project ID: FSP-285469 | C-10344497

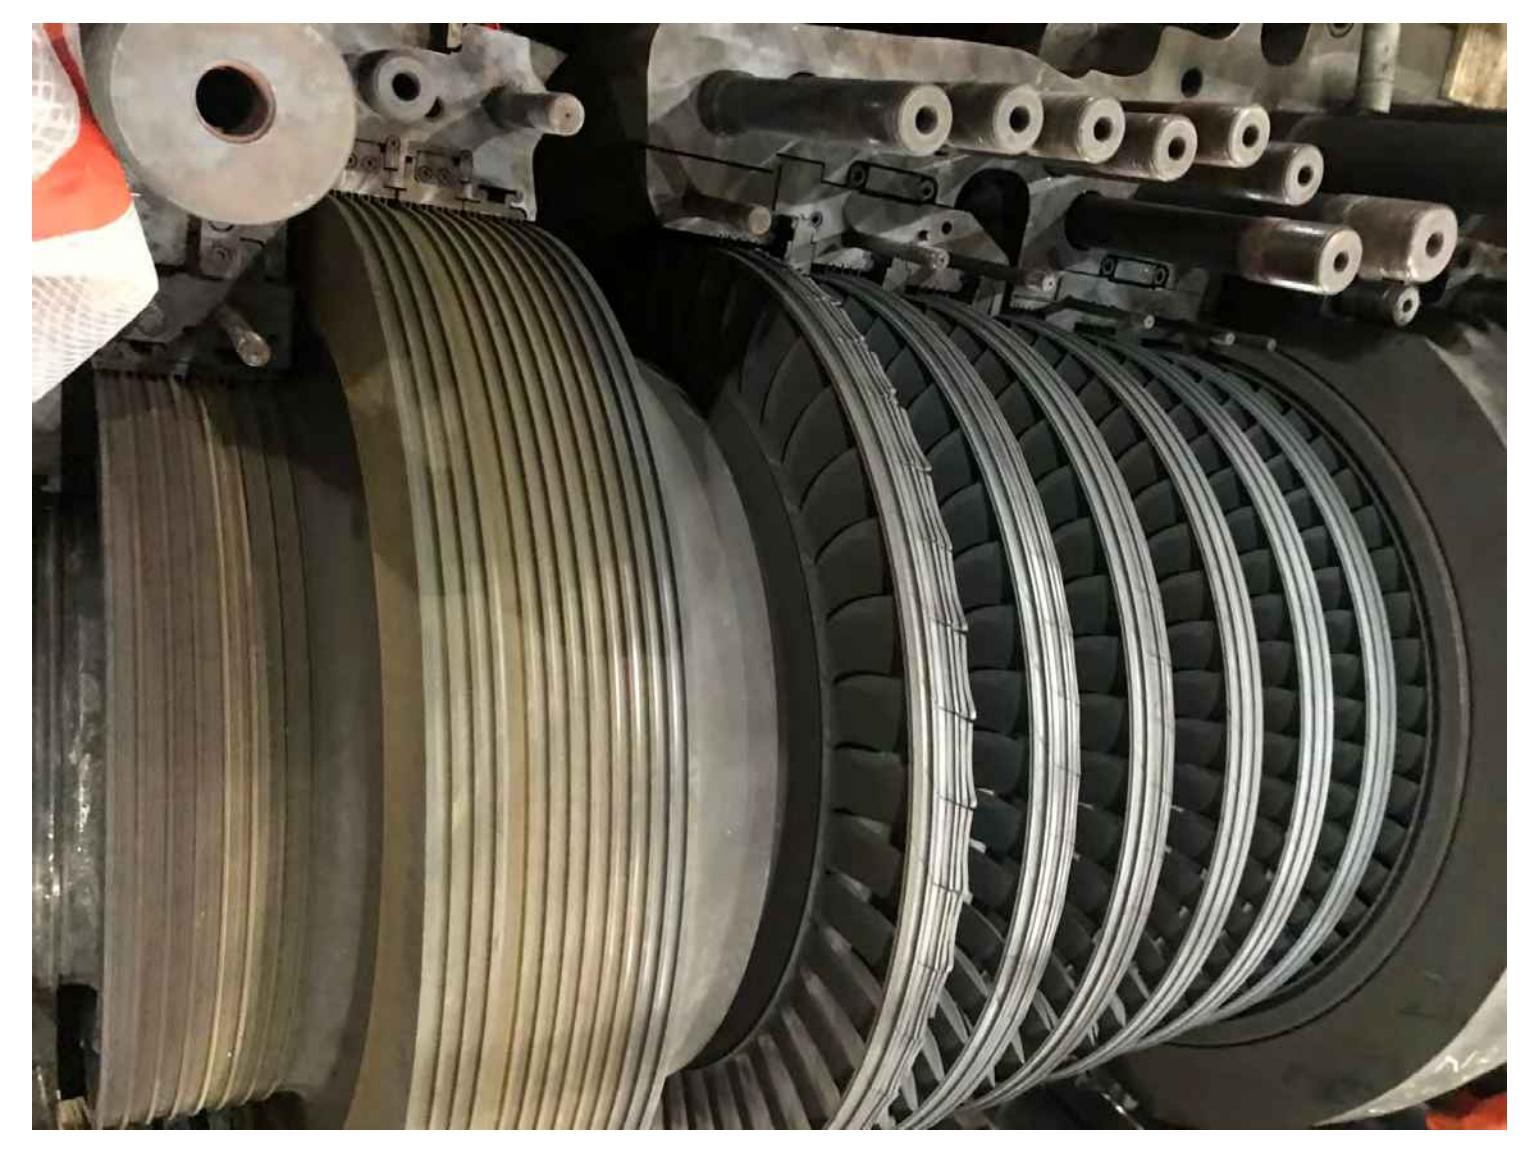
HIP Rotor

At disassembly it was found that the integral shrouds of the stage nine buckets had sustained significant damage, presumably due to overheating from a hard rub with the blade ring spill strips. Distortion and elevated hardness was also found on the stage seven and eight bucket shrouds. Additionally, it was found that a middle row of the #1 dummy ring packing had several segments that had failed hook fits and allowed the stationary packing to come into contact with the rotor during operation. The castellations on the balance piston in this area were found to have been "machined" off, and grooves had been worn into the rotor due to contact with the offending packing segments. The cause of the hook failure is not known at this time, however, overheating of this area is suspected.

HP Stage 4-9 – As Found

The stage 7 thru 9 buckets were removed by GE OSS bucket technicians. New buckets were supplied and installed by Ethos Energy. Final machining of the bucket covers and rotor balance piston was performed by Ethos Energy. New dummy ring packing was also supplied by Ethos to replace the damaged row. After final machining the rotor was low speed balanced.

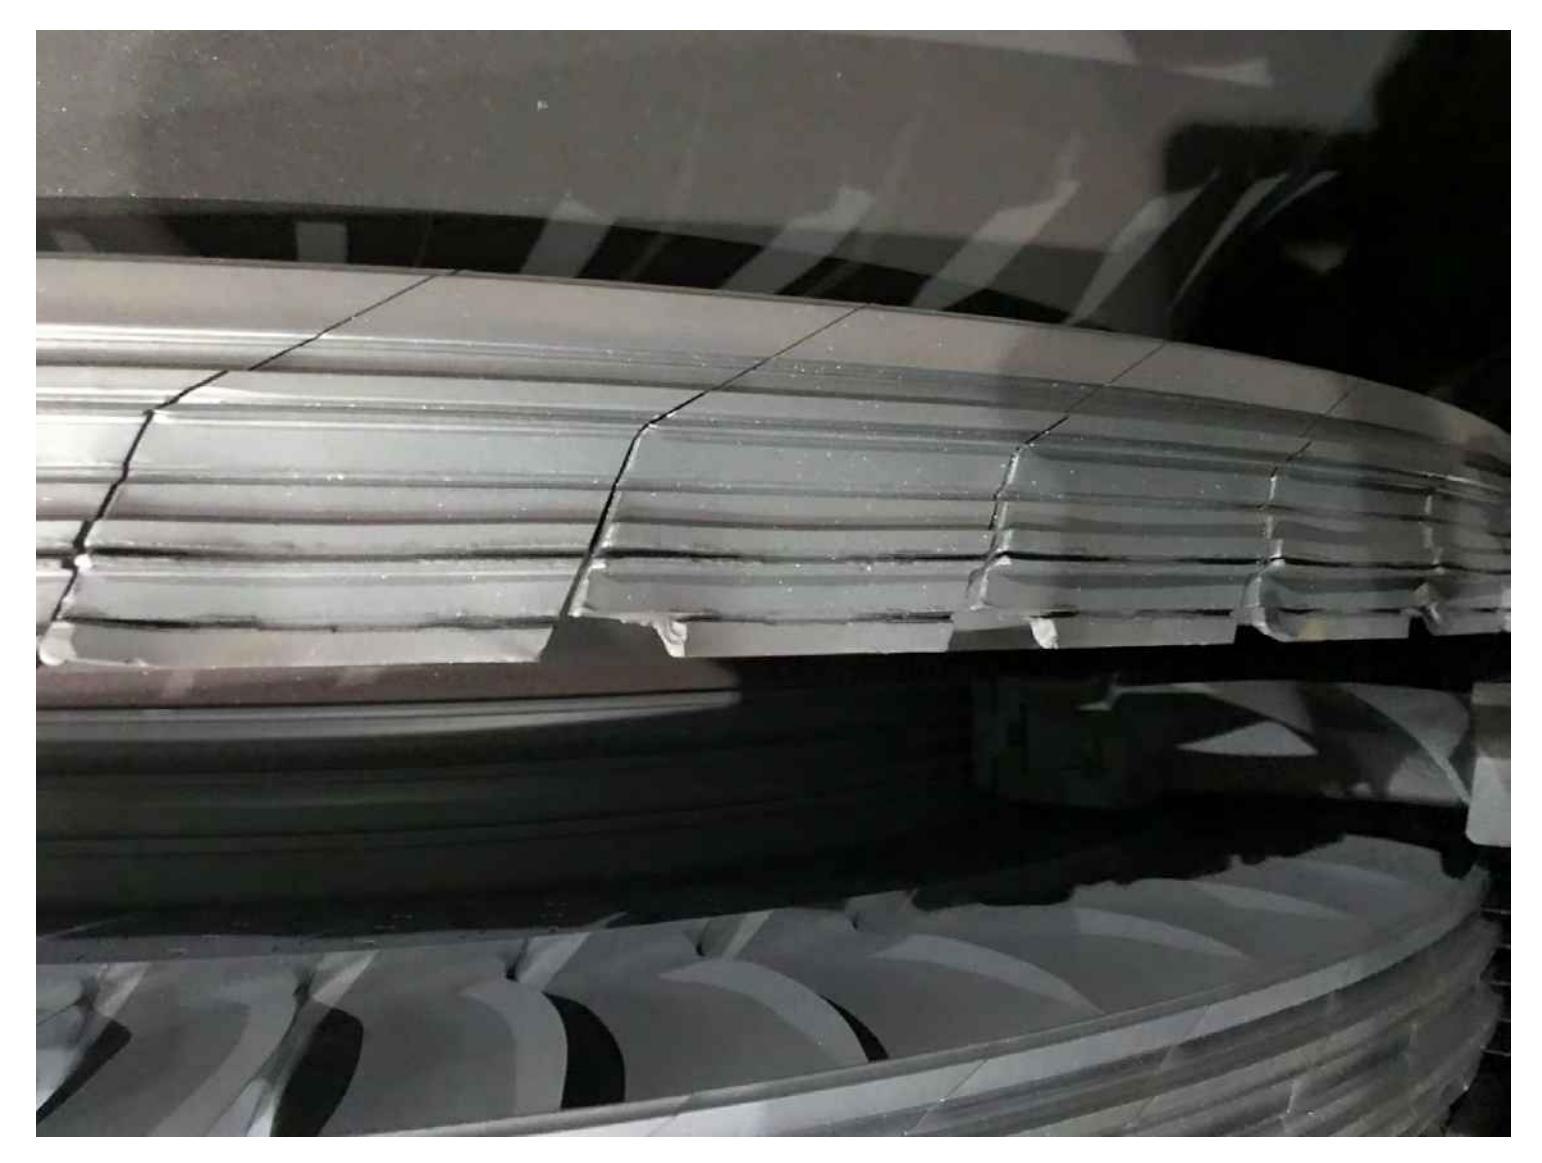
HIP Rotor

HP Stage 9 covers – As Found

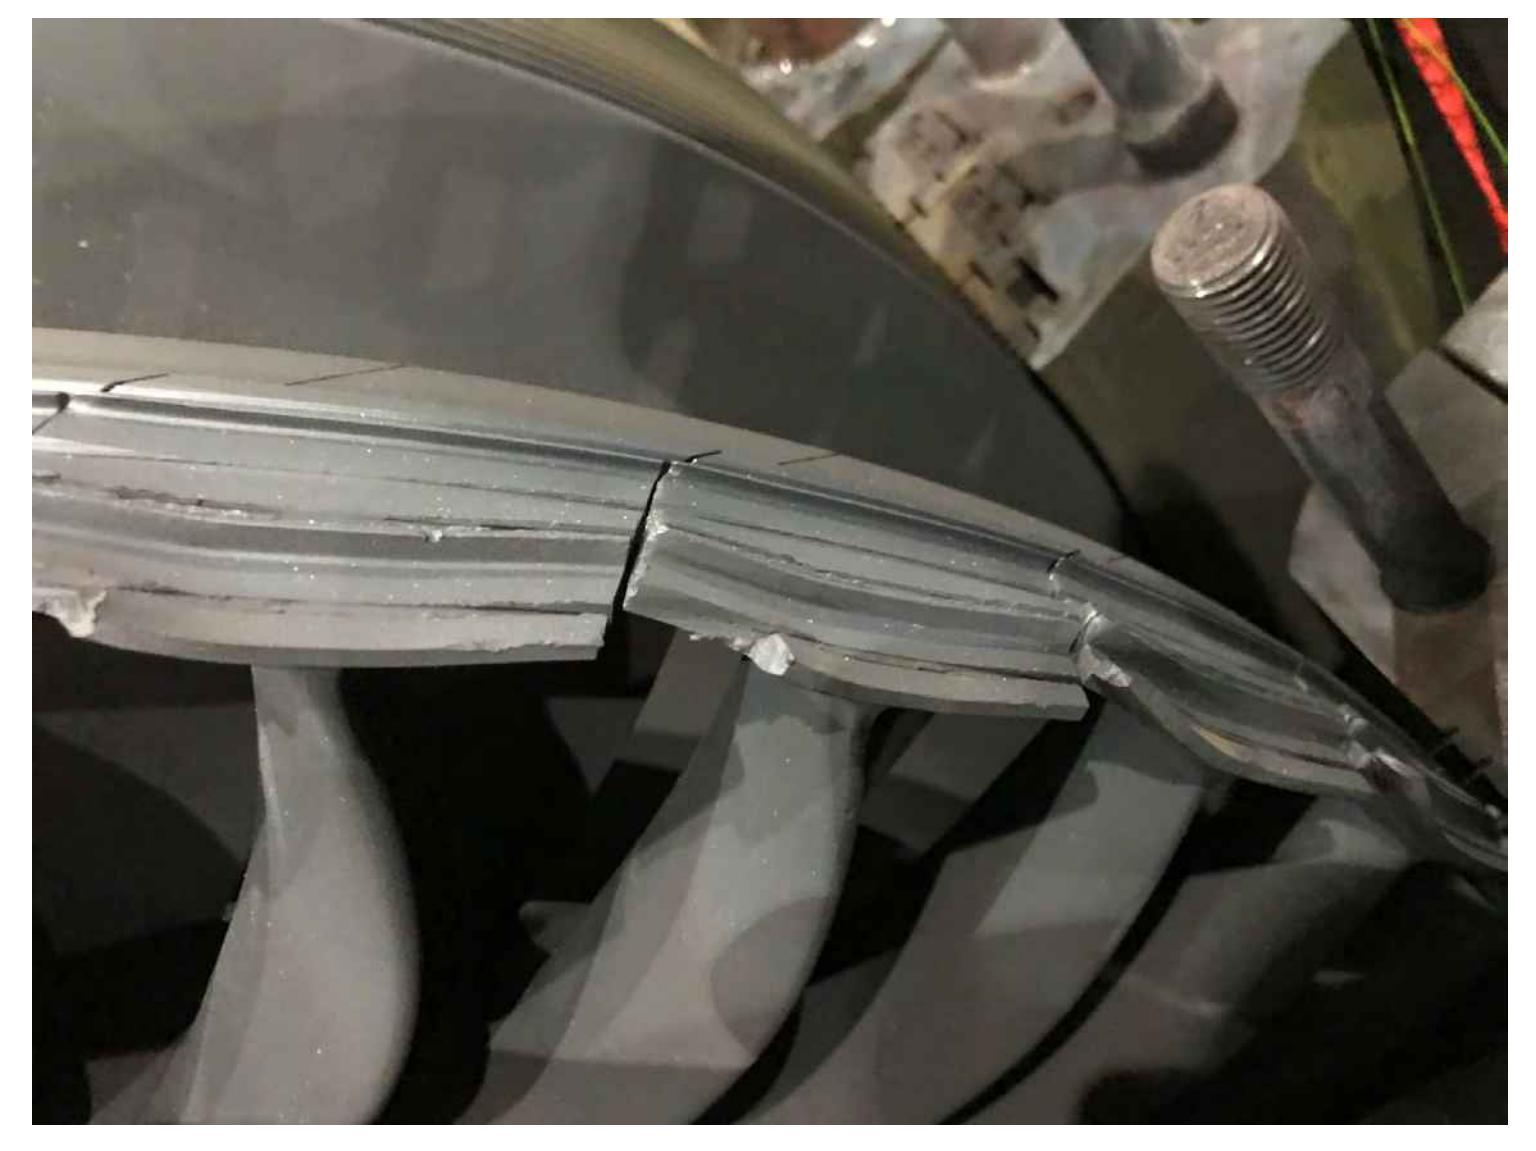
HIP Rotor

HP Stage 9 Covers – As Found

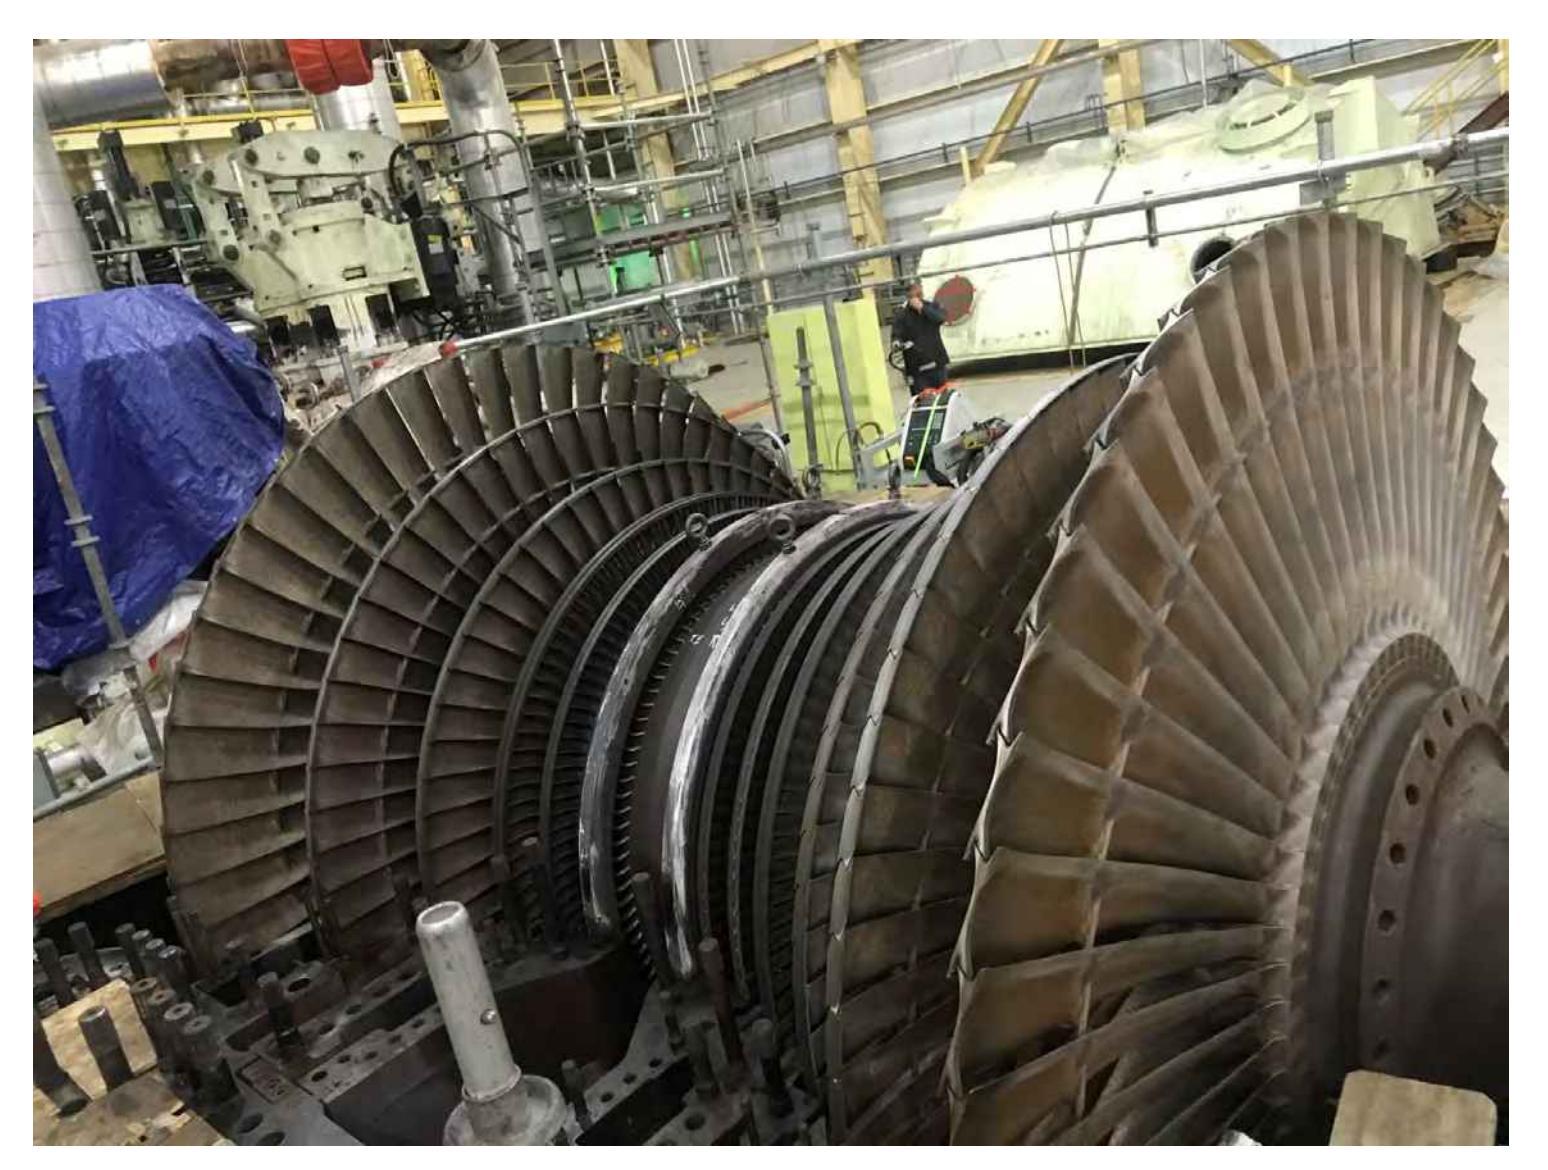
The LPA rotor was removed, grit blasted and non-destructively examined. Through the wet magnetic particle inspection, linear indications were found on all of the L-1 buckets. The buckets were removed and the serrations were glass bead blasted and non-destructively examined.

Several of the L-0 erosion shields were found to have "bleed out" during the dye penetrant examination. Erosion was found observed on all of the "Z" lock L-0 shrouds.

LPA Rotor – As Found

The L-1 buckets were replaced and the rotor was low speed balanced by Ethos Energy. More detailed observations can be found in the NDE report included in the appendix portion of this report.

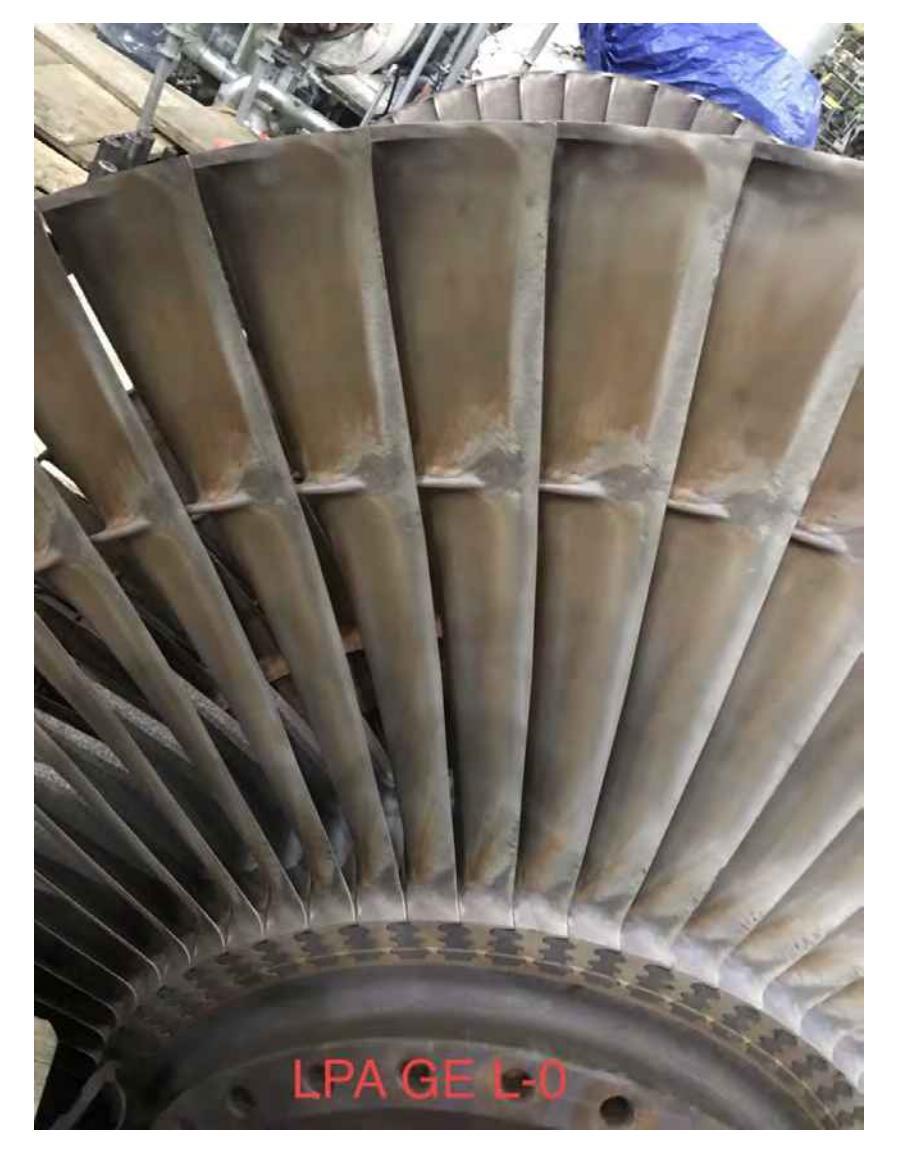
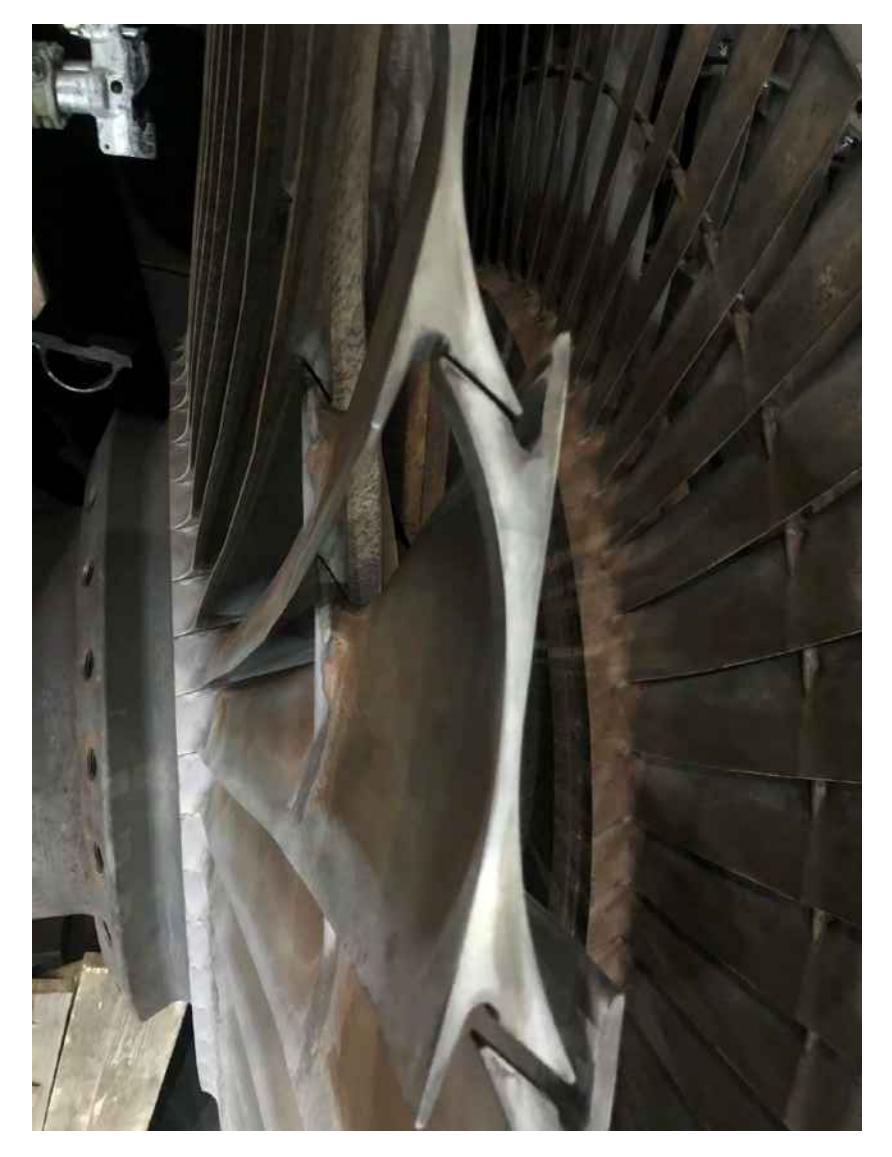
LPA Rotor

LPA Generator End – L-0 As Found Condition

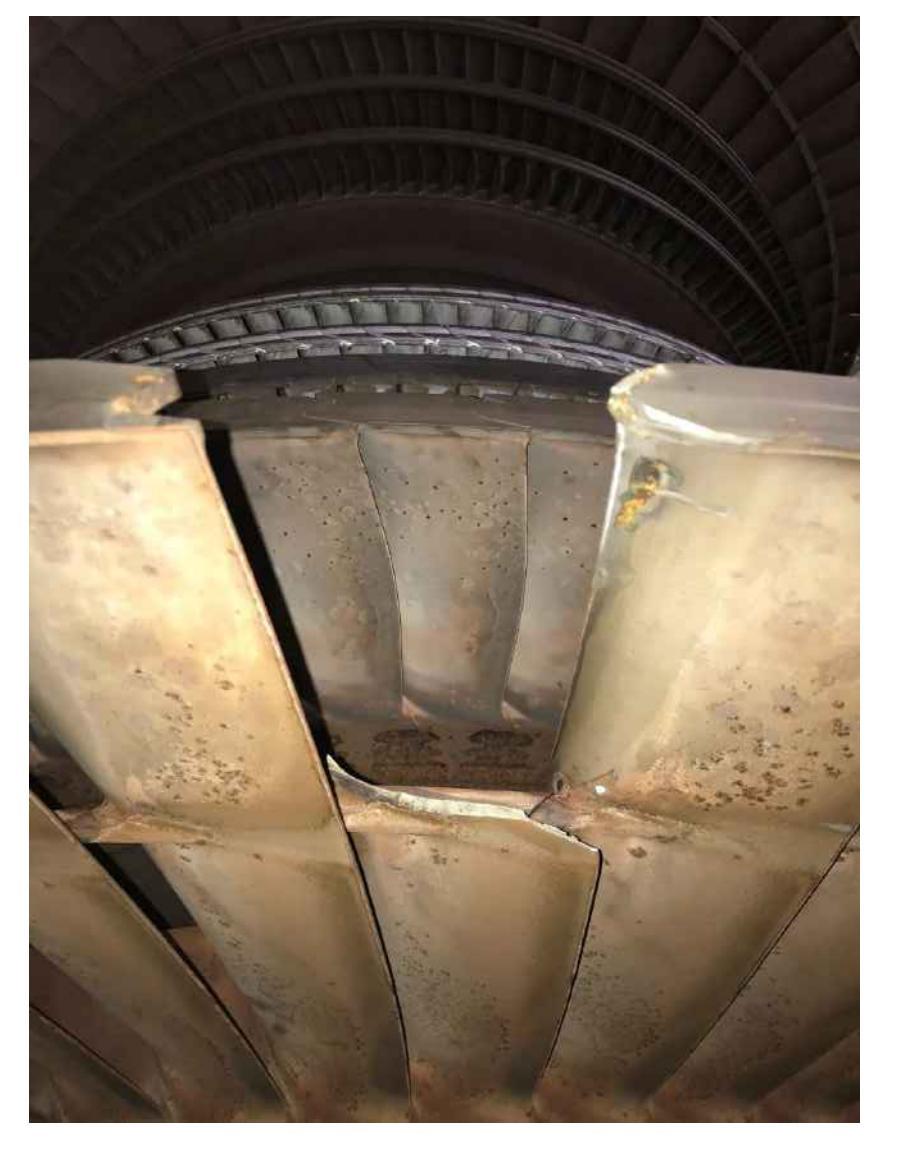
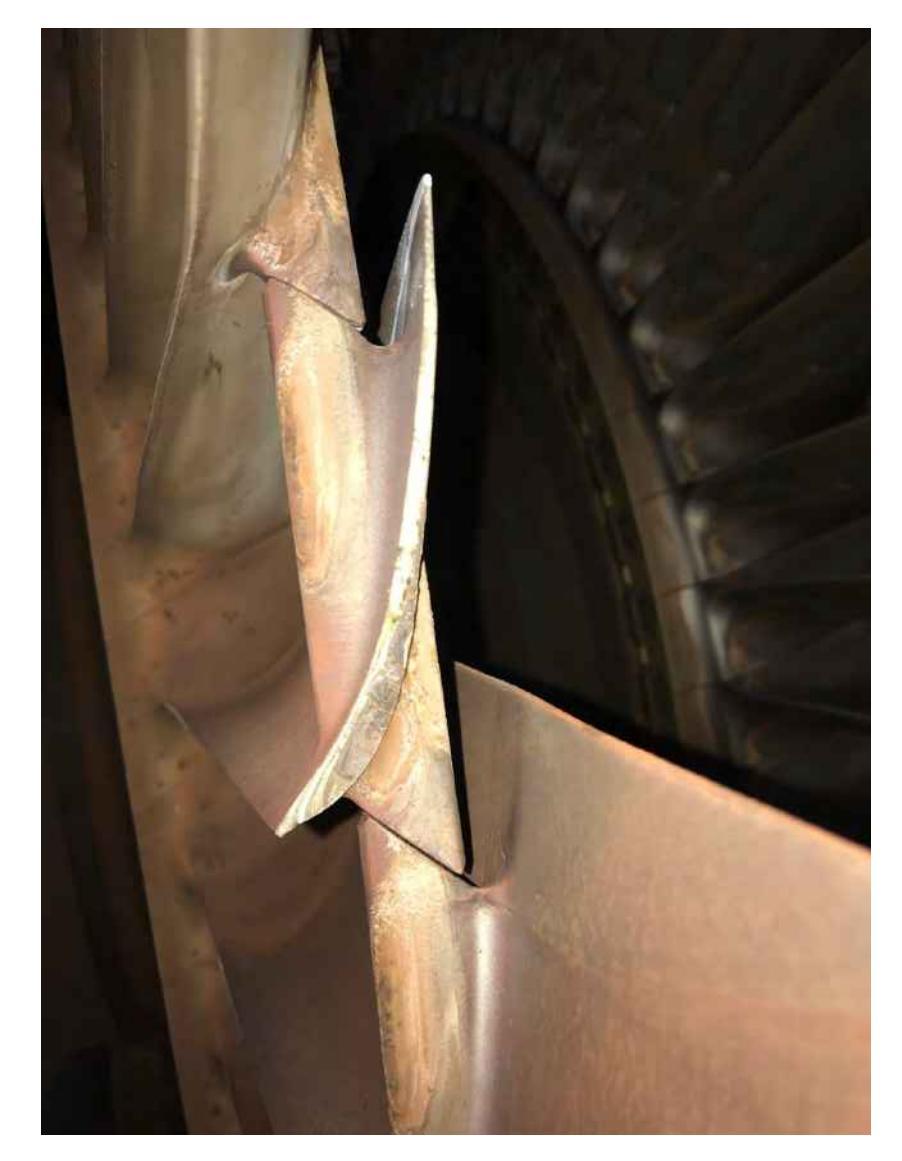
One of the generator end L-1 buckets failed in service, causing damage to the other buckets in that row, the spill strips, partitions of the adjacent blade ring, L-0 buckets and L-0 erosion shields. The LPB rotor was removed, grit blasted and non-destructively examined. Through the wet magnetic particle inspection, linear indications were found on all of the remaining L-1 buckets on both ends of the rotor. The buckets were removed and the serrations were glass bead blasted and non-destructively examined.

LPB Generator End - Failed L-1 Bucket

The generator end L-0 buckets should be replaced at the next opportunity. Separation between several of the turbine end buckets and erosion shields was also observed, and, strong consideration should be given to replacing this row as well.

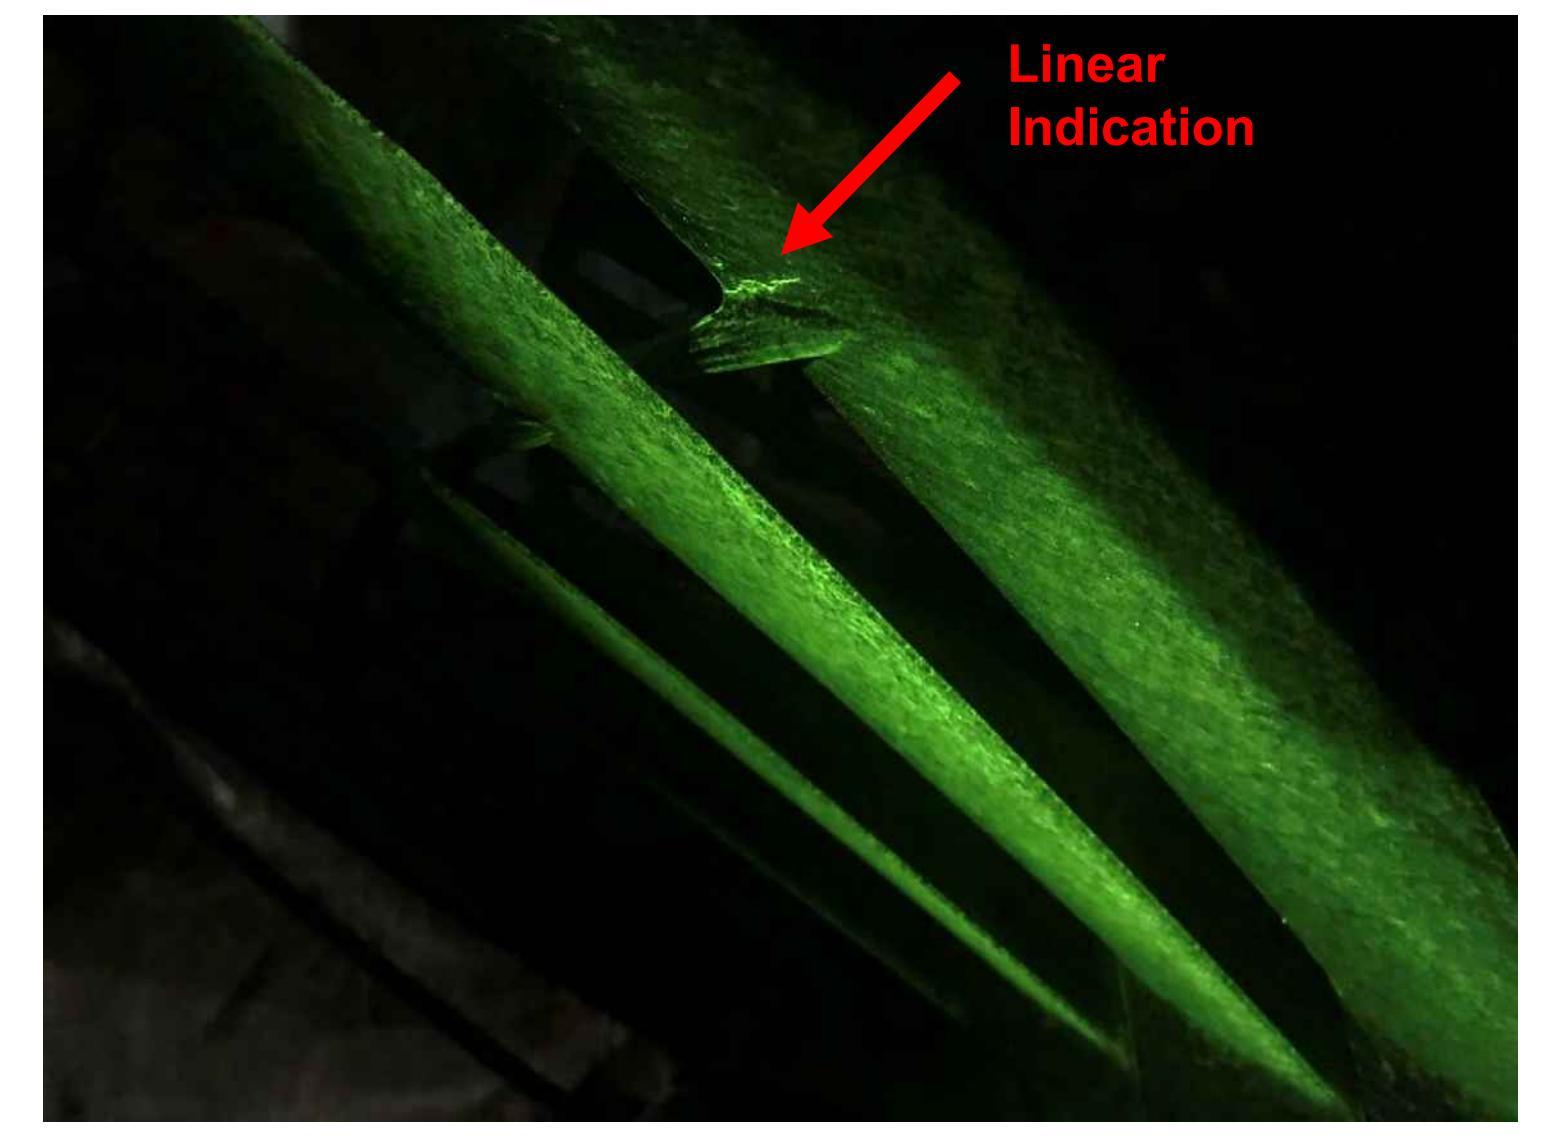
LPB Rotor

The L-1 buckets were replaced and the rotor was low speed balanced by Ethos Energy. Several of the L-0 erosion shields were found to have indications on the generator end due to impact damage from the failed L-1 bucket. The damaged erosion shields were removed. All significant impact damage to the generator end L-0 buckets was blended out. More detailed observations can be found in the NDE report included in the appendix section of this report.

LPB L-1 Buckets - Linear Indication

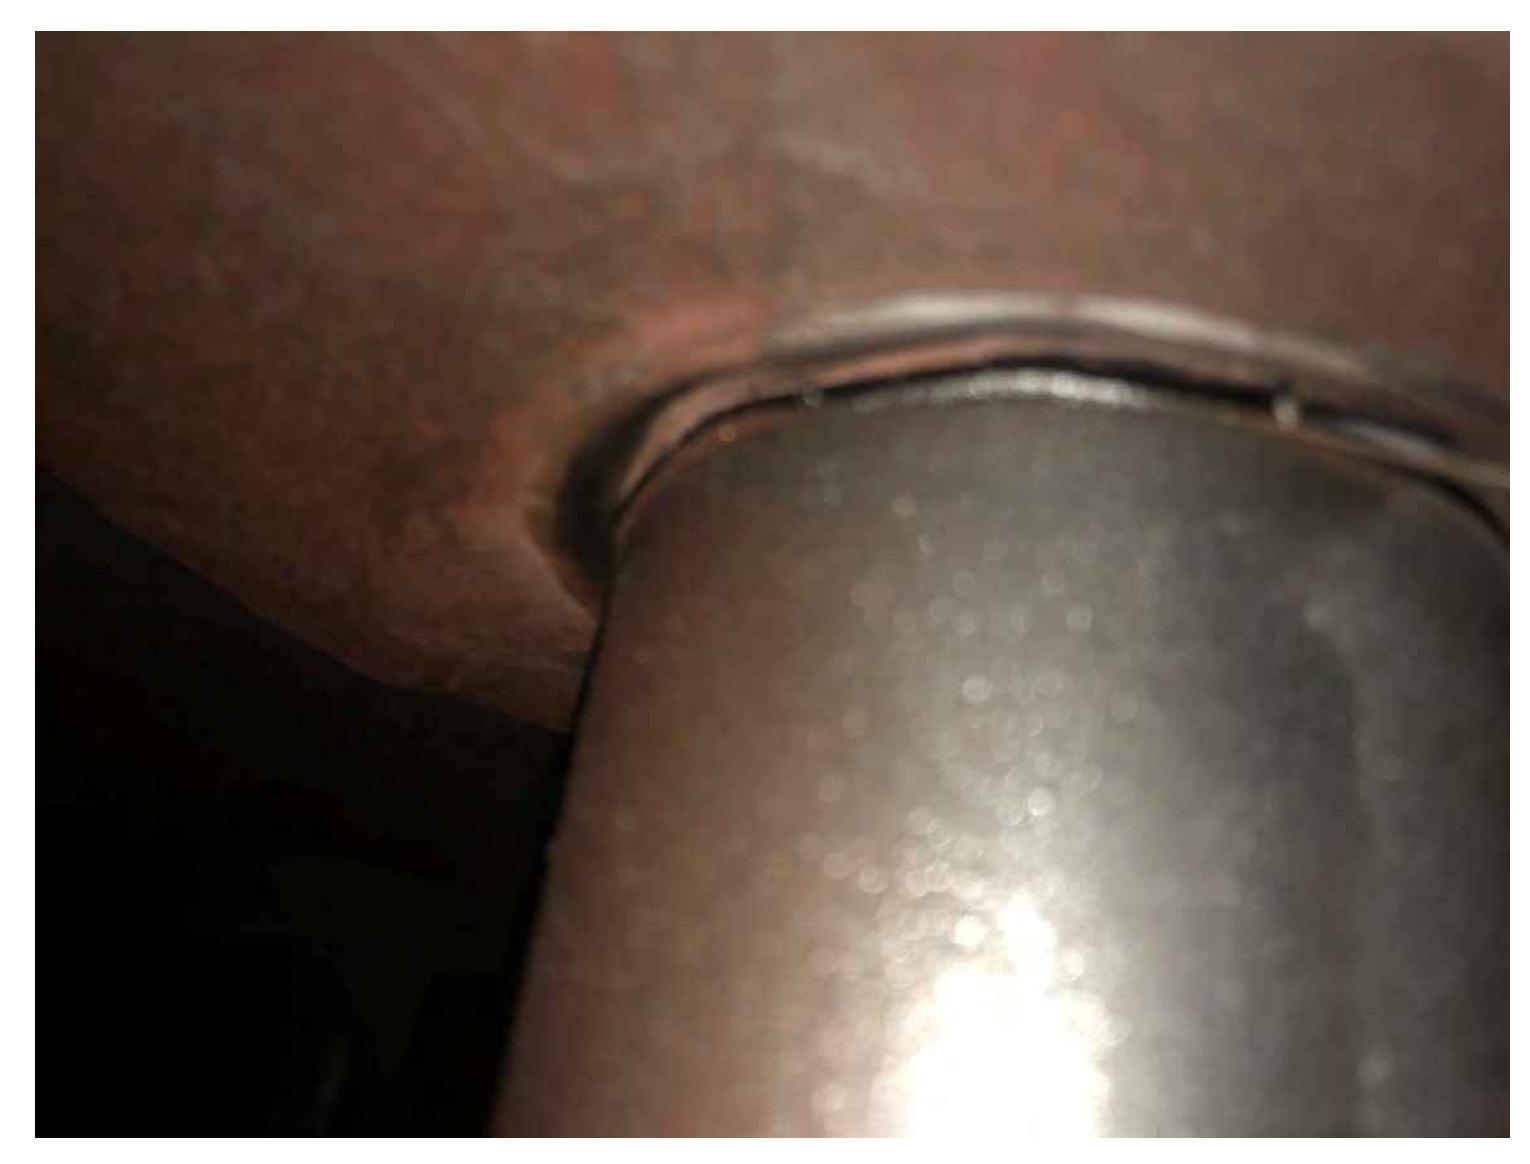
Strut Repair

At disassembly it was found that three of the four struts, which act to stiffen the cylinder cover in the area of the crossover pipe flange, were dislocated or loose. These struts enter axially through the generator end of the cylinder cover and are attached to the inner side wall. The struts are then seal welded to the exterior surface. The dislocated and broken struts were welded by APCOM/FieldCore boiler maker welders, per a welding procedure supplied by the customer.

Broken HIP Outer Cylinder Strut – Typical 3 of 4

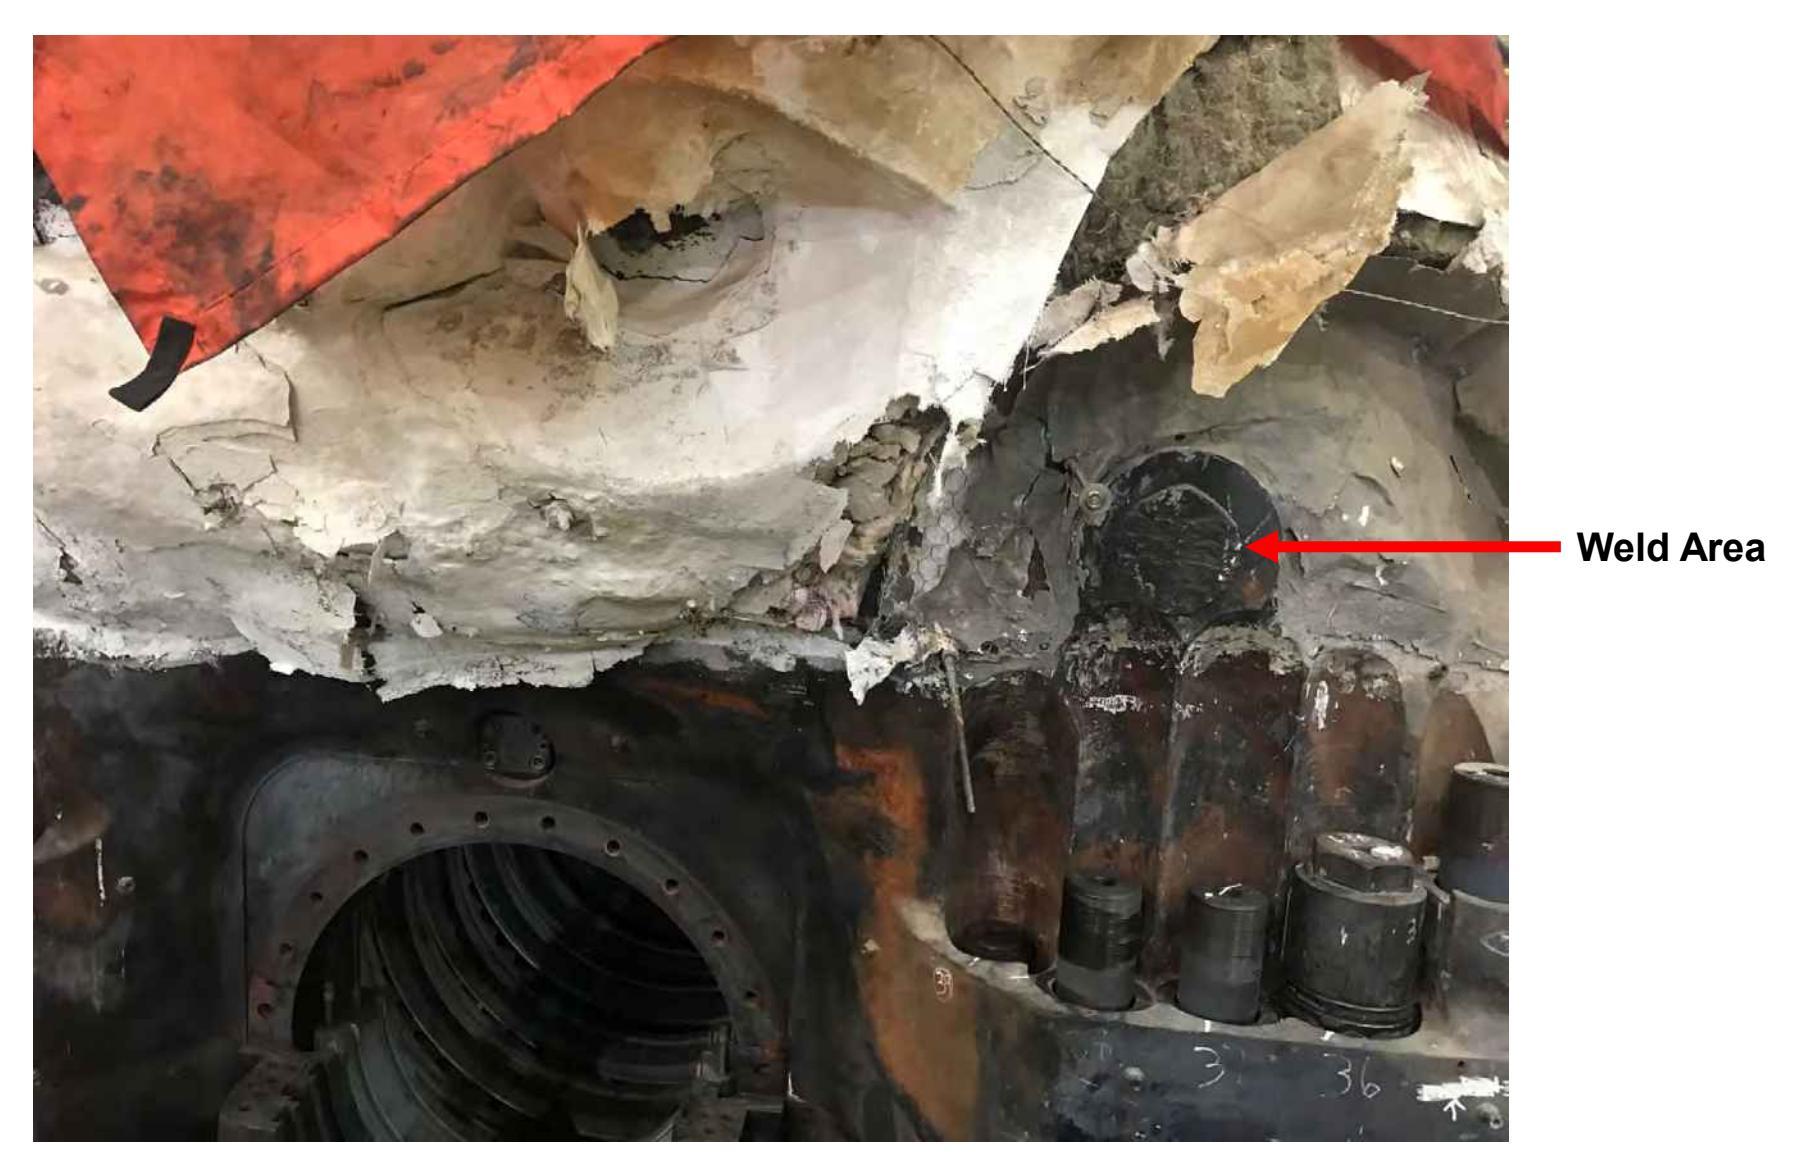
HIP Outer Cylinder Exterior Strut Weld

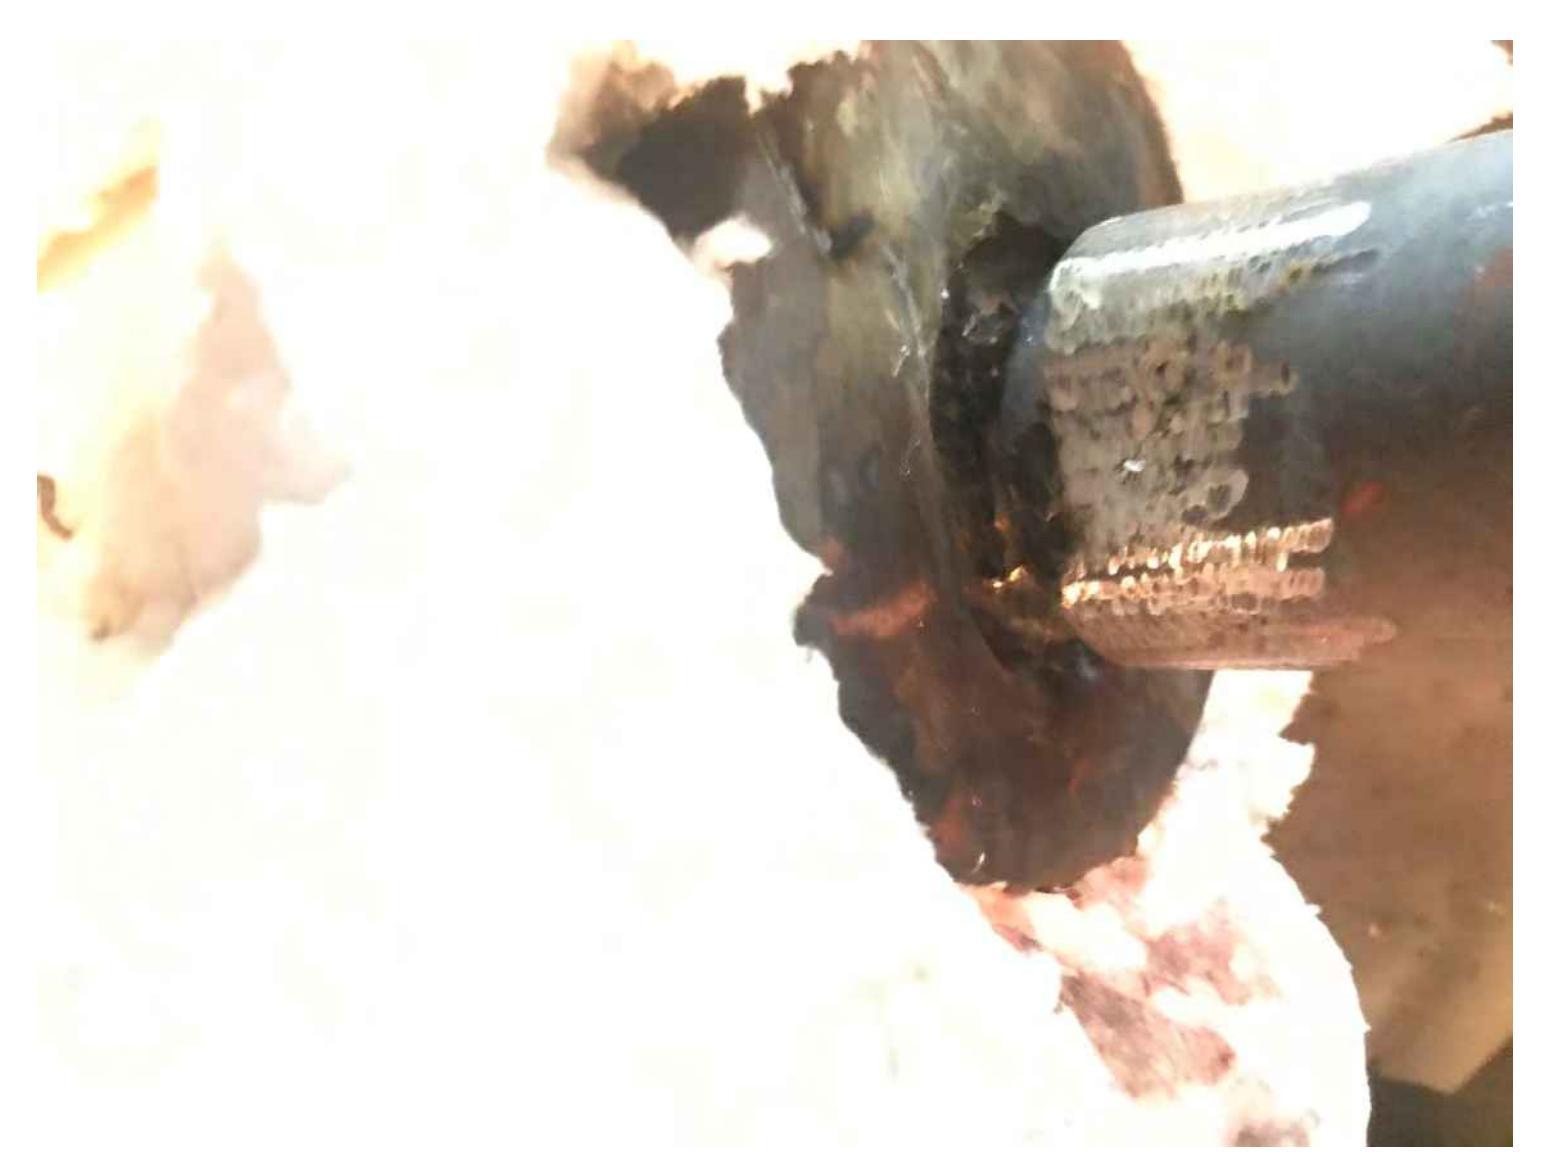
Strut Repair

Strut Weld Prep

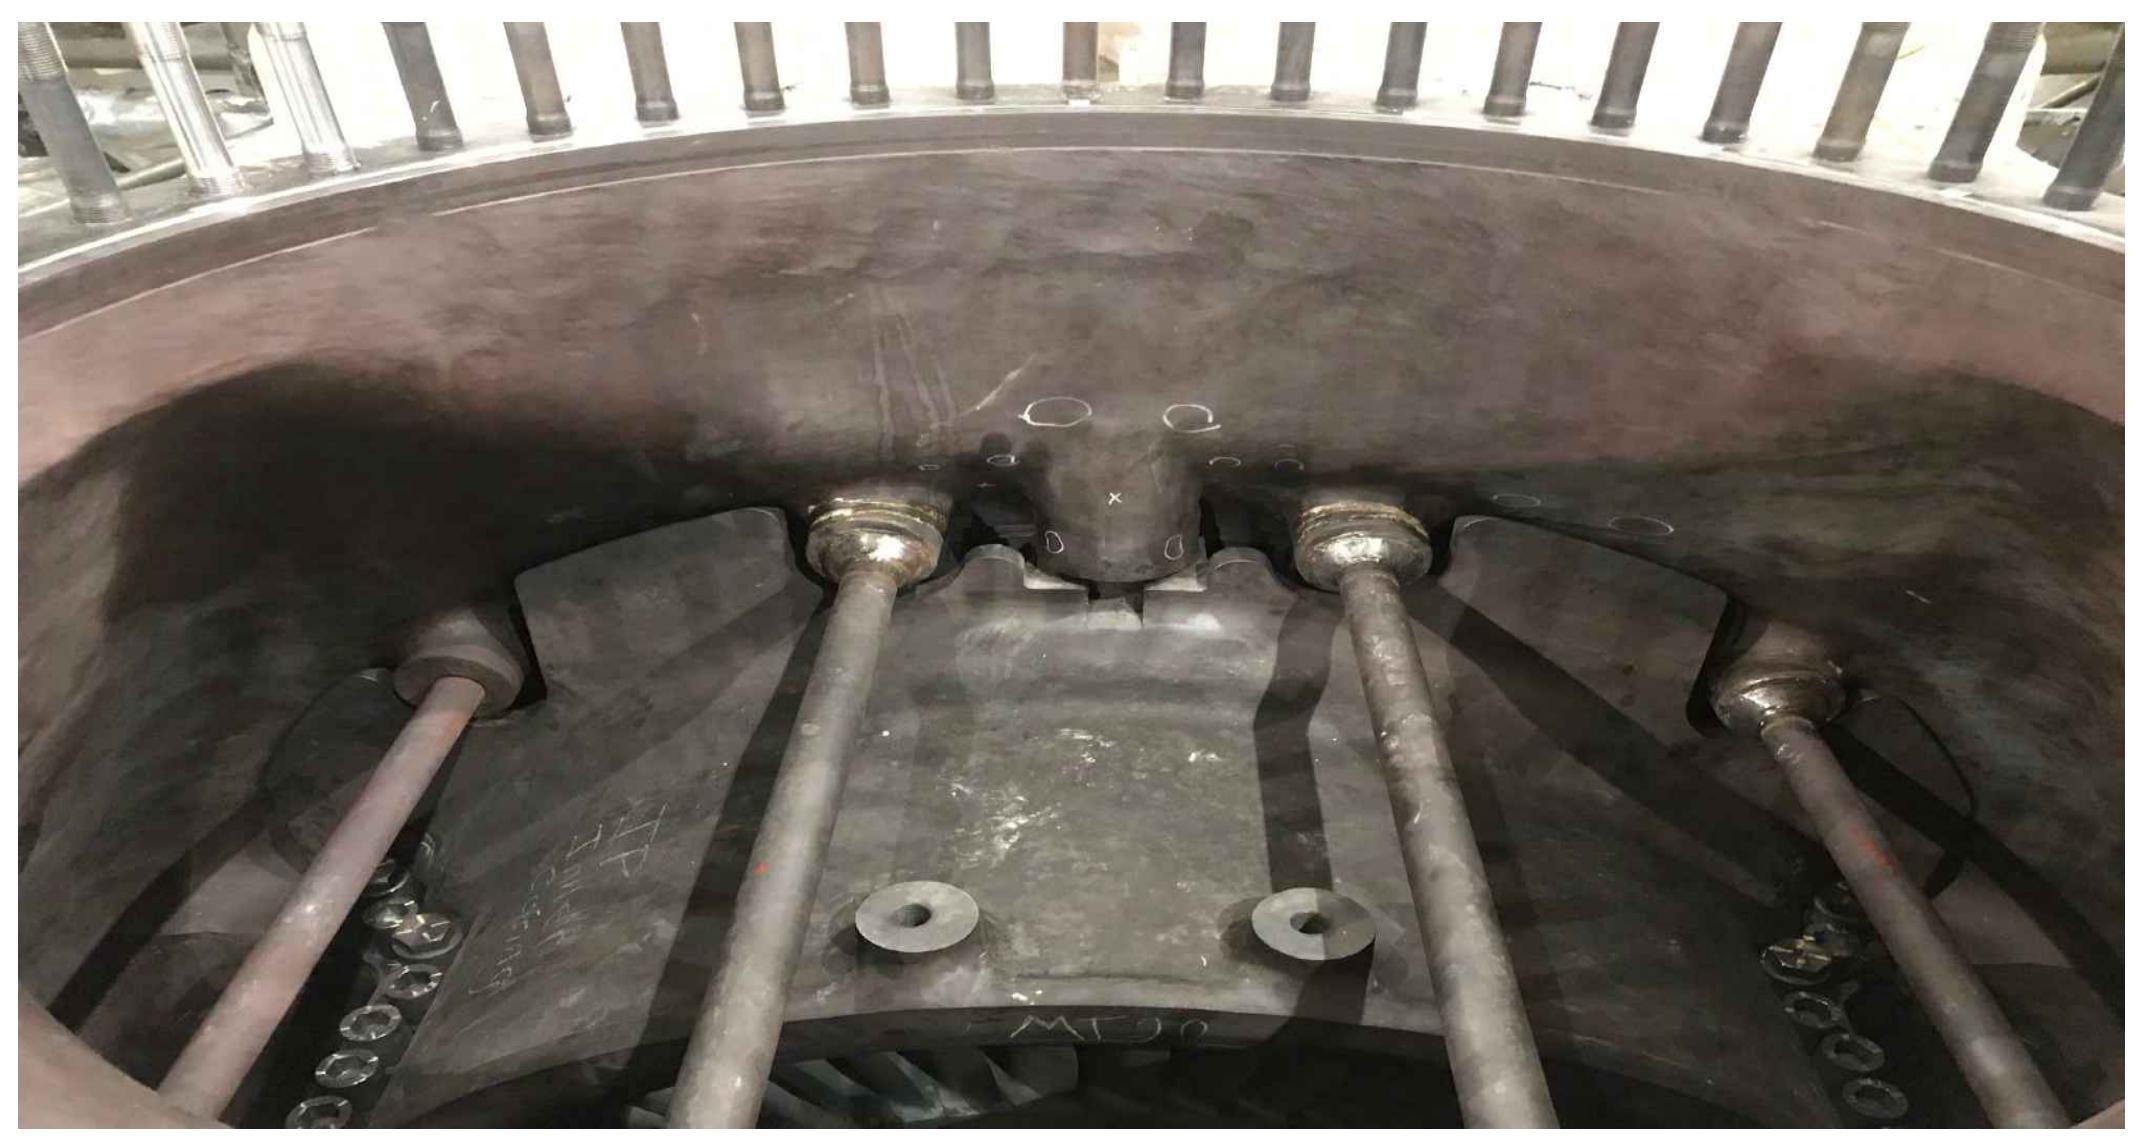
HIP Outer Cylinder Struts – Weld Repaired
