Comanche Unit 3 -Spring 2020 Outage

Full Train Major, Main Steam Valves & Generator

COMANCHE (CO) Steam Turbine ESN: SY0093272 Generator ESN: SY0350139 Job Start Date: 13 Jan 2020 Oracle Project ID: FSP-285469 | C-10344497

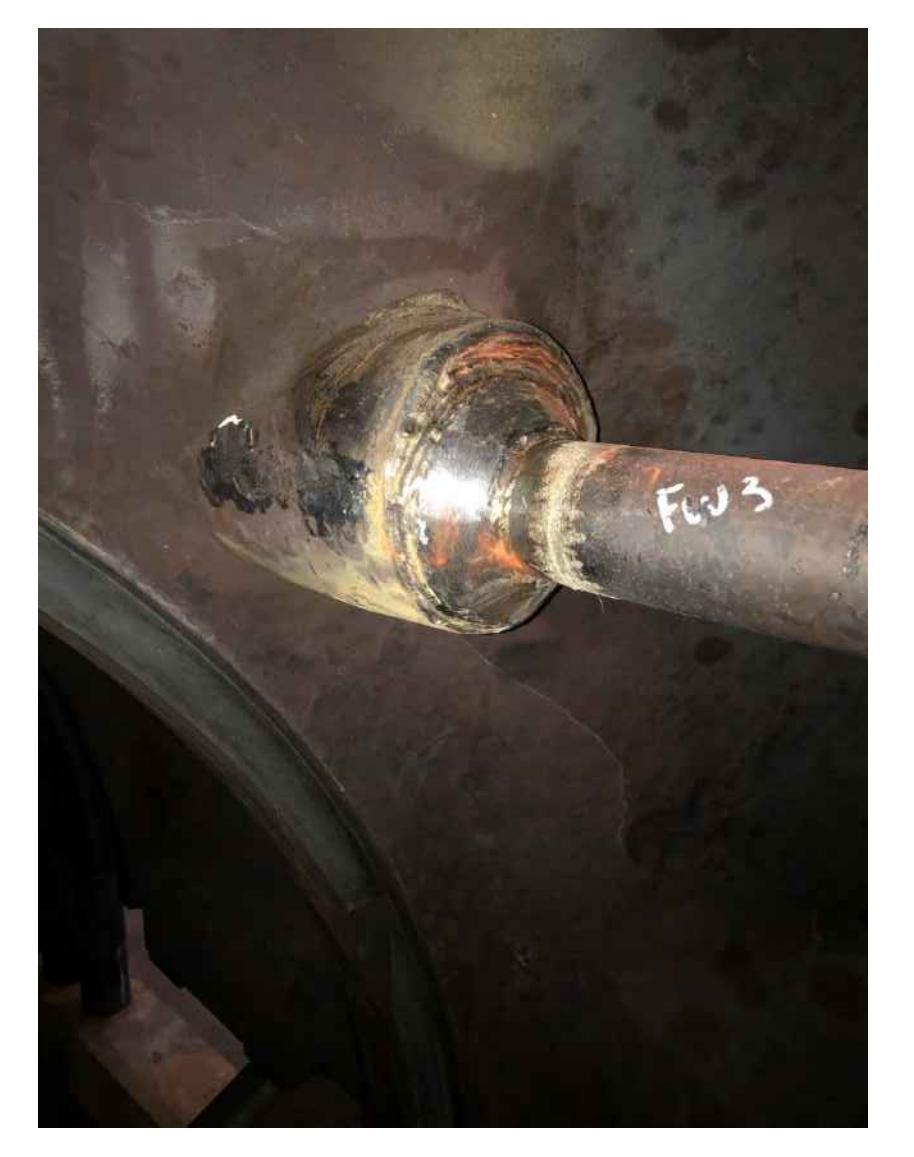
Left Side Bottom Strut – Weld Repaired

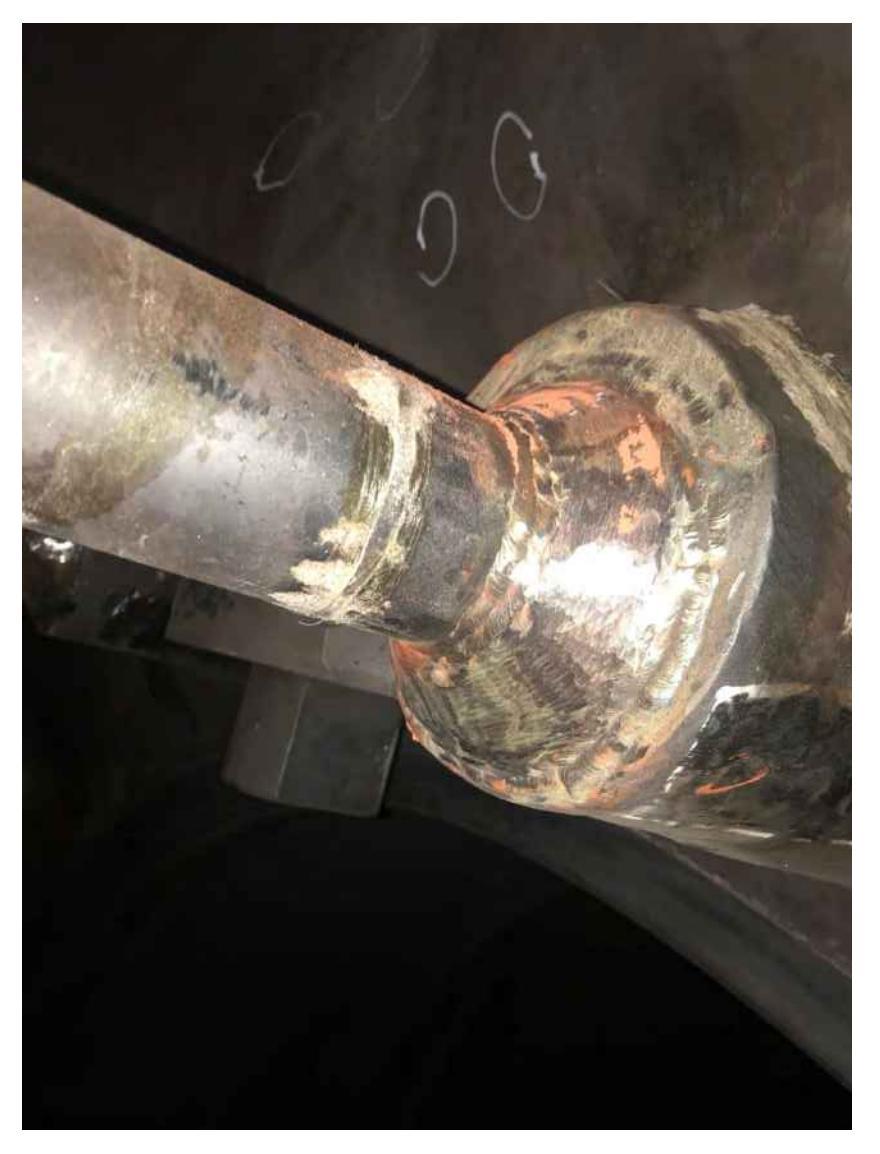
Left Side Top Strut – Weld Repaired

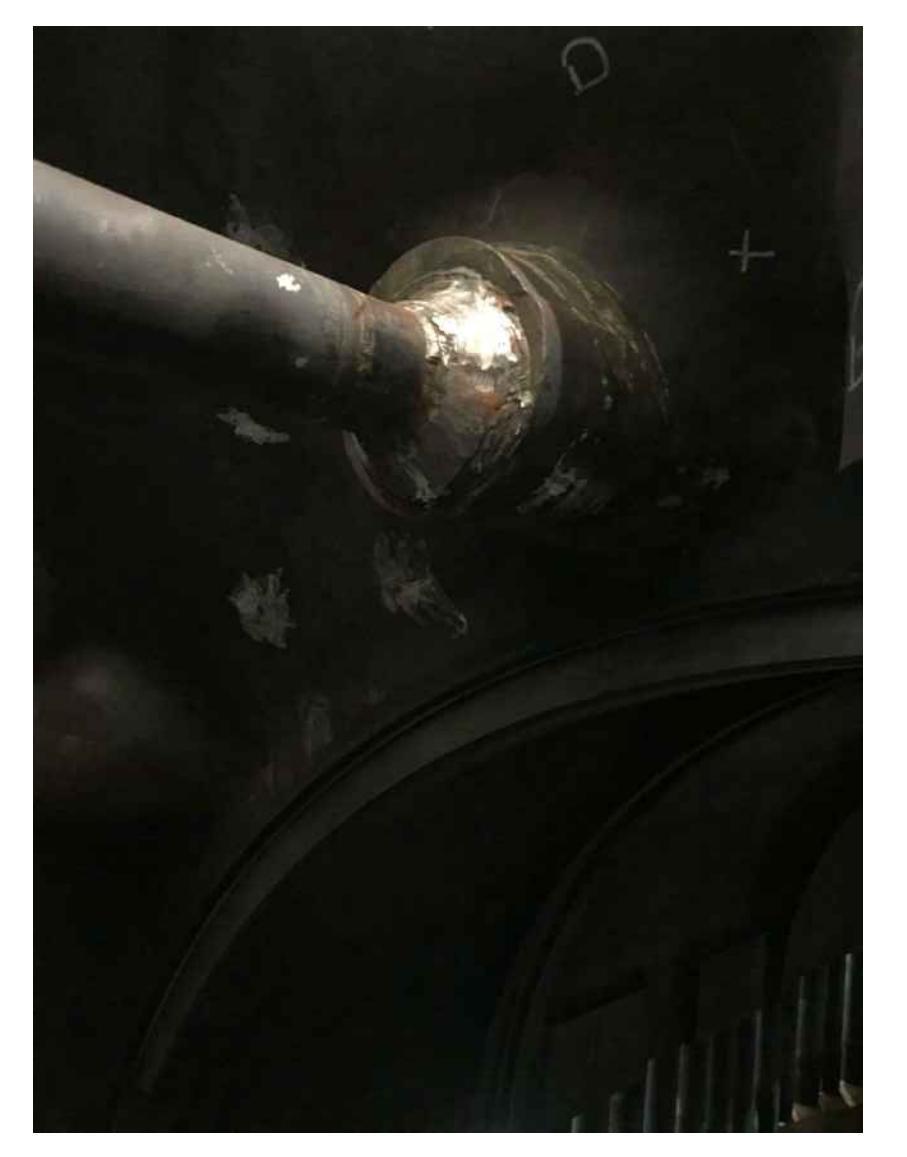
Right Side Top Strut – Weld Repaired

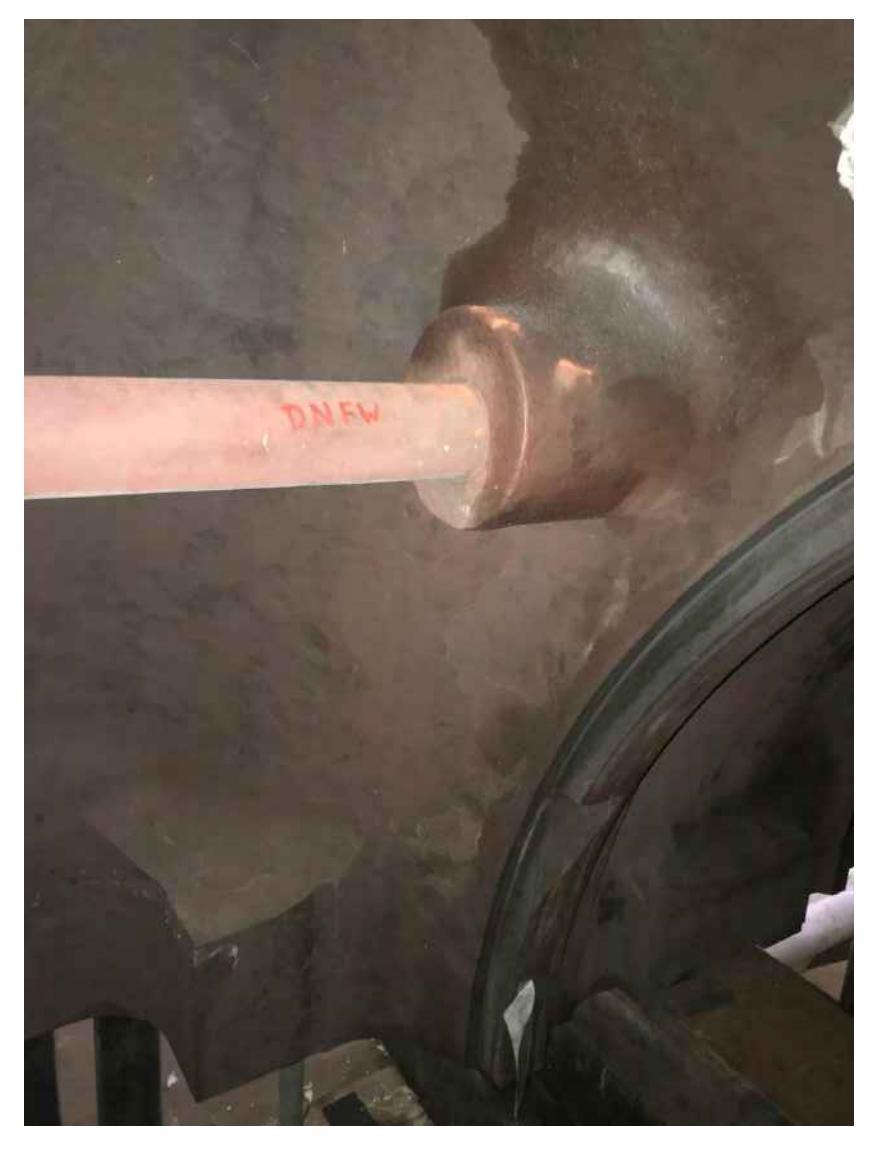
Right Side Top Strut – No Repair Needed

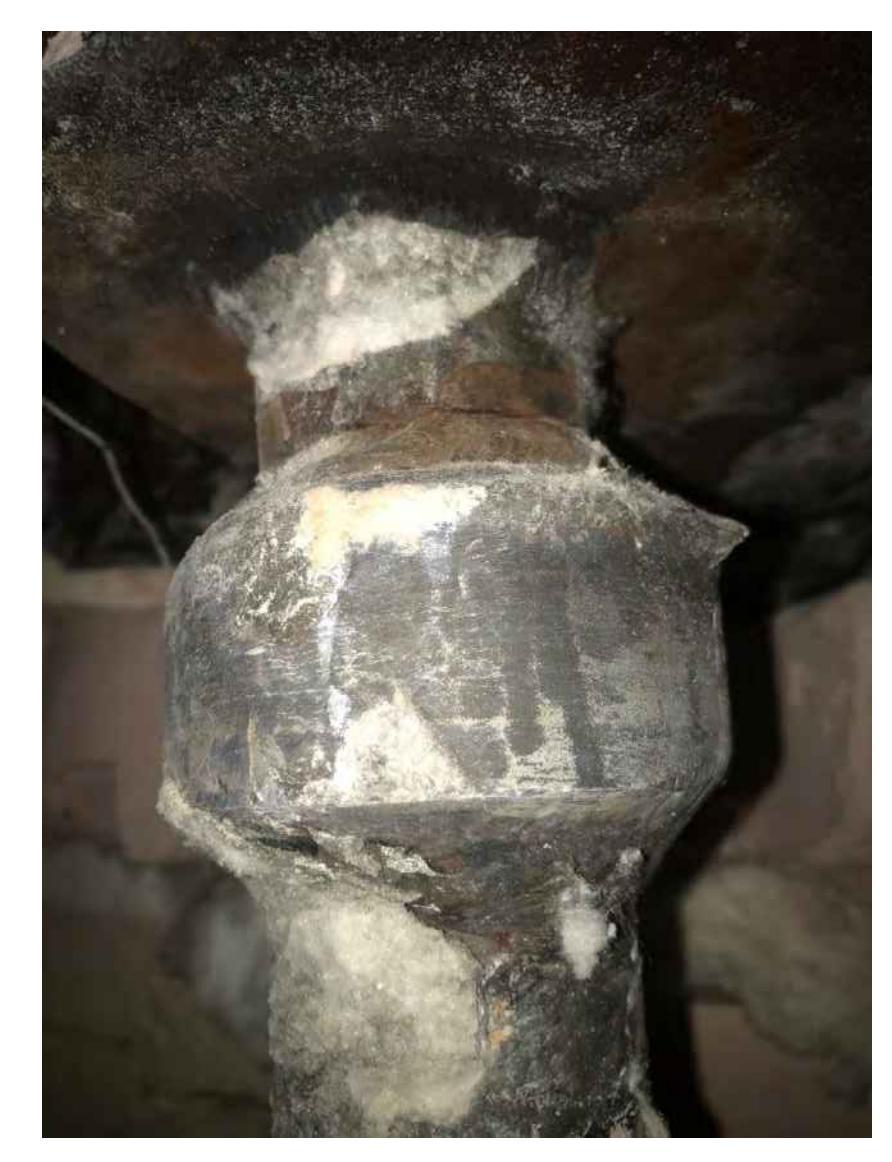
HIP Inner Drain Piping

HIP Inner Cylinder Drain Piping – As Found

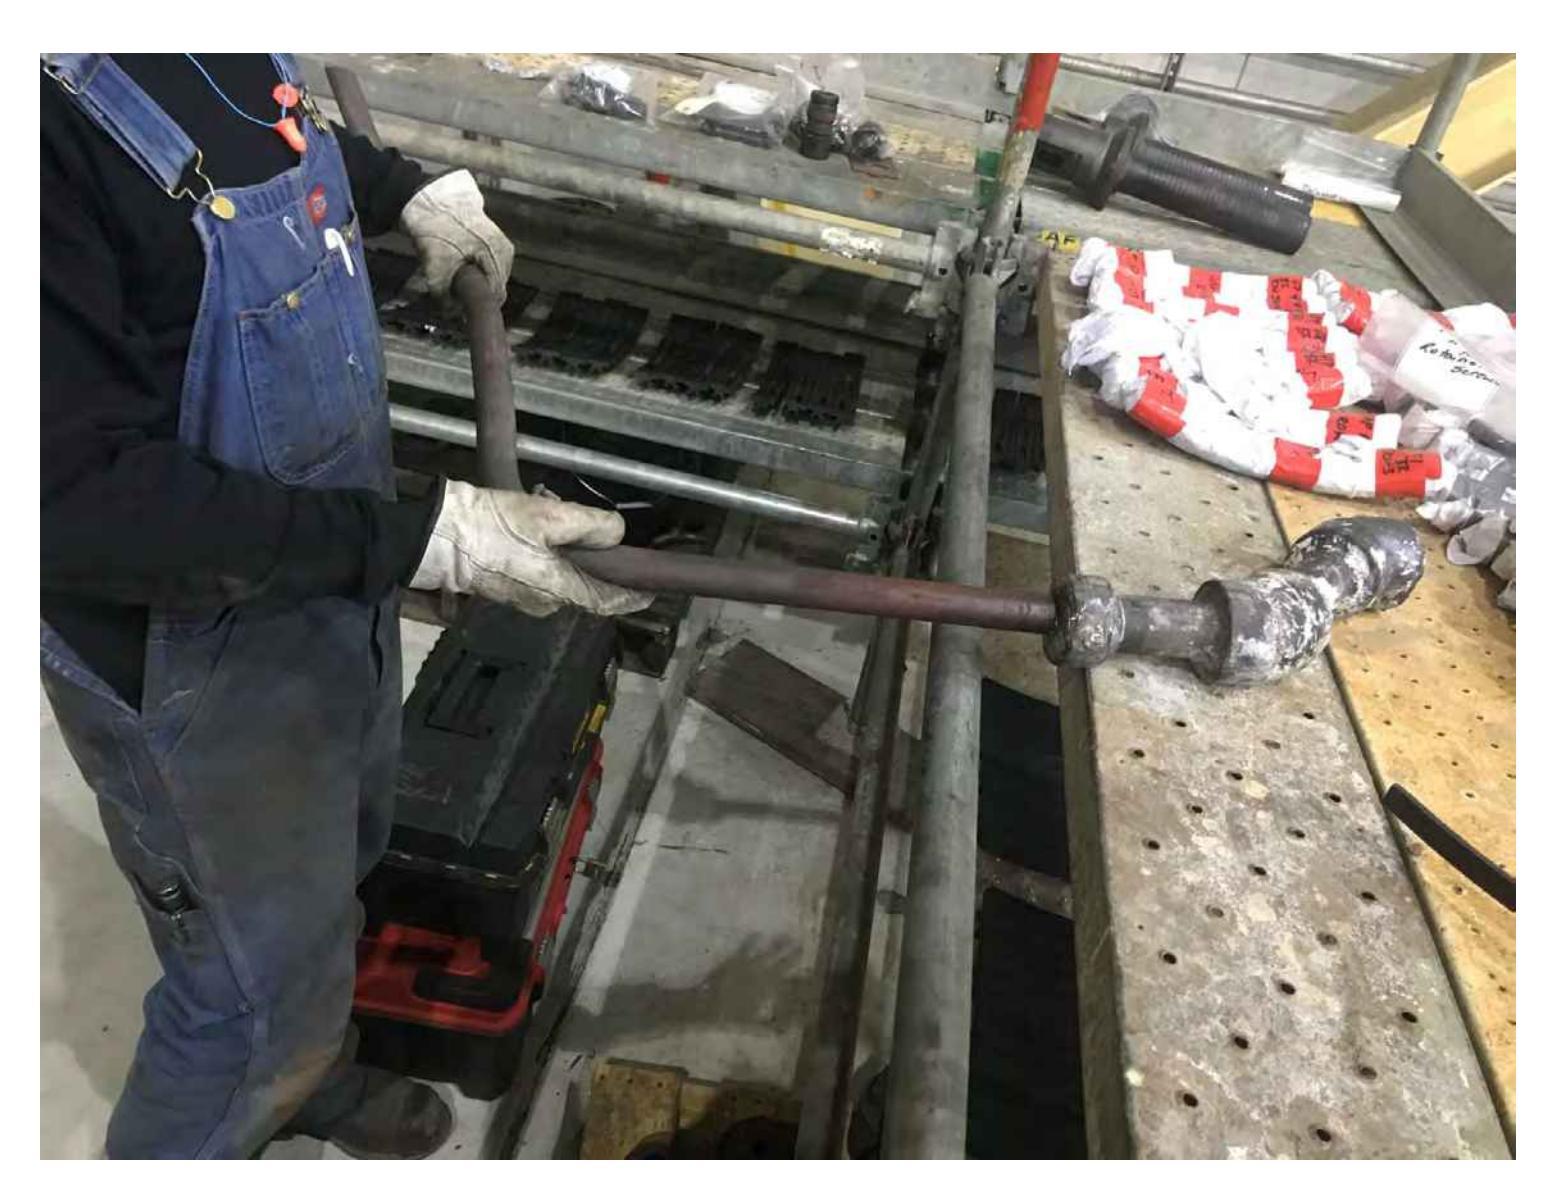
HIP Inner Drain Piping

HIP Inner Cylinder Drain Pipe – As Found - Removed

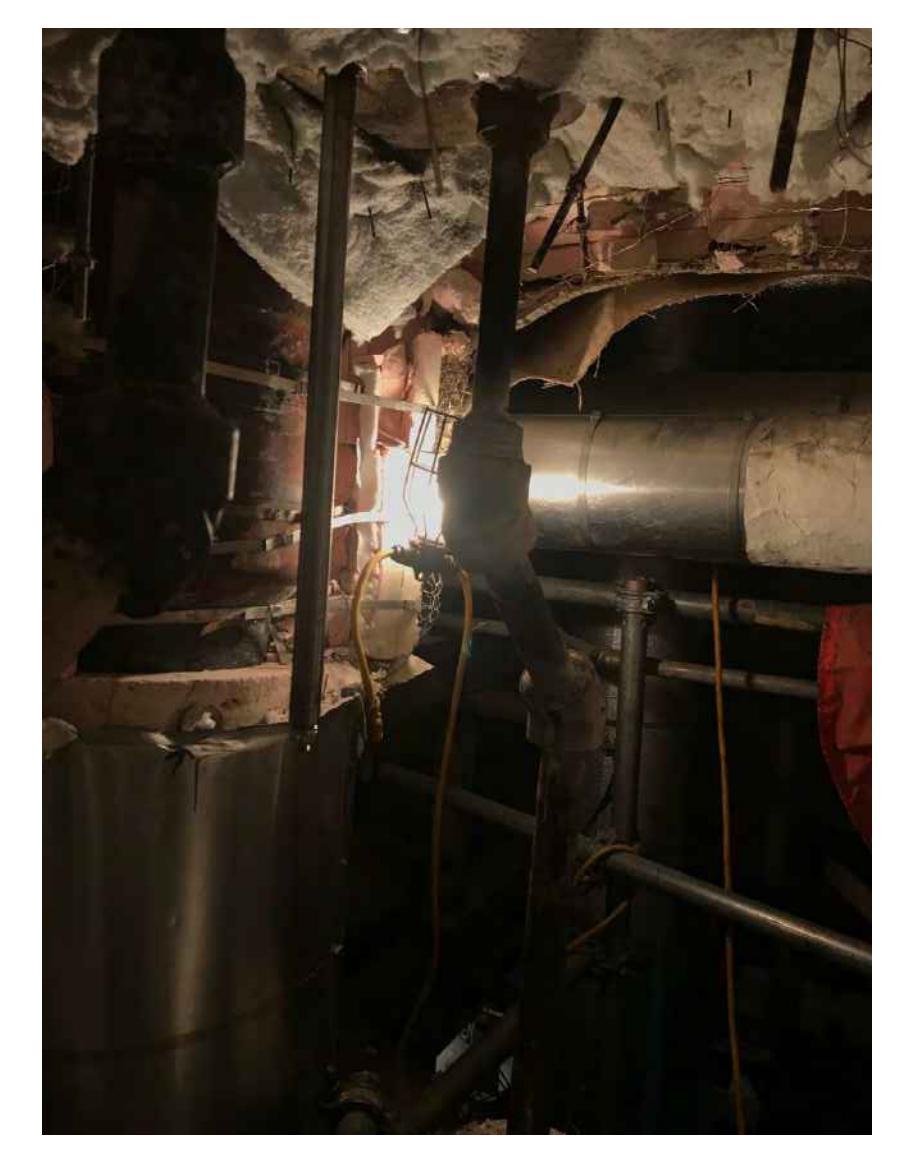
HIP Inner Drain Piping

HIP Inner Cylinder Drain Piping – New Configuration

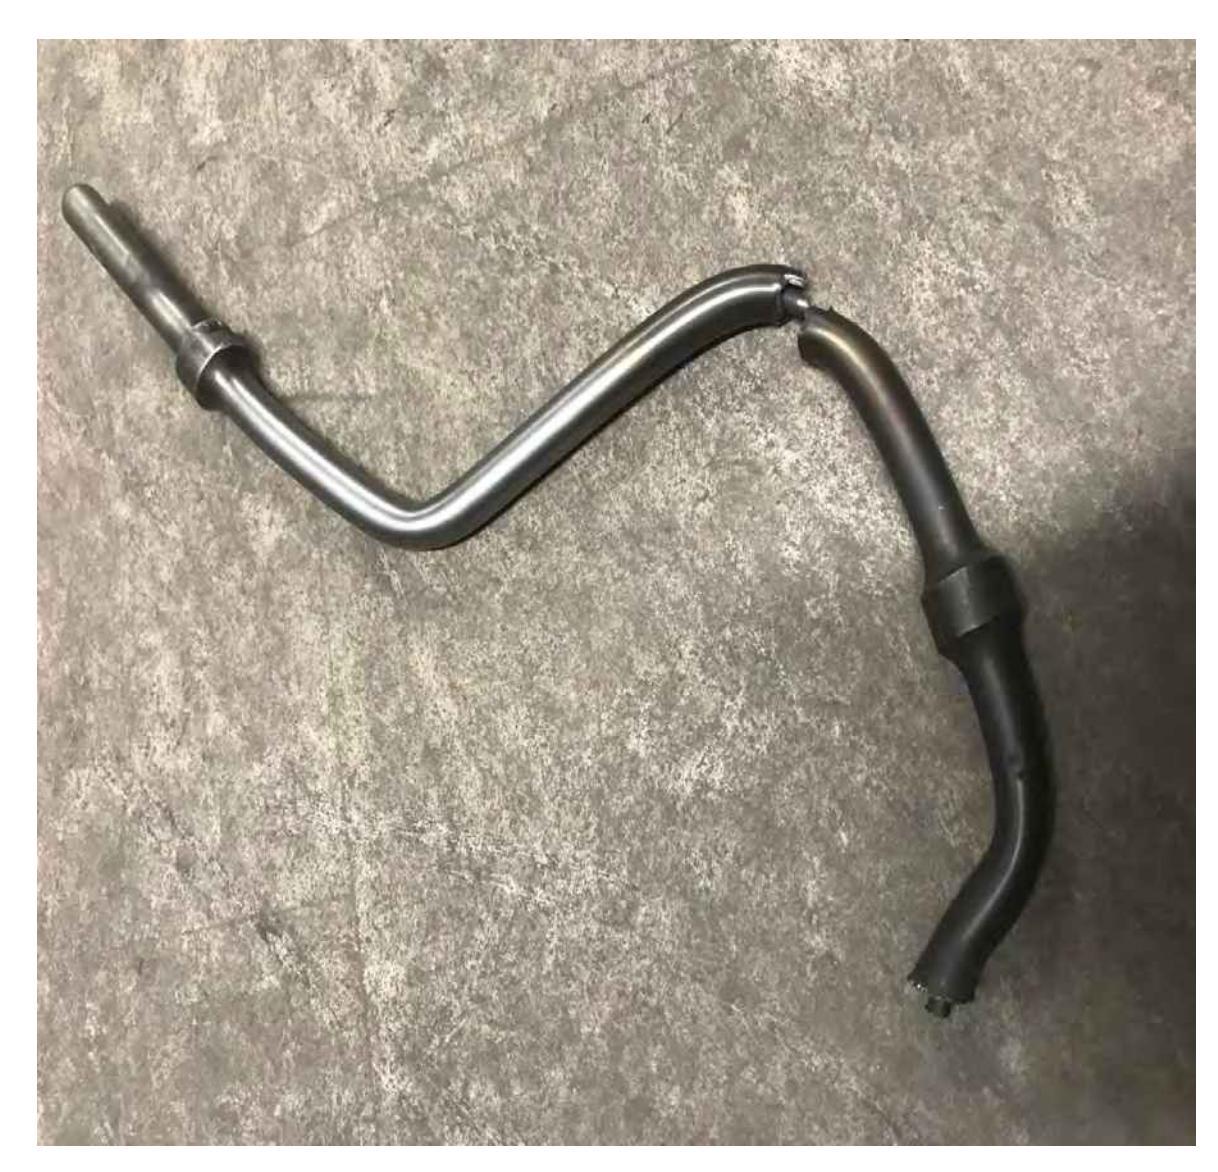
During assembly for alignment the thermowell that passes through the outer and inner cylinder bases was damaged. This thermowell houses a thermocouple that measures the first stage metal temperature. The thermowell was bent beyond repair and the thermocouple was damaged. The thermowell was PMI'ed by the customer and found to be 304 SS. The remaining section of thermowell that passes through the outer cylinder base was removed. The pieces were sent out as samples and a new thermowell was fabricated. A new "in kind" thermocouple was acquired. The new thermowell was installed at assembly. The thermowell was welded by Xcel Comanche welders using a weld procedure supplied by the customer.

HIP First Stage Metal Temperature Thermowell

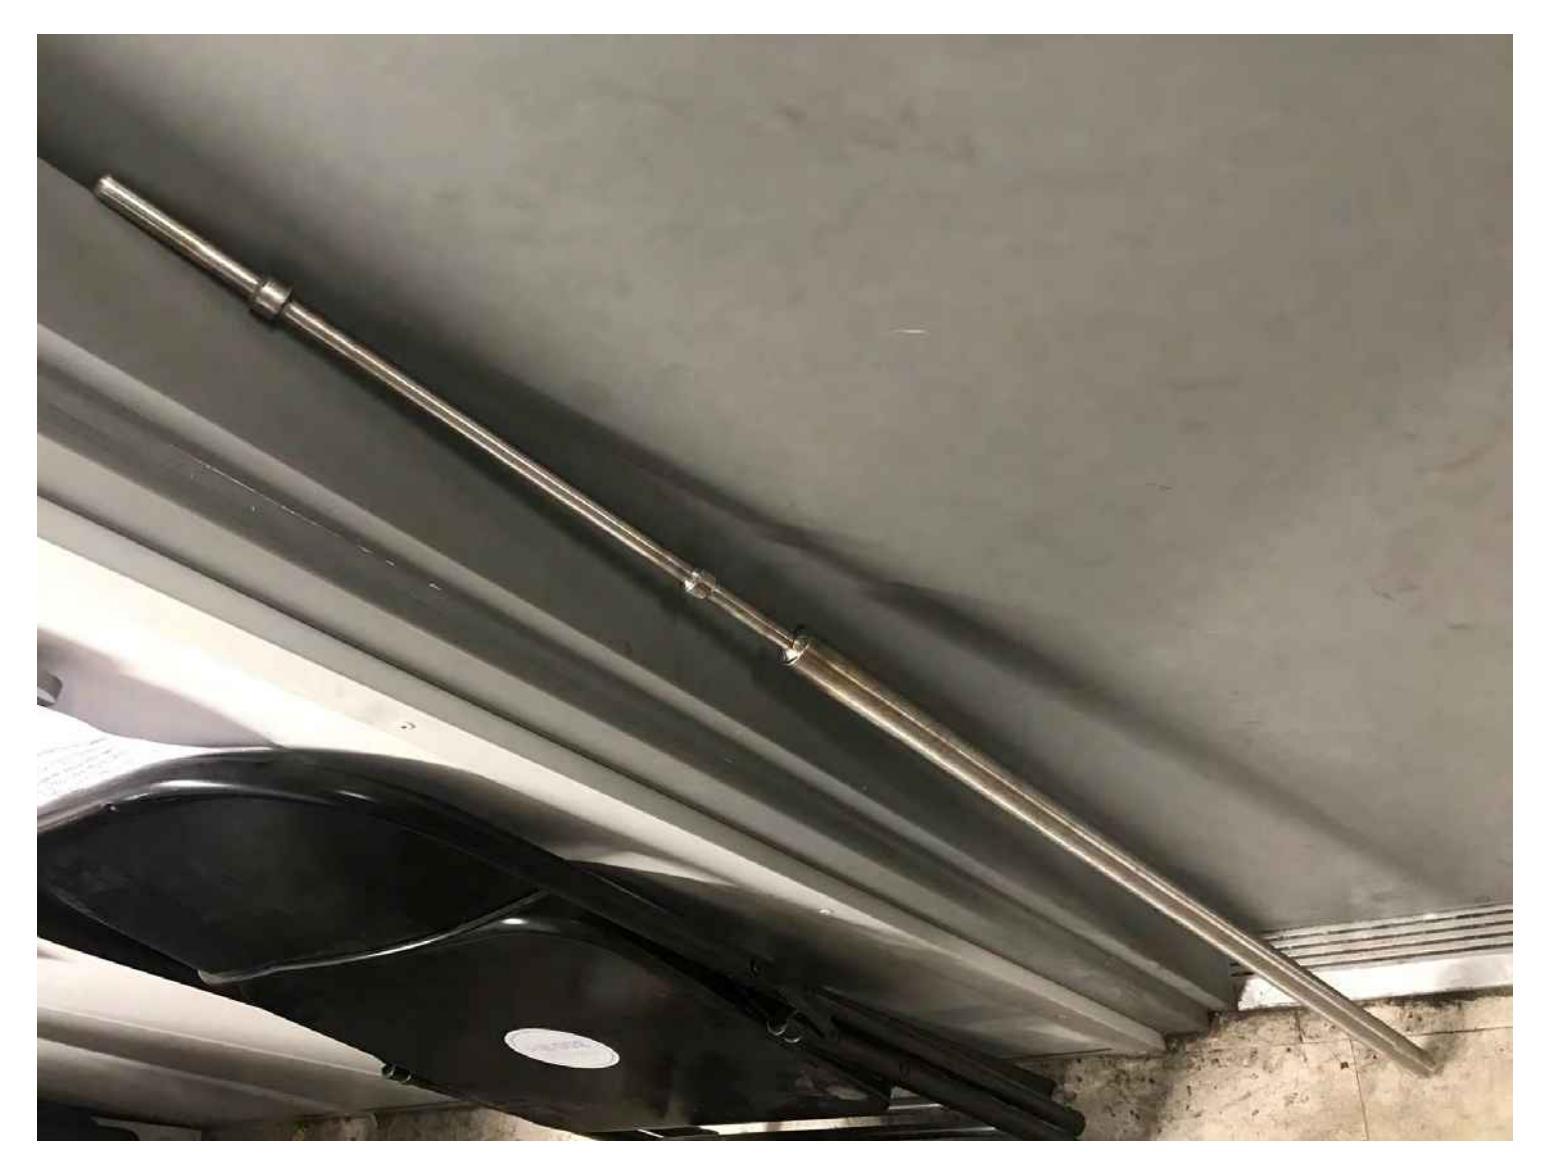
Replacement Thermowell

Replacement First Stage Metal Temperature Thermowell

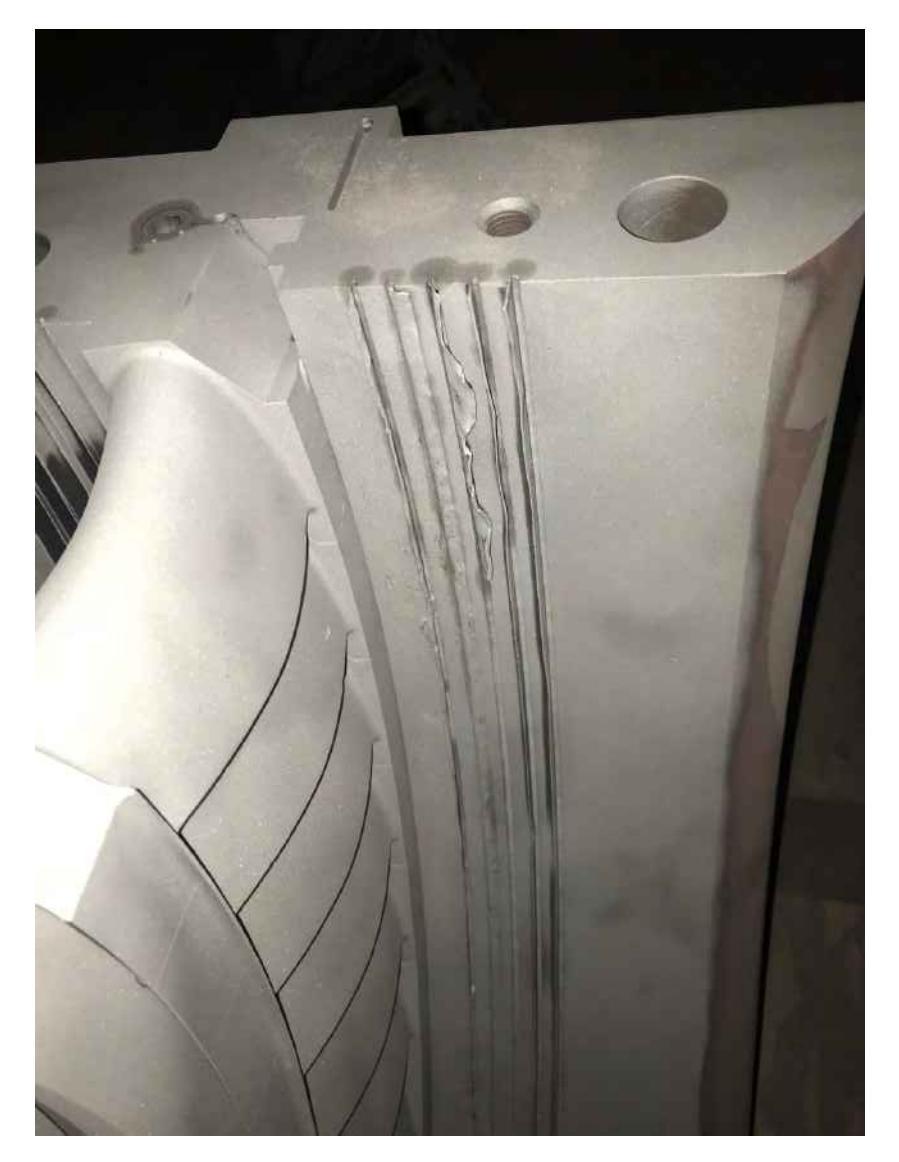
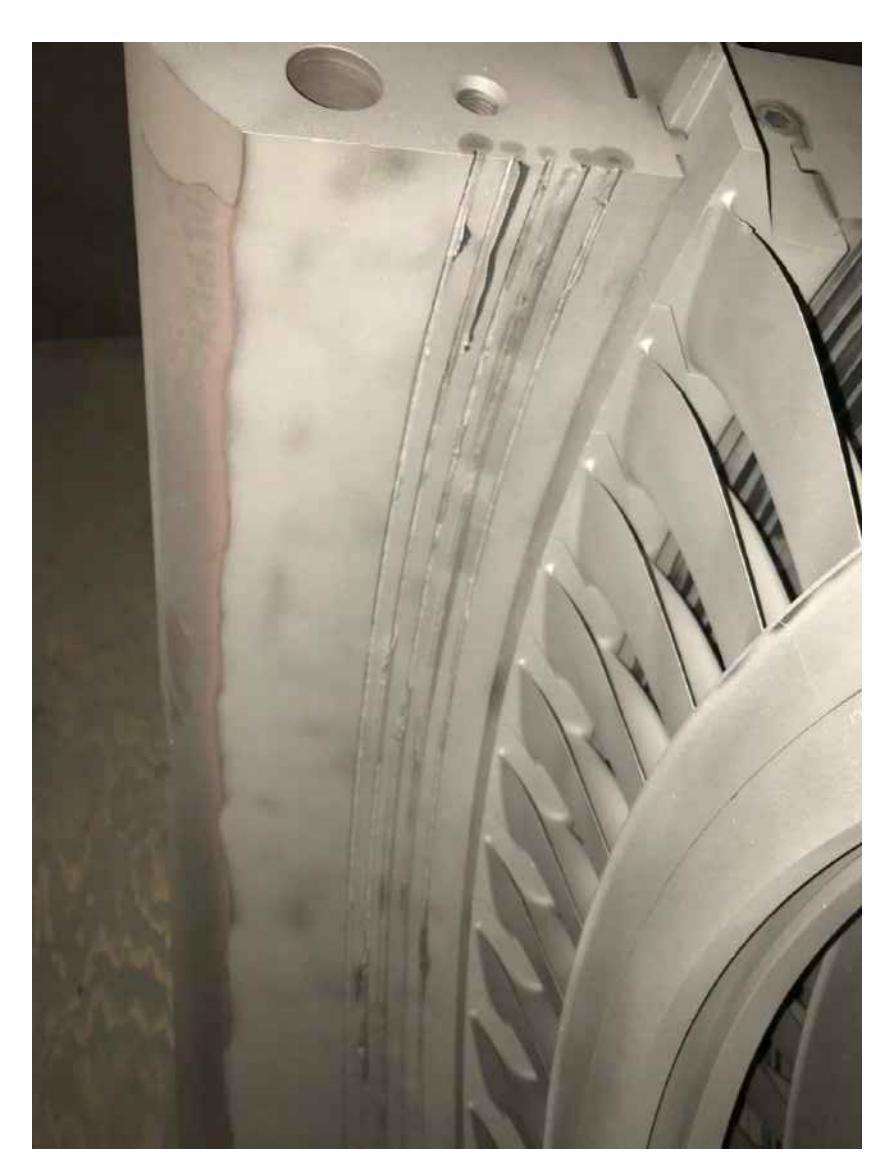
HP Blade Ring Spill Strips

The caulked-in spill strips were found to be in very poor condition, especially the bottom sections. The stage 9 spill strips were replaced and machined to size

Stage 9 Upper Half – As Found Spill Strip Condition

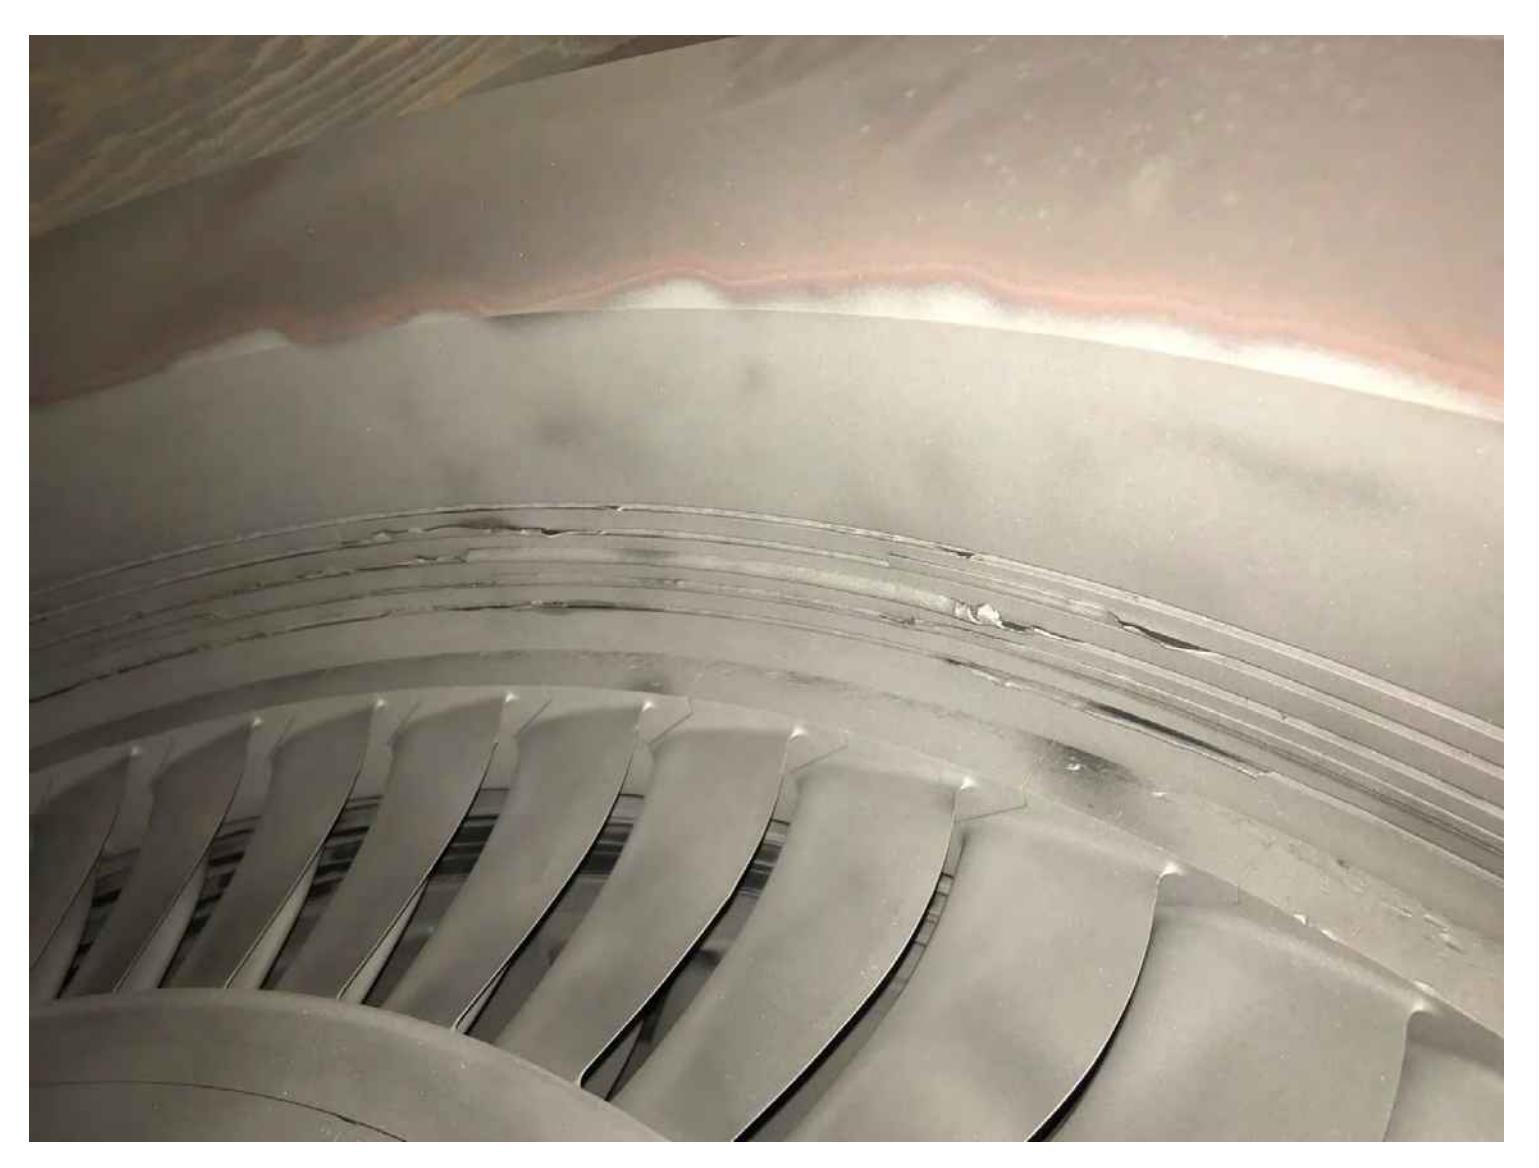
HP Blade Ring Spill Strips

Stage 9 Upper Half – As Found Spill Strip Condition

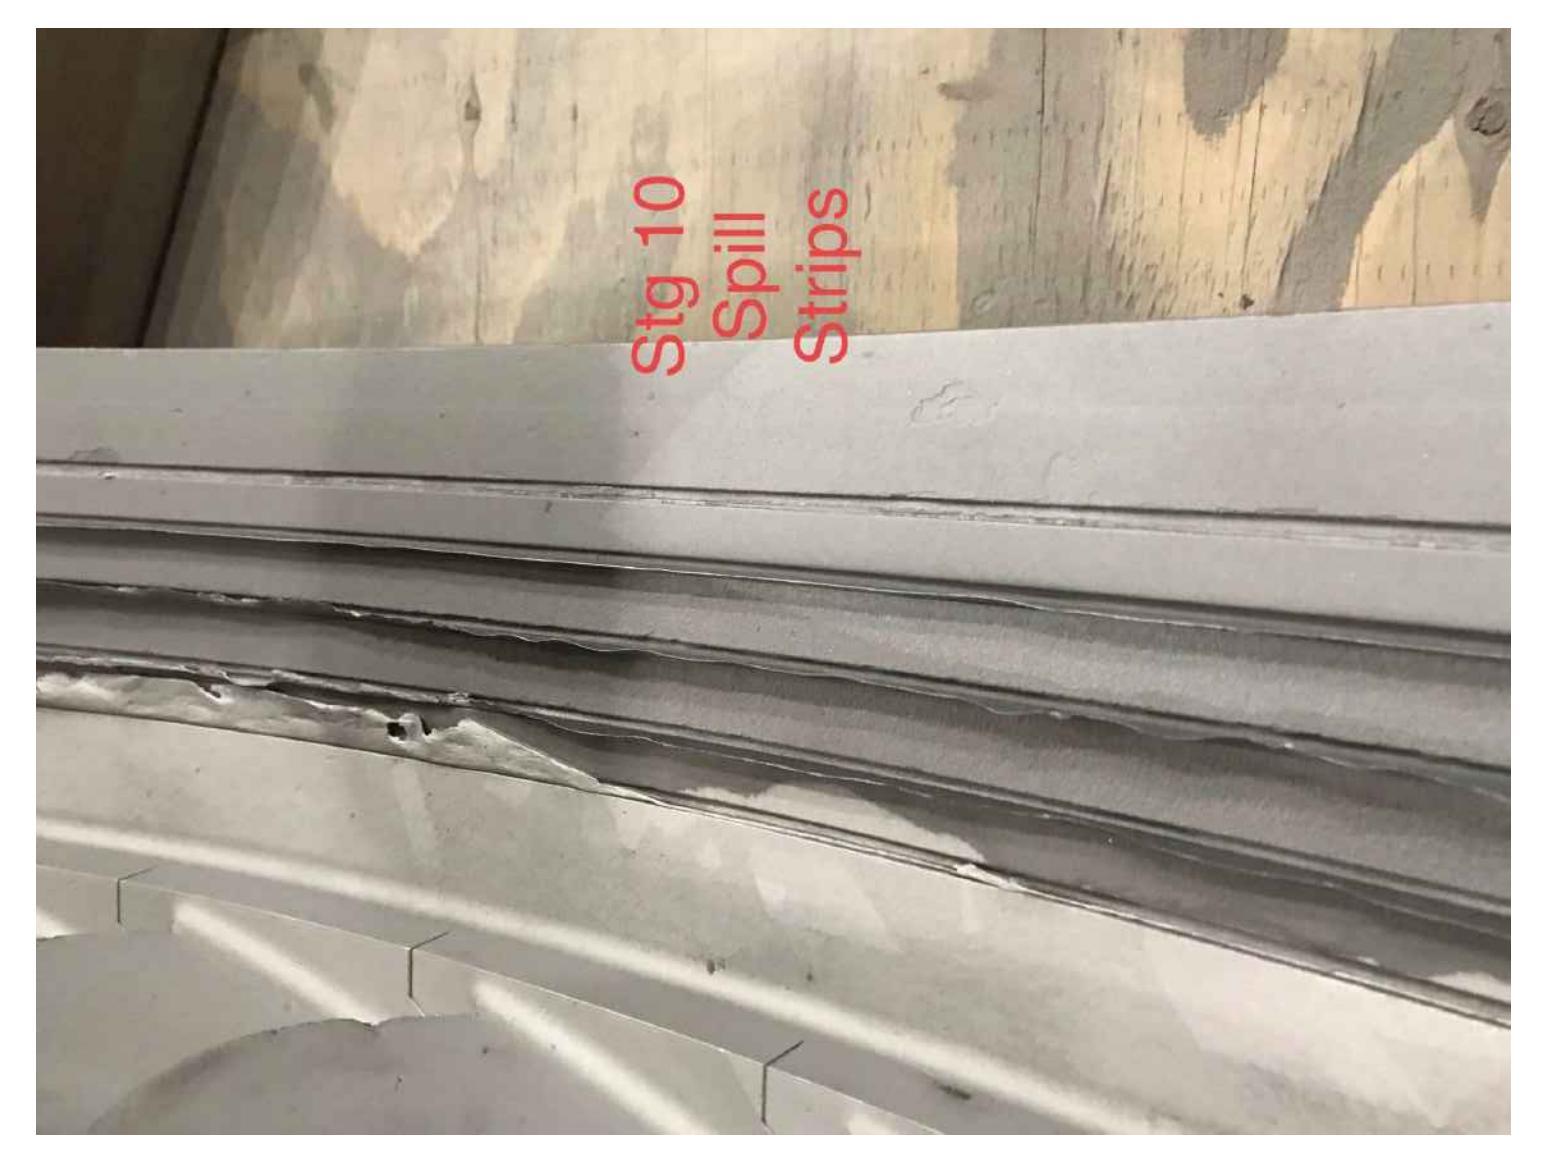
IP Blade Ring Spill Strips

Stage 10 Spill Strips – As Found After Grit Blasting

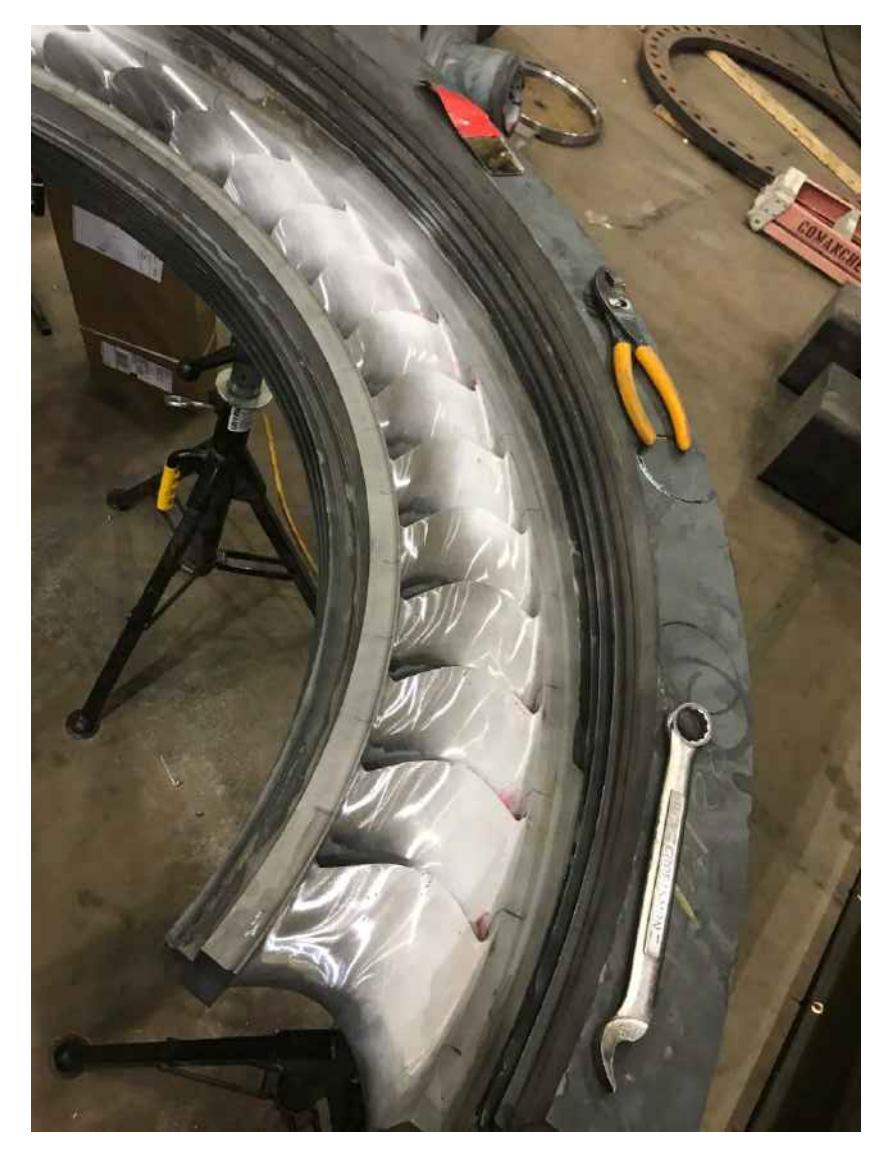
IP #1 Blade Ring Partition Repair

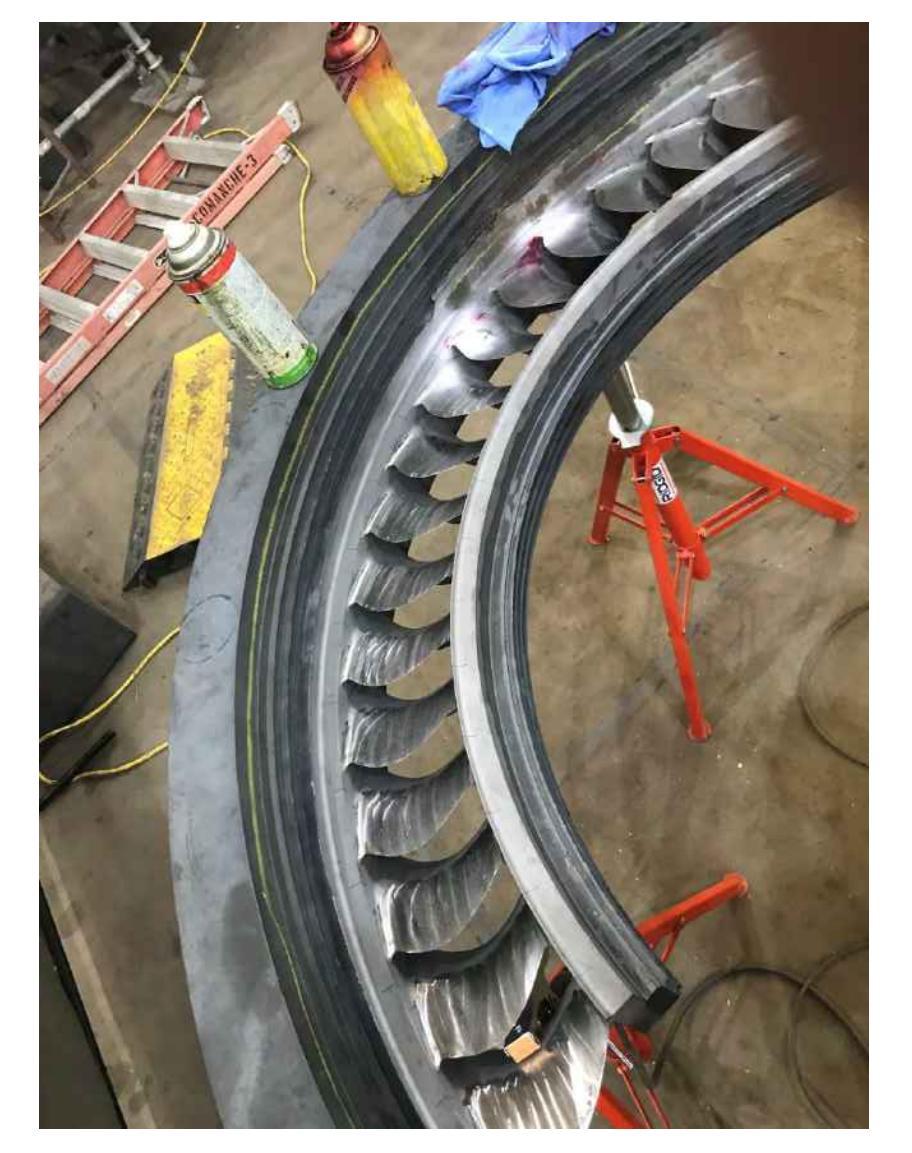
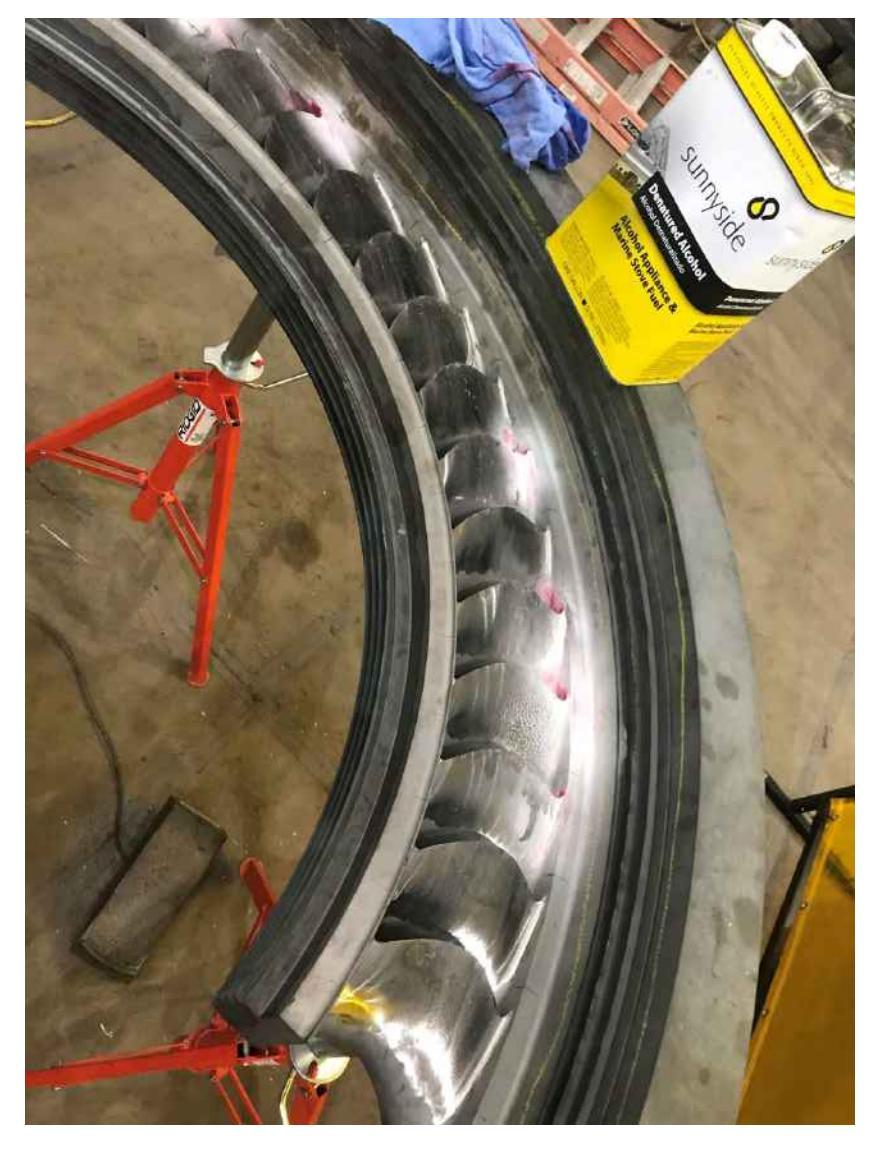
IP #1 Blade Ring Partitions Repair

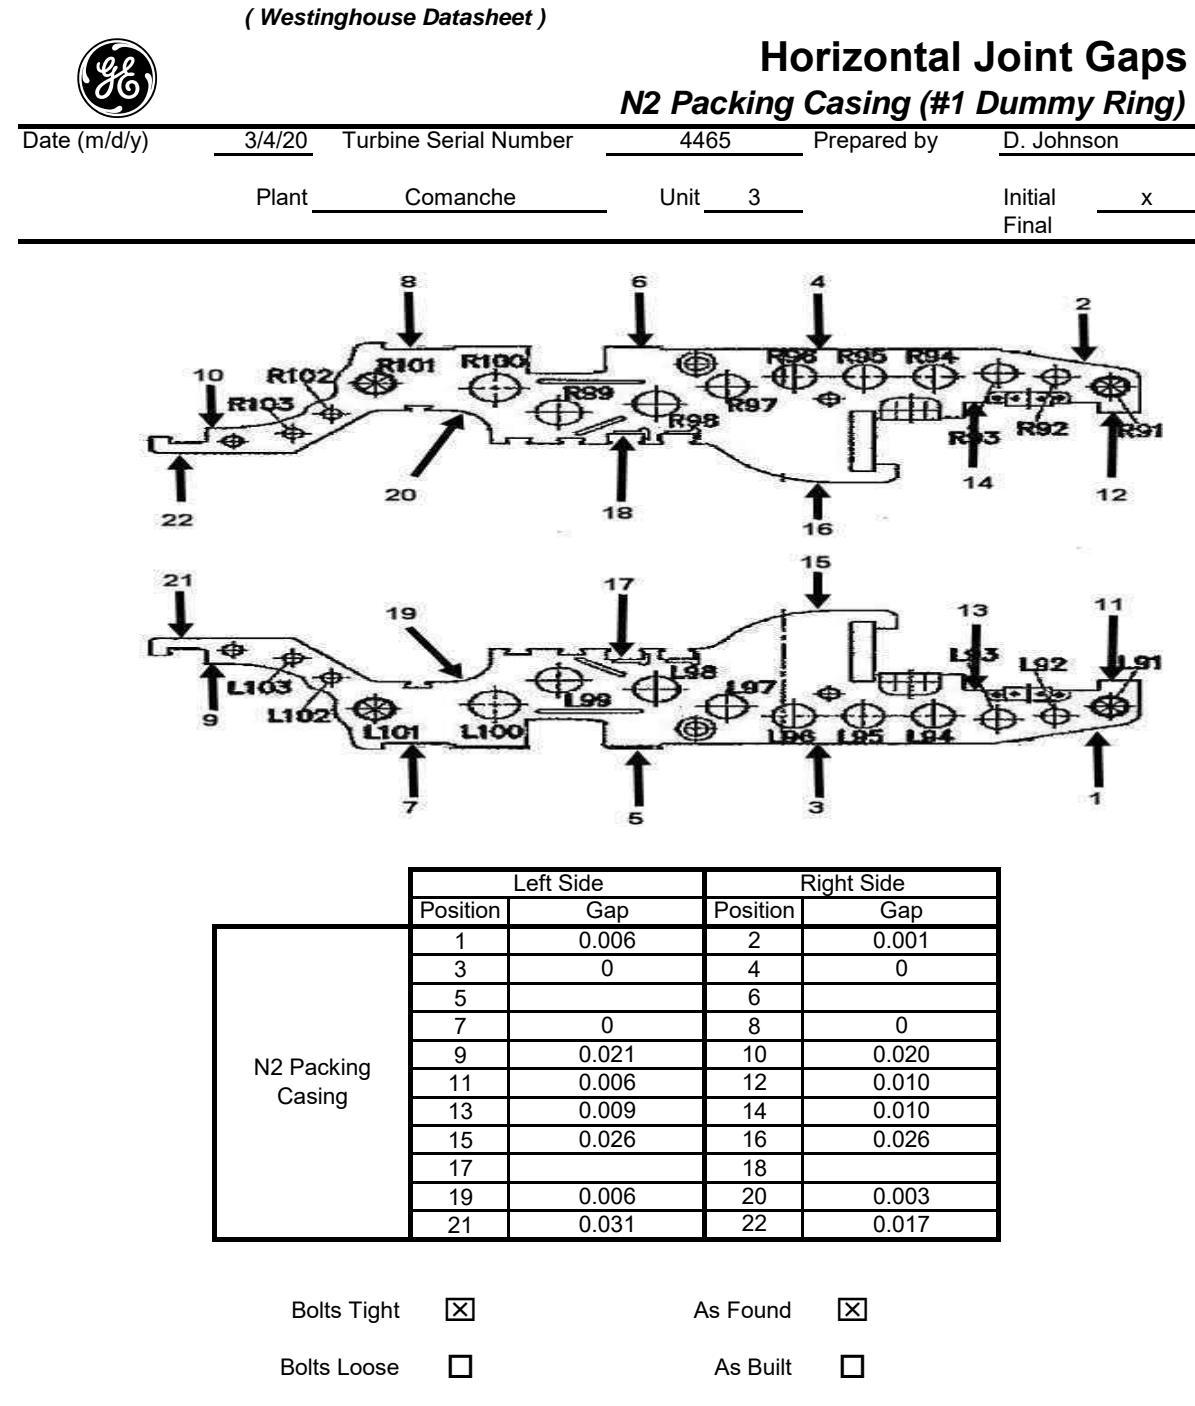
#1 Dummy Ring Distortion

Measurements taken during tops-on alignment after tightening bolts Missing hardware would not allow for the horizontal joint to be closed
