Comanche Unit 3 -Spring 2020 Outage

Full Train Major, Main Steam Valves & Generator

COMANCHE (CO) Steam Turbine ESN: SY0093272 Generator ESN: SY0350139 Job Start Date: 13 Jan 2020 Oracle Project ID: FSP-285469 | C-10344497

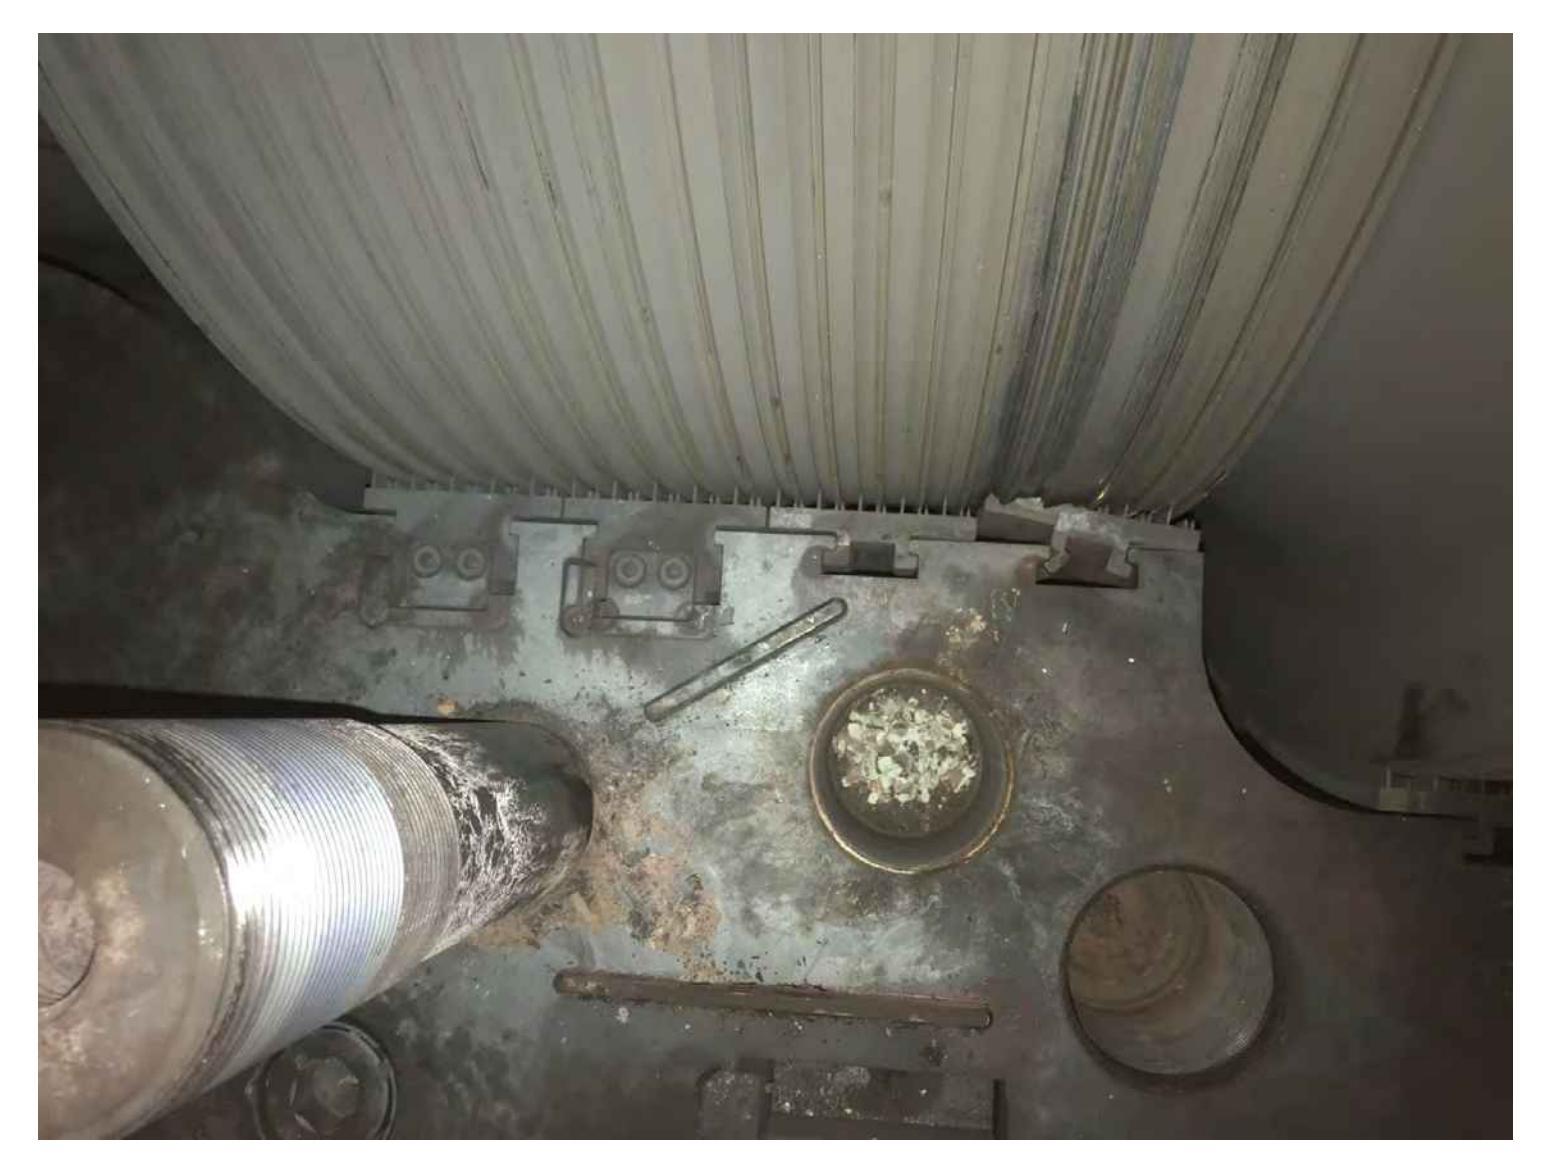
#1 Dummy Ring Packing Failure

#1 Dummy Ring Right Side – Failed Packing Hook Fit

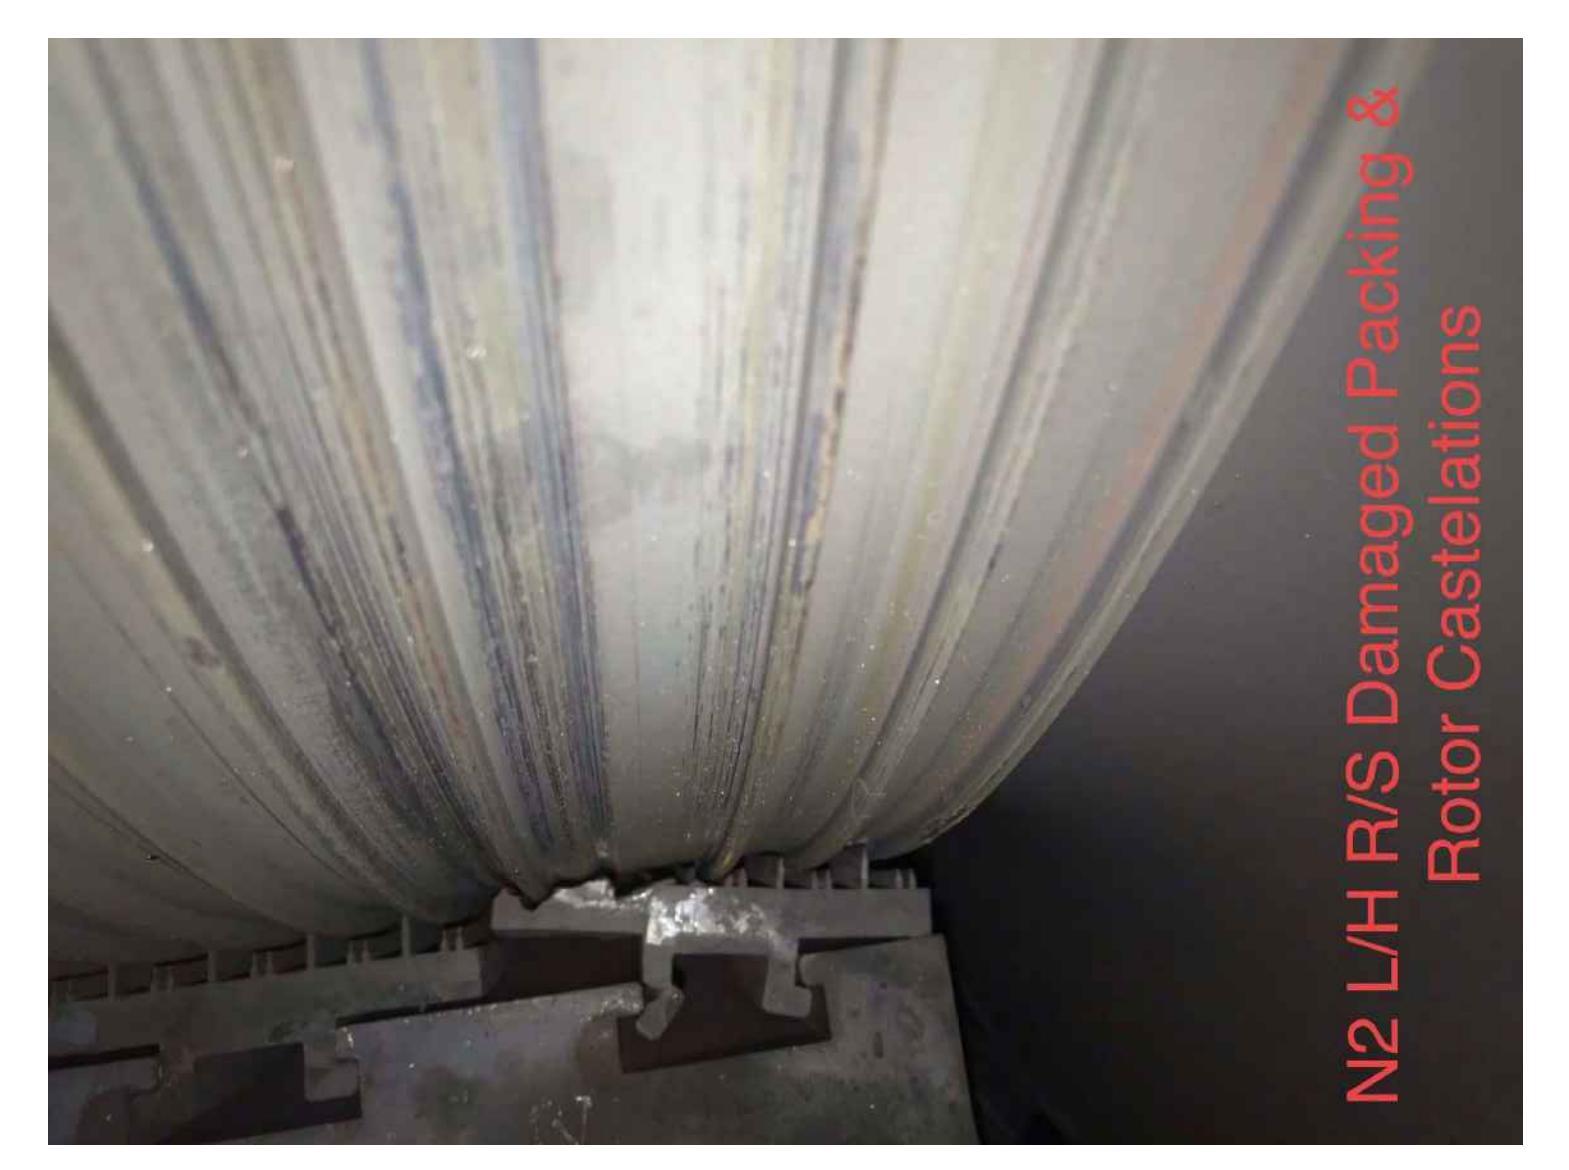
#1 Dummy Ring Packing Failure

#1 Dummy Ring Right Side – Row K Failed Hook Fit

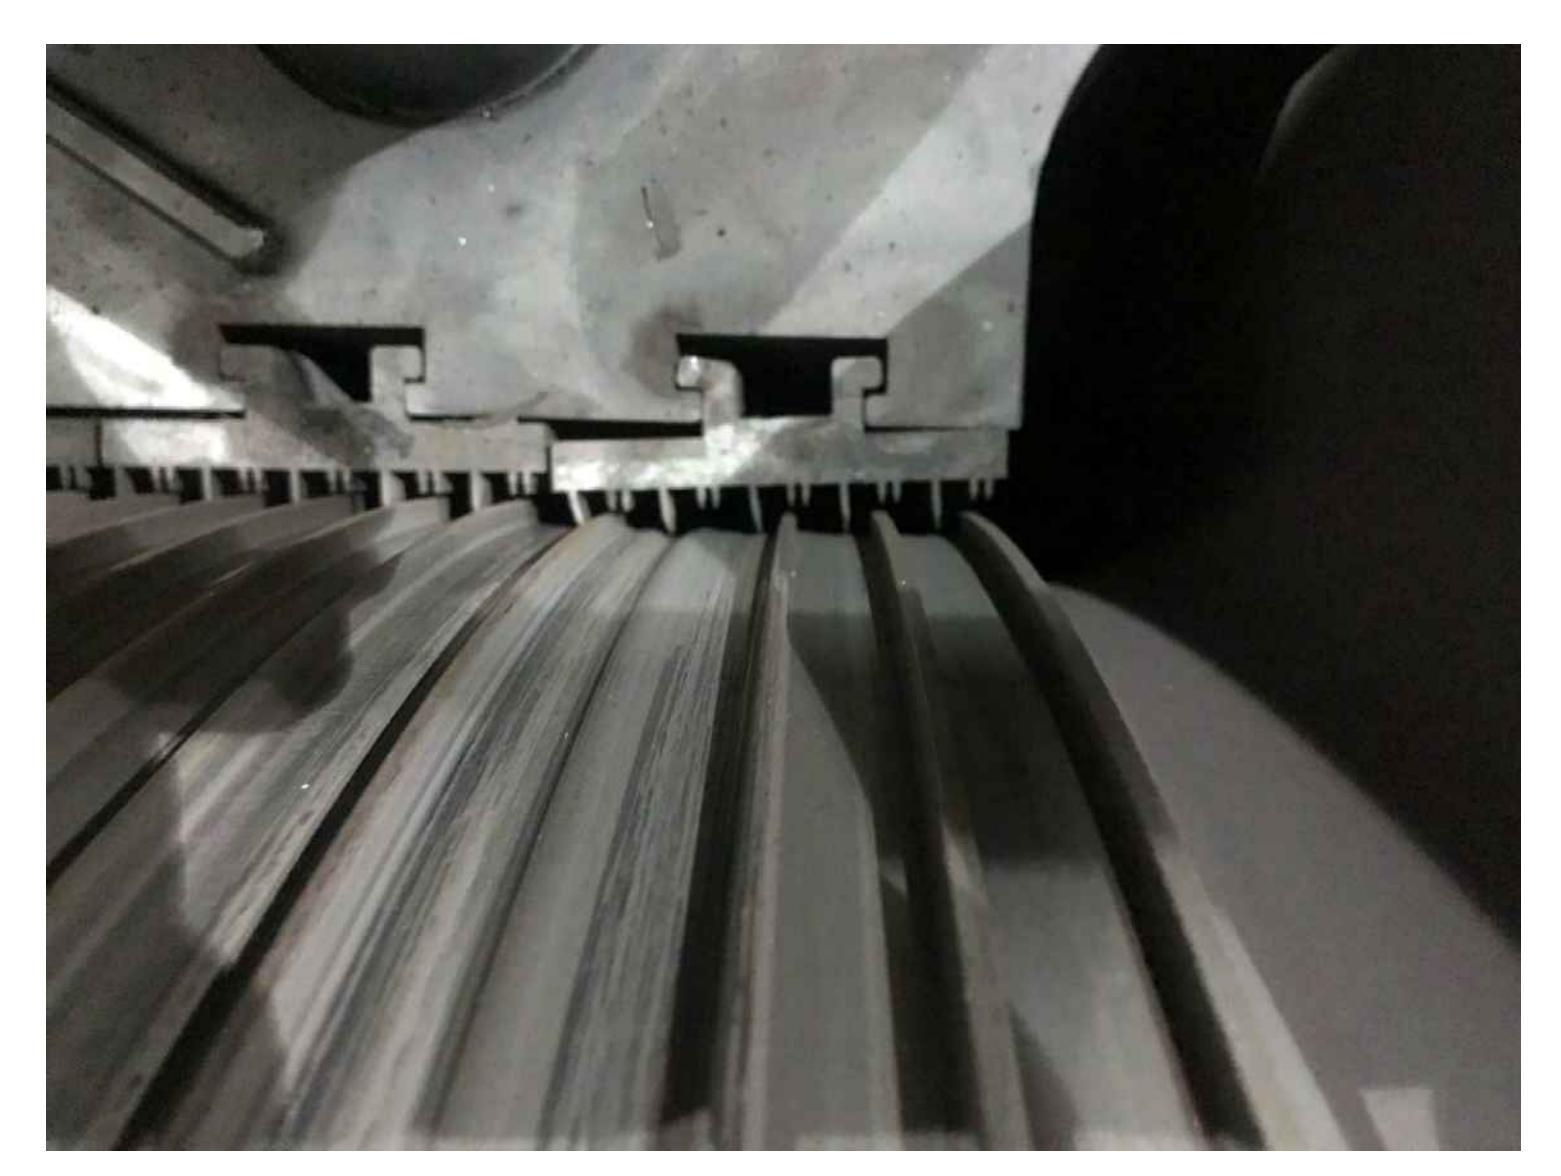
#1 Dummy Ring Packing Failure

#1 Dummy Ring Left Side – Row K Hook Fit Beginning Failure

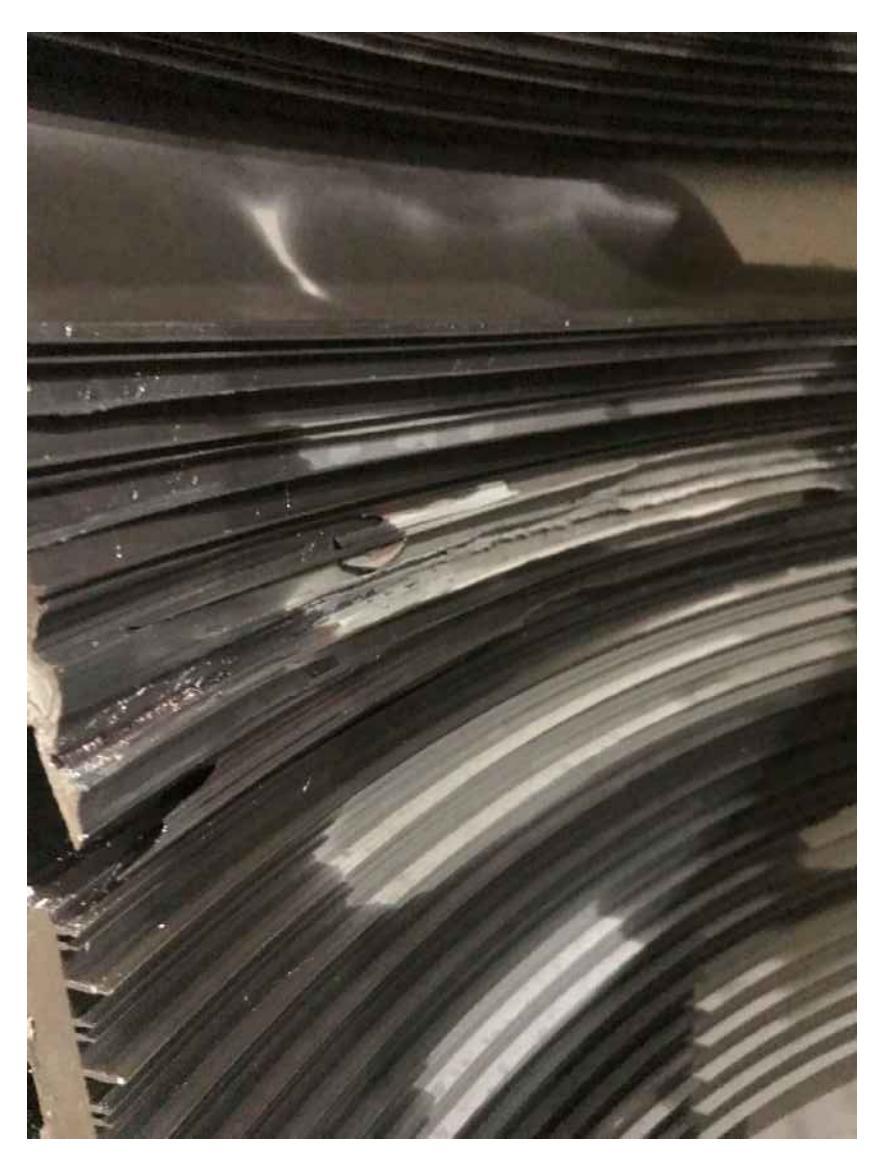
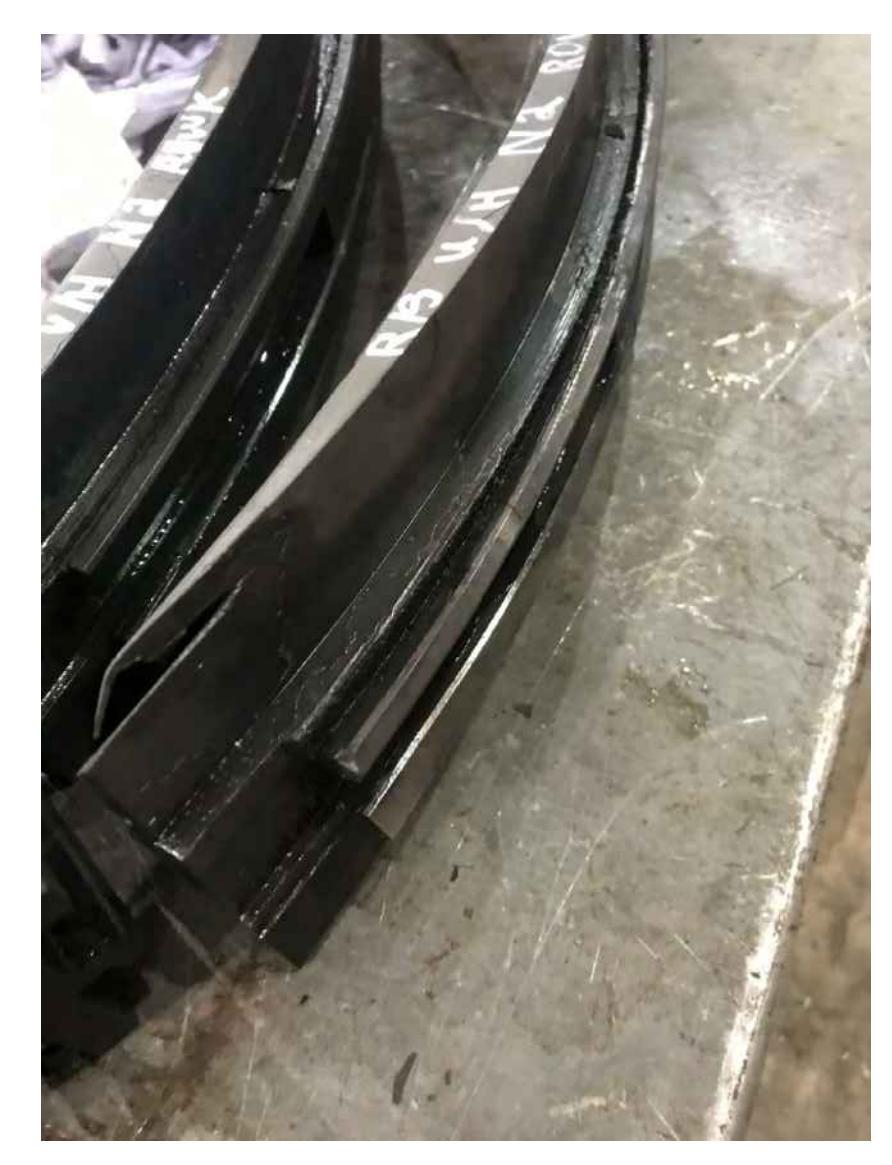
#1 Dummy Ring Packing Failure

#1 Dummy Ring – Row K Failed Packing Segments

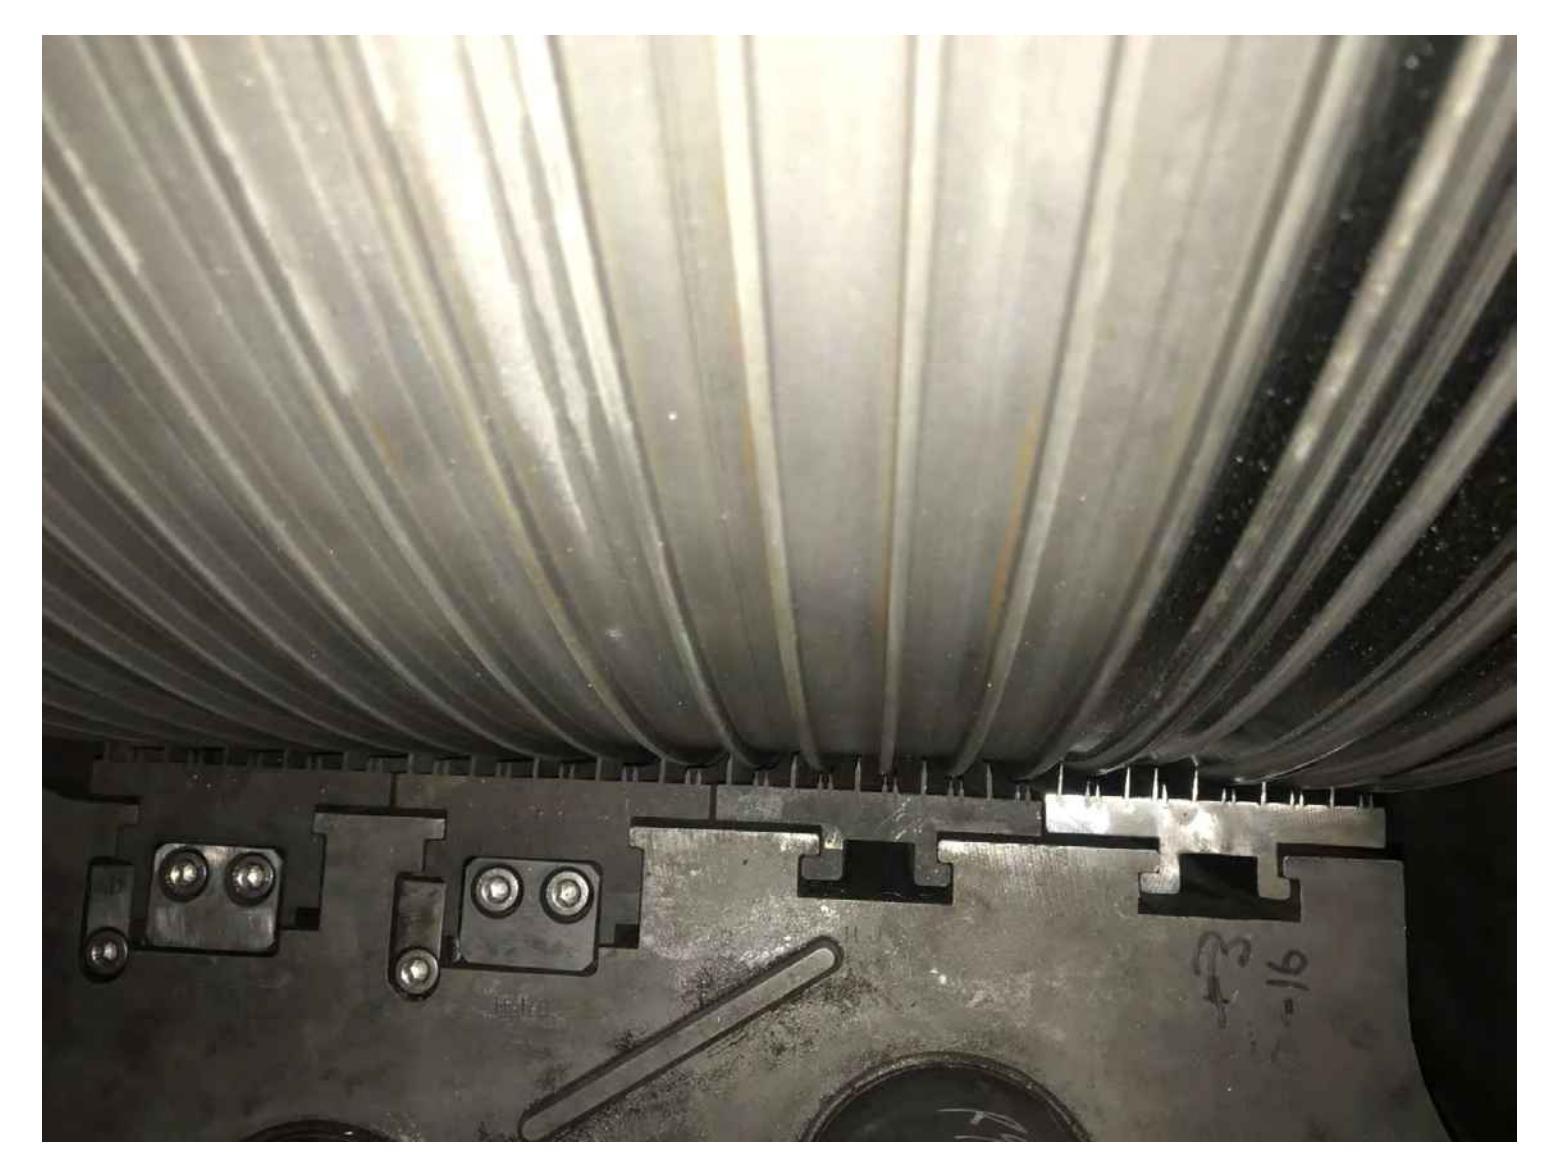
#1 Dummy Ring Packing Failure

#1 Dummy Ring Right Side – New Row K Packing

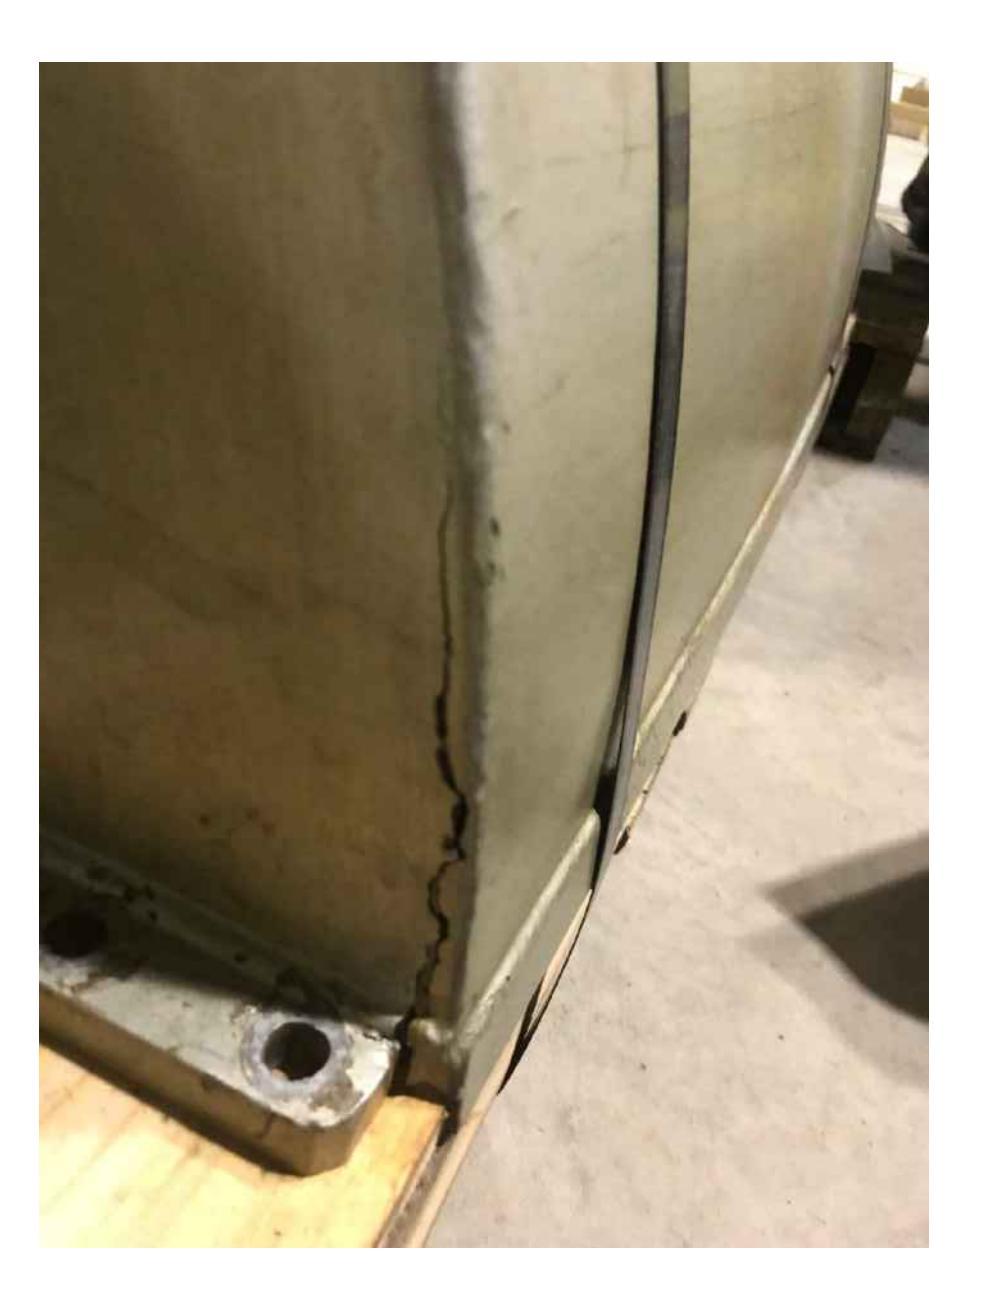
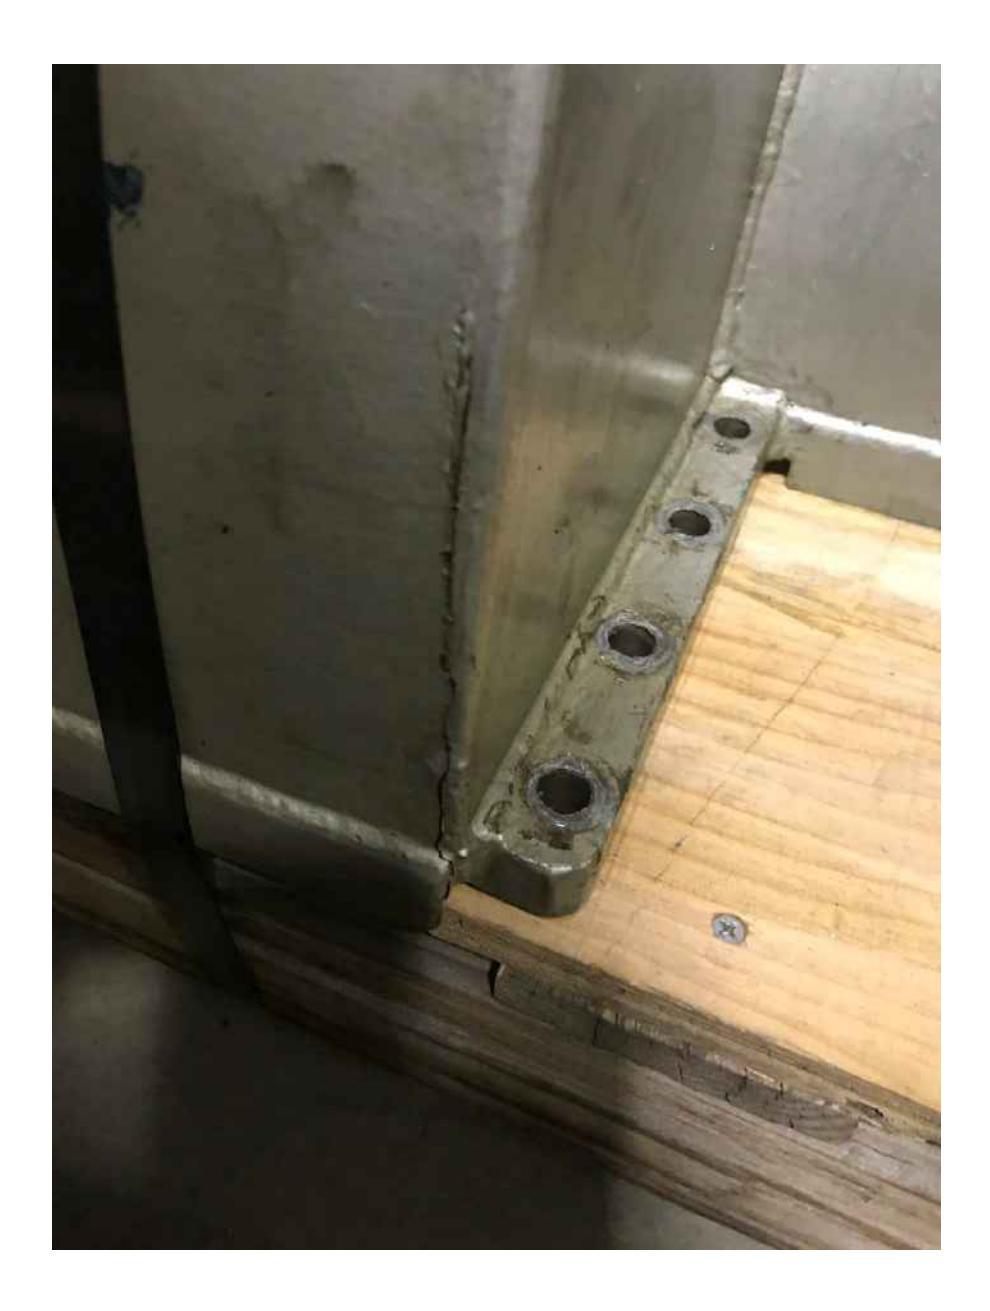
Coupling Guards - Cracked Welds

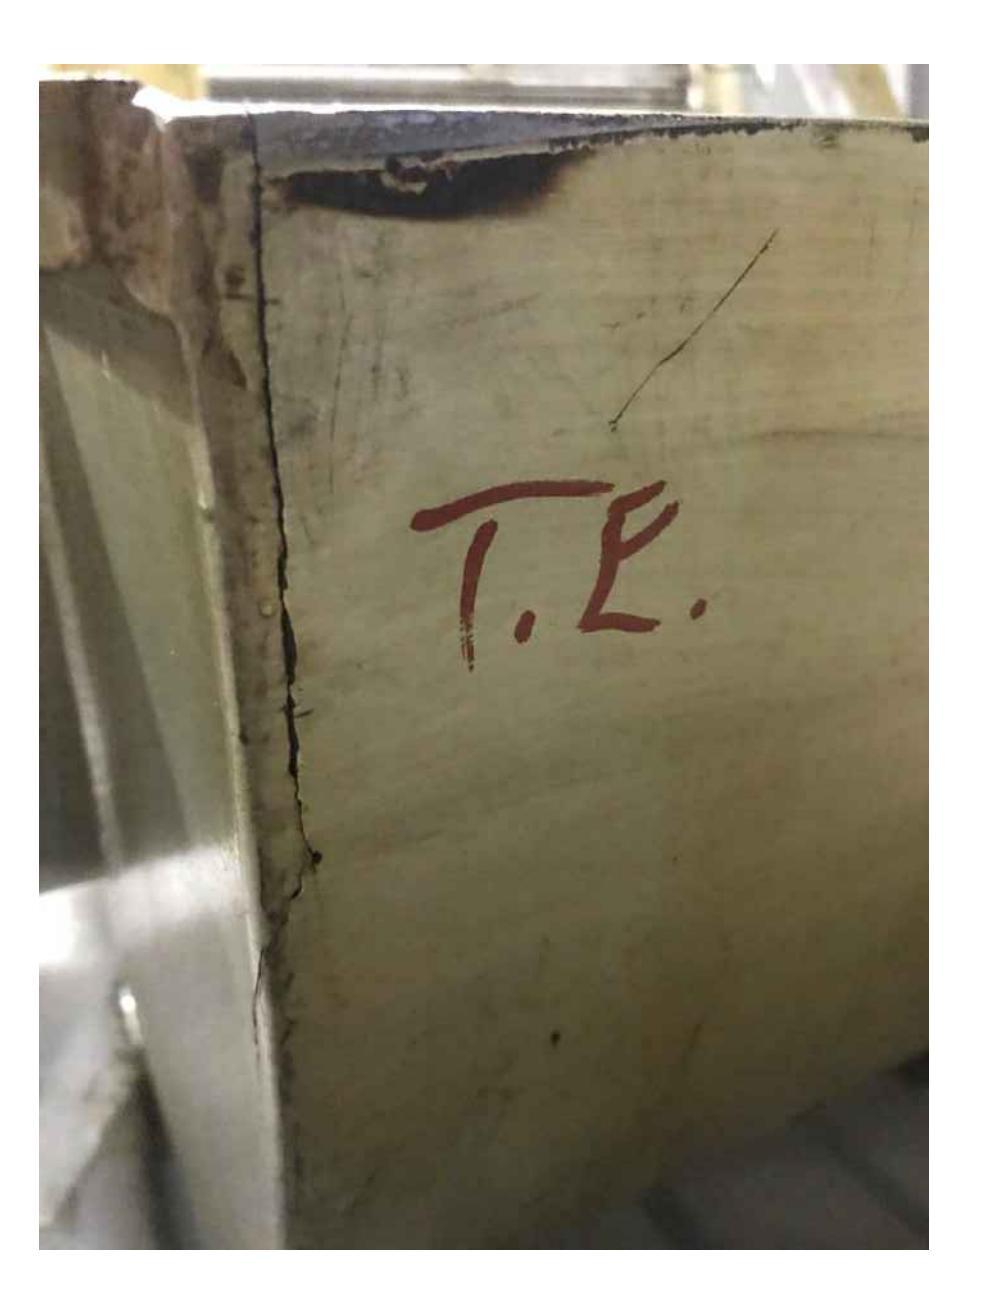
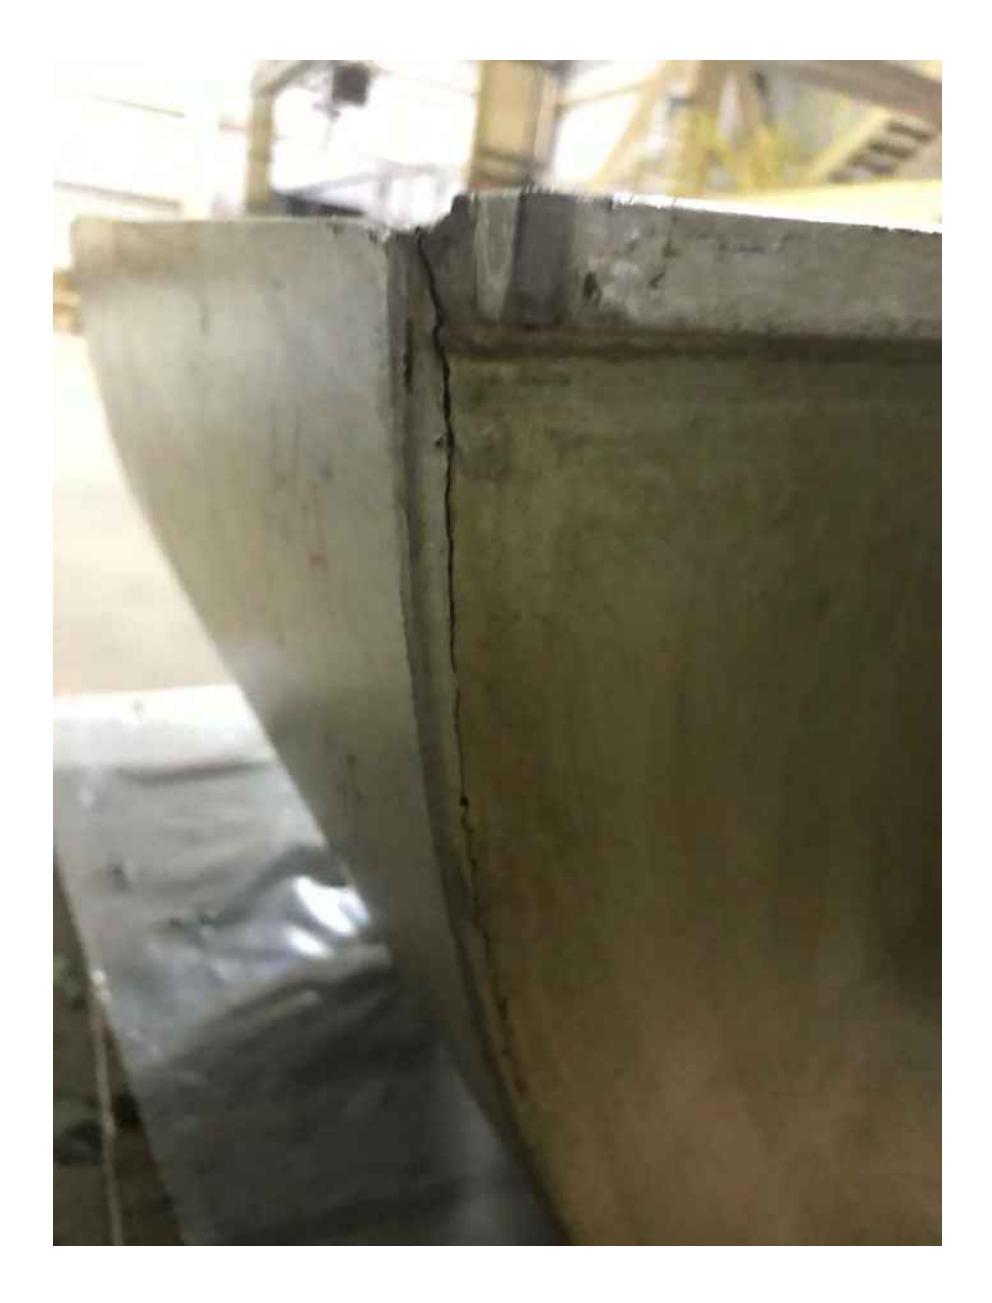
Coupling Guards - Cracked Welds

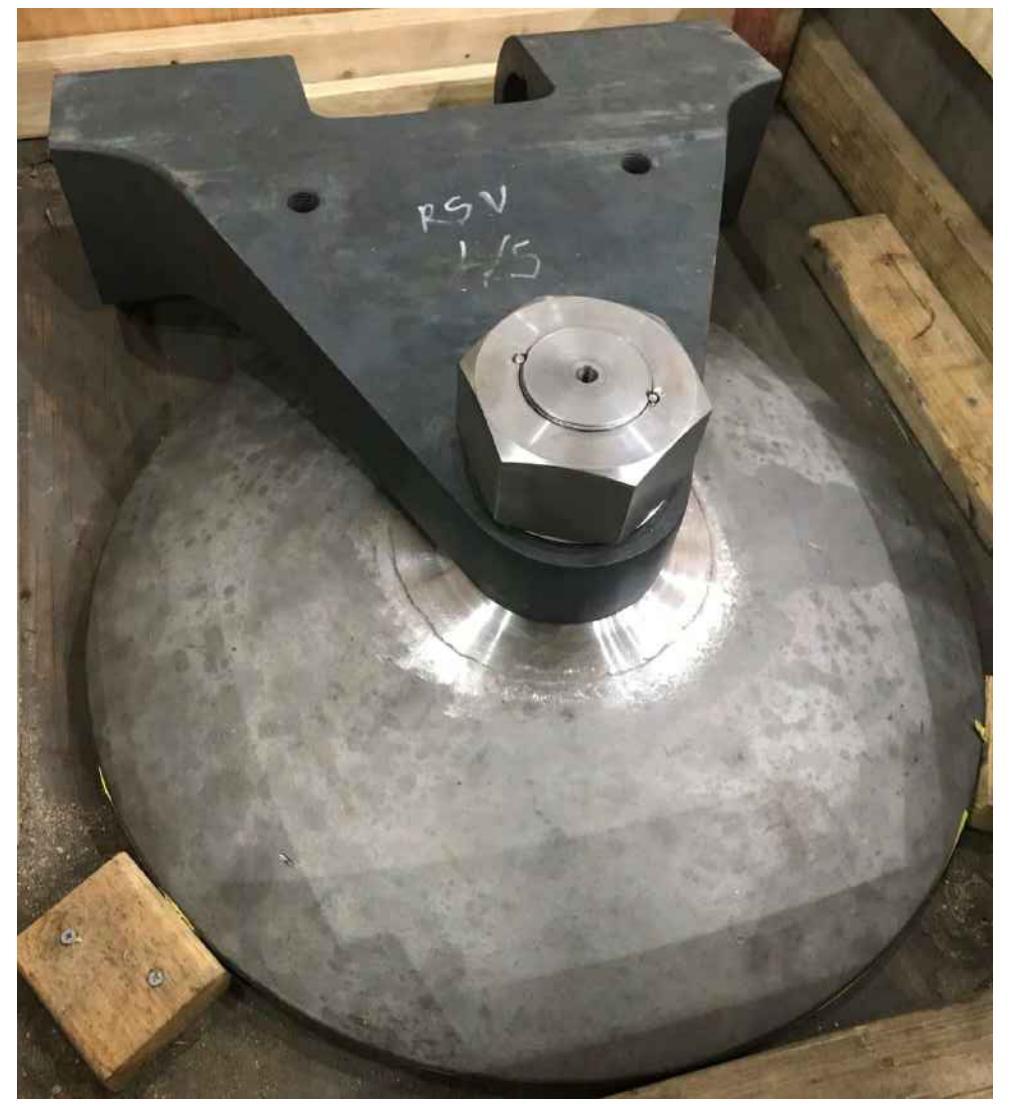
Left Side Reheat Stop Valve Yoke-Disc Assembly – After Repair

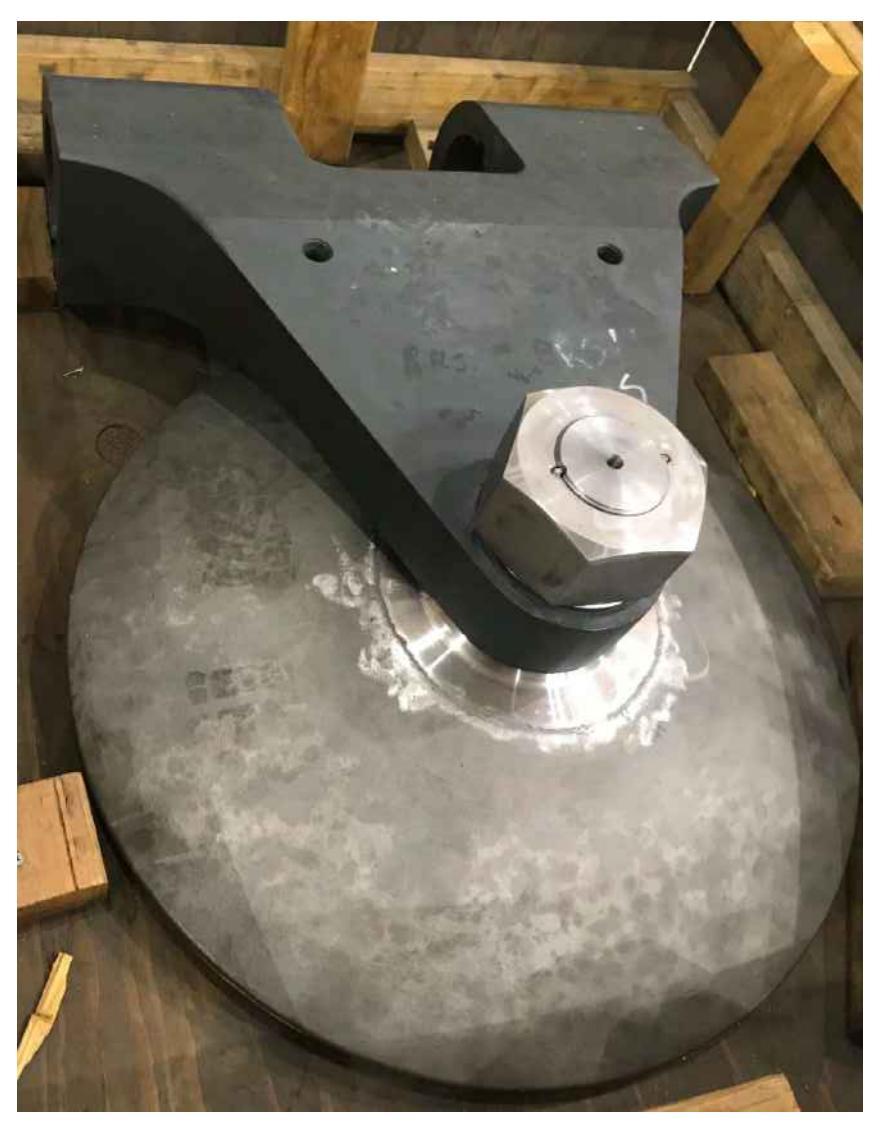
Right Side Reheat Stop Valve Yoke -Disc Assembly – After Repair

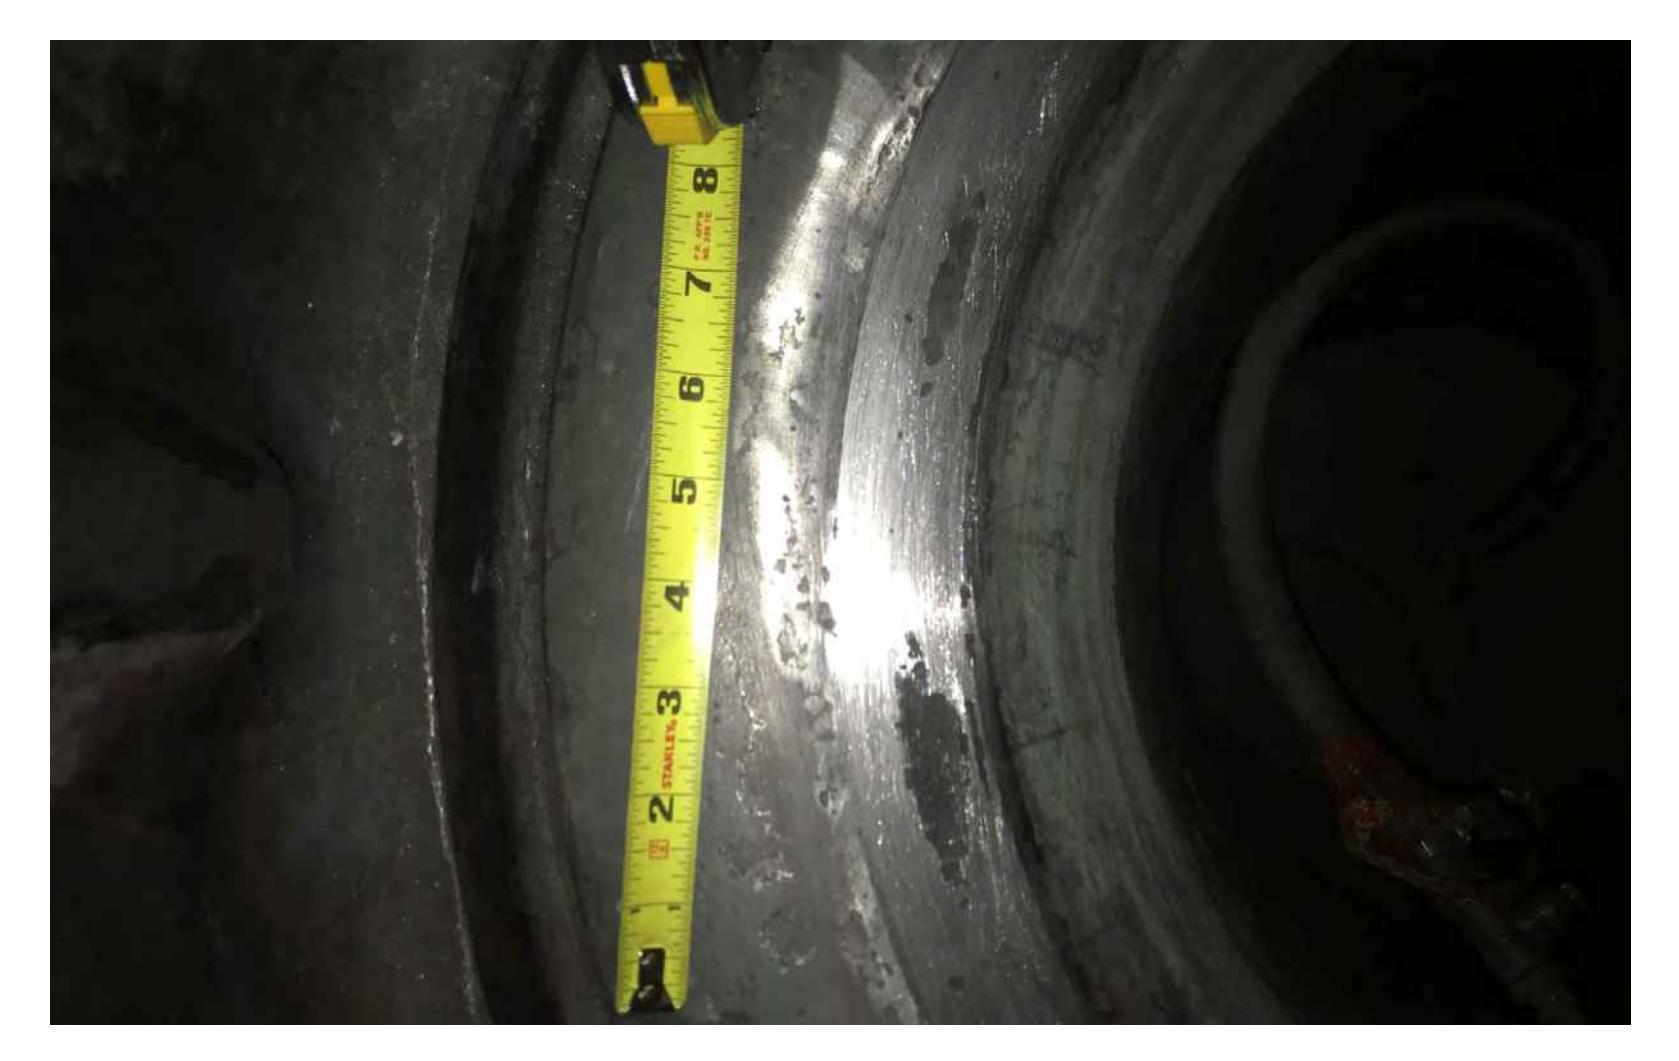
Intercept Valve Pictures

Right Side Inboard Intercept Valve Seat Damage

The right side inboard seat should be weld repaired and lapped during the next outage. The intercept valve body was PMI'ed by the customer and found to be either 434 SS or grade 91 Steel.

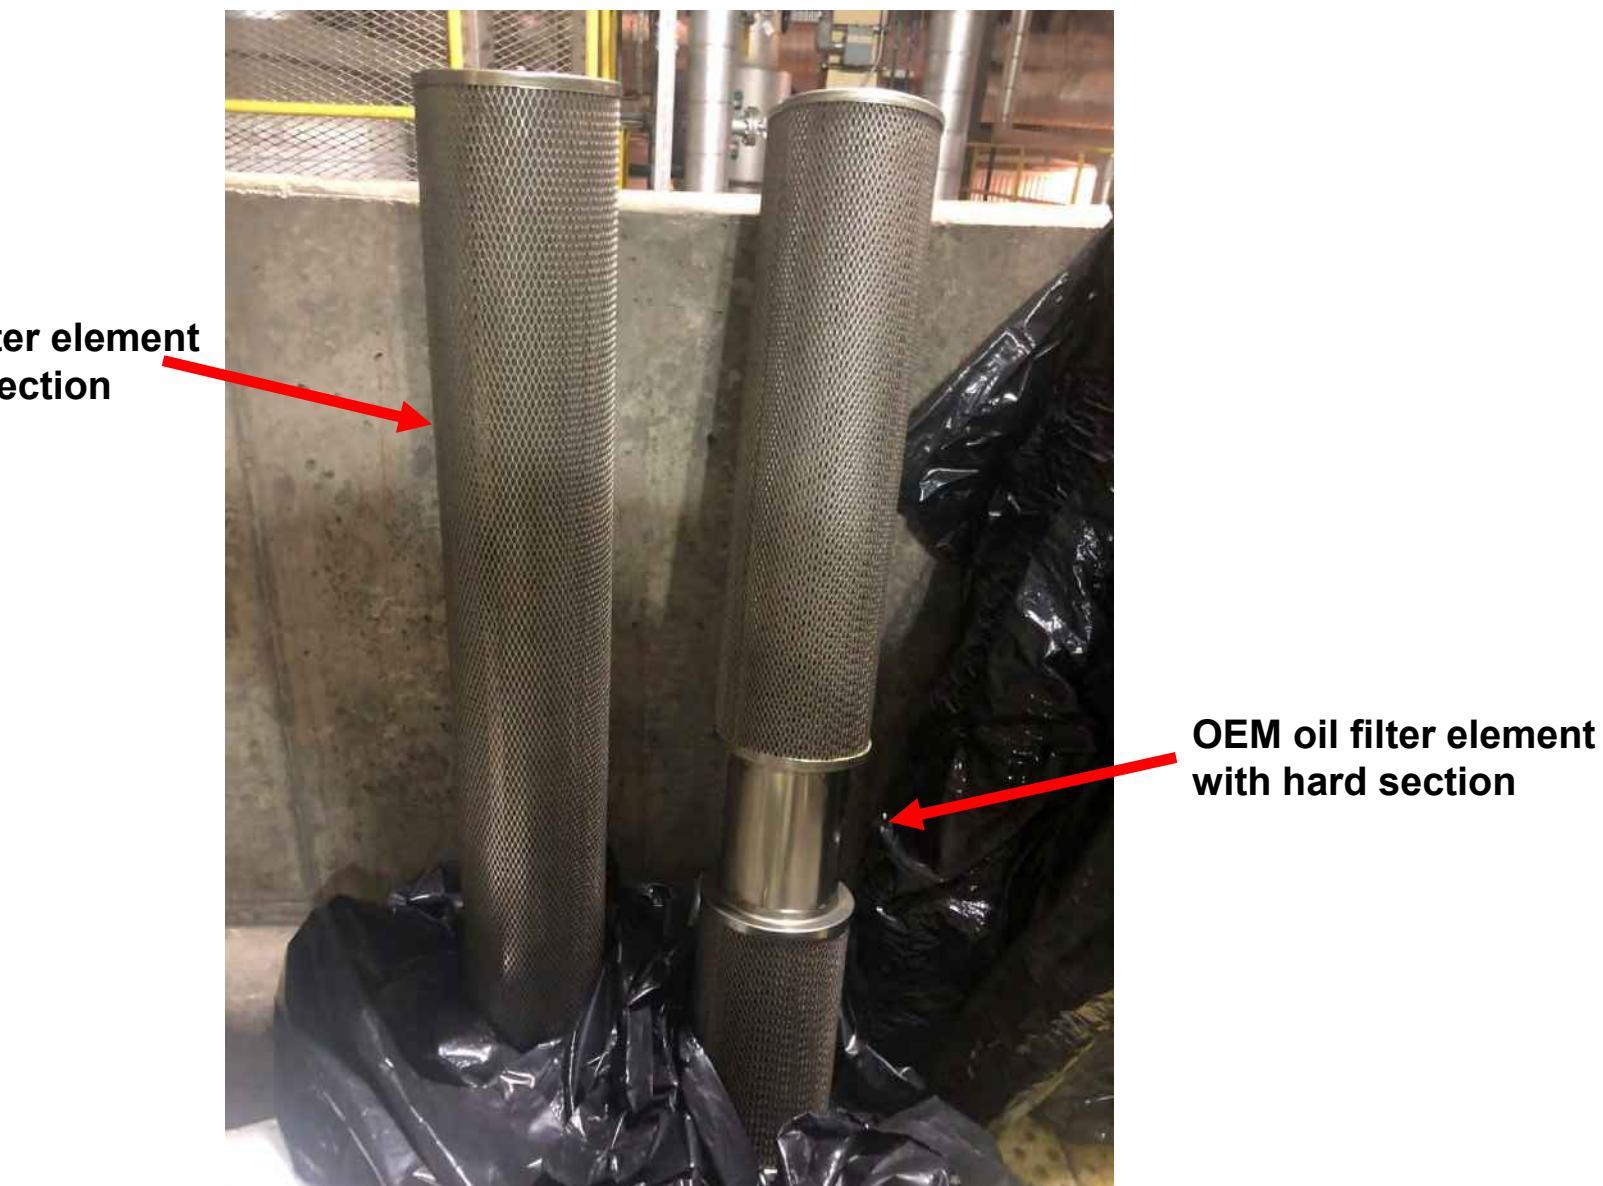
Lube Oil Filter Element Failure

psi or every six months, whichever comes first. Differential pressure across the filter was found to be 3 psi, which is quite low. Also, the filter elements that had been installed were not correct, per OEM design. Furthermore, the stabilizing brackets at the top of the filter housing were found damaged. This bracket was the only component that was found to be magnetic, so, it is assumed to have been the source of the magnetic particles.

Installed oil filter element without hard section

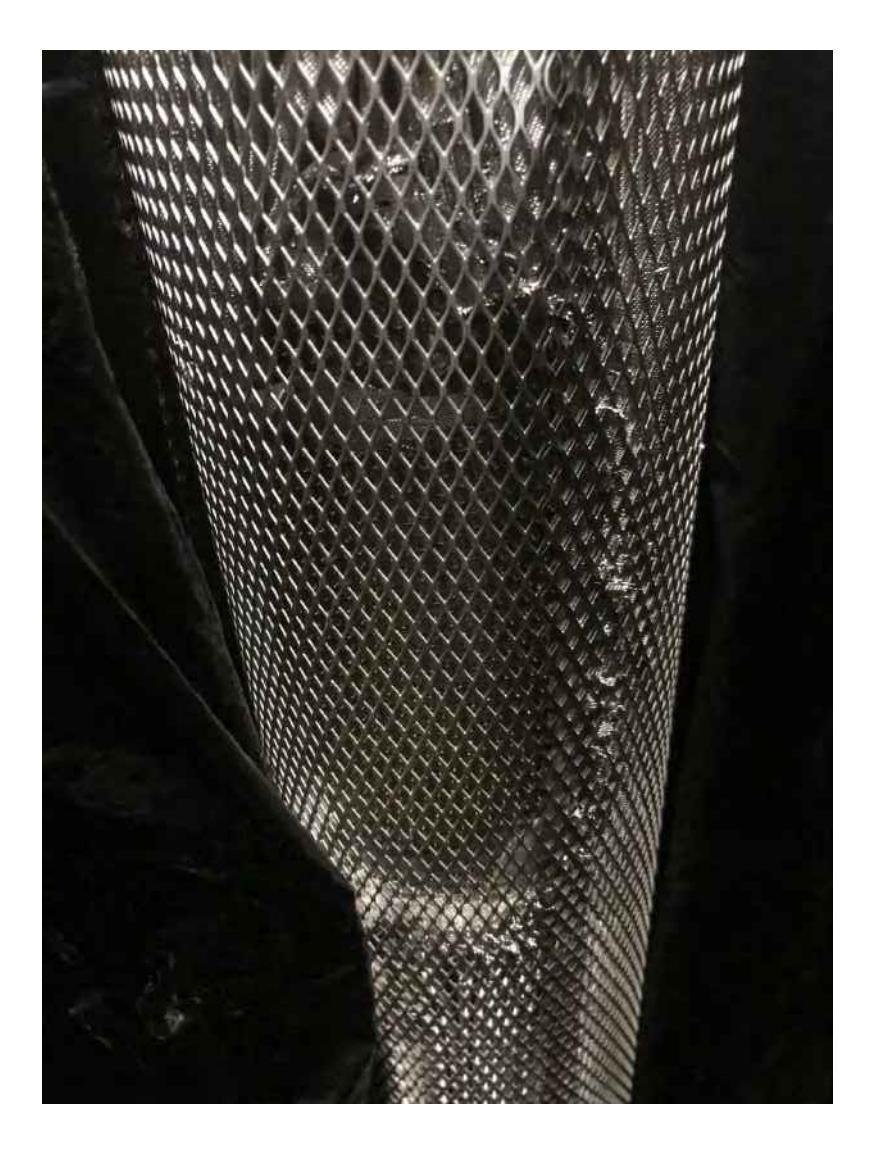
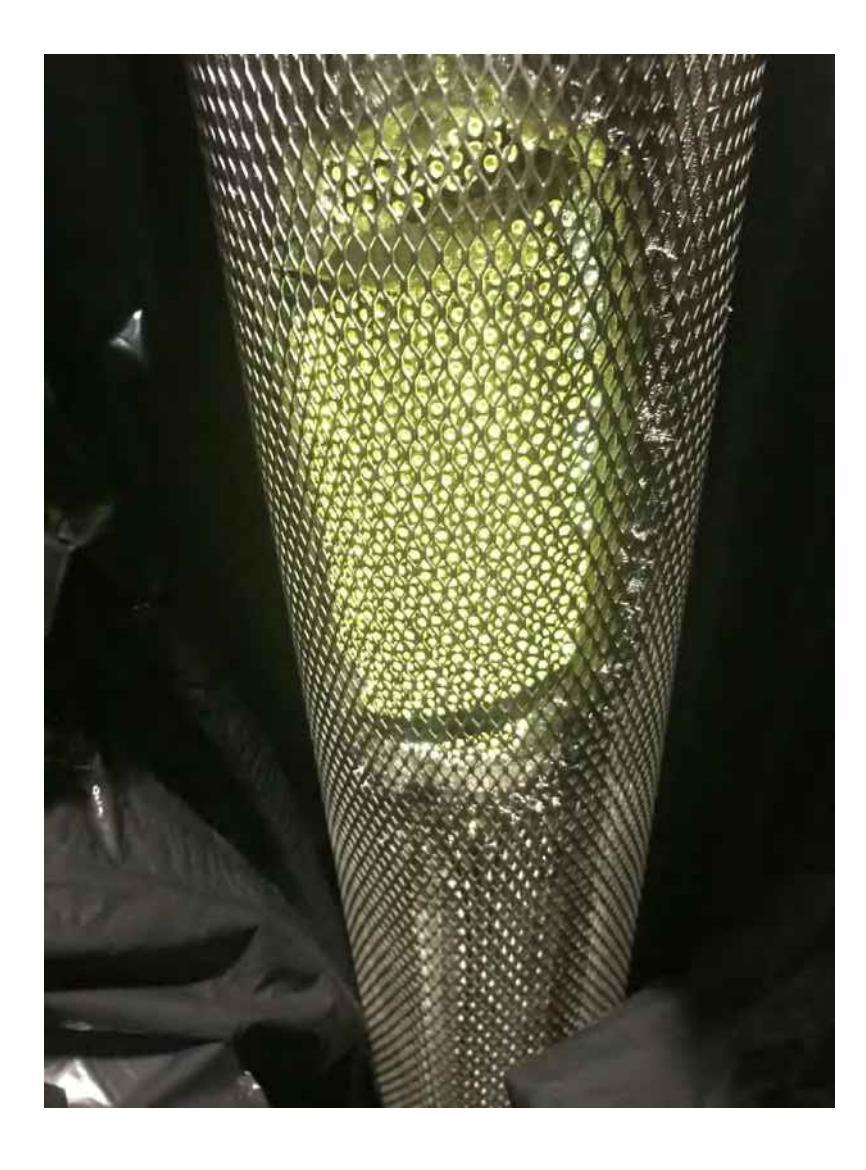
Lube Oil Filter Element Failure

Another finding of significance was made during the lube oil flush. Small wires and magnetic particles were found in the filter bags at the turbine bearing jumper oil lines. The source of the wires was found to be a failed filter element. It was discovered that the lube oil filter elements had not been changed for several years. The OEM recommends that the filter elements be changed when the differential pressure, across the filter element, reaches 15

"Blown Out" Filter Element
