Comanche Unit 3 -Spring 2020 Outage

Full Train Major, Main Steam Valves & Generator

COMANCHE (CO) Steam Turbine ESN: SY0093272 Generator ESN: SY0350139 Job Start Date: 13 Jan 2020 Oracle Project ID: FSP-285469 | C-10344497

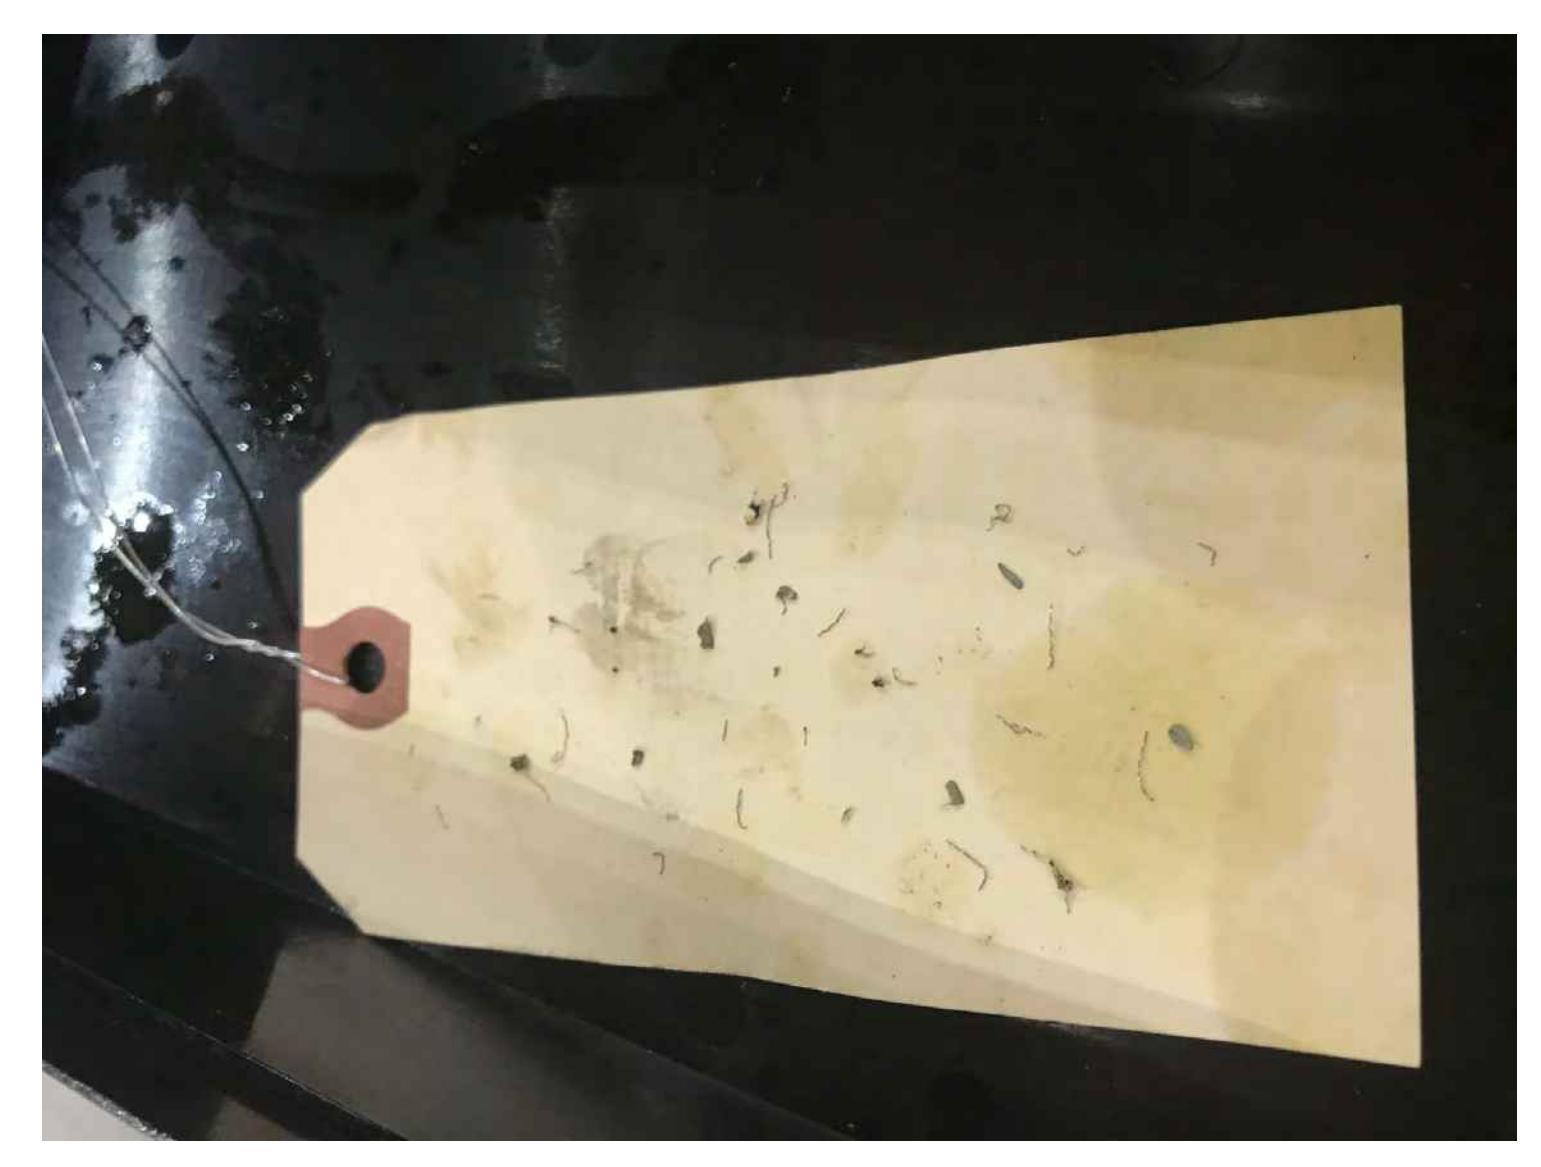
Lube Oil Filter Element Failure

Another finding of significance was made during the lube oil flush. Small wires and magnetic particles were found in the filter bags at the turbine bearing jumper oil lines. The source of the wires was found to be a failed filter element. It was discovered that the lube oil filter elements had not been changed for several years. The OEM recommends that the filter elements be changed when the differential pressure, across the filter element, reaches 15

Metal Wires Found in Flush Strainer Bags

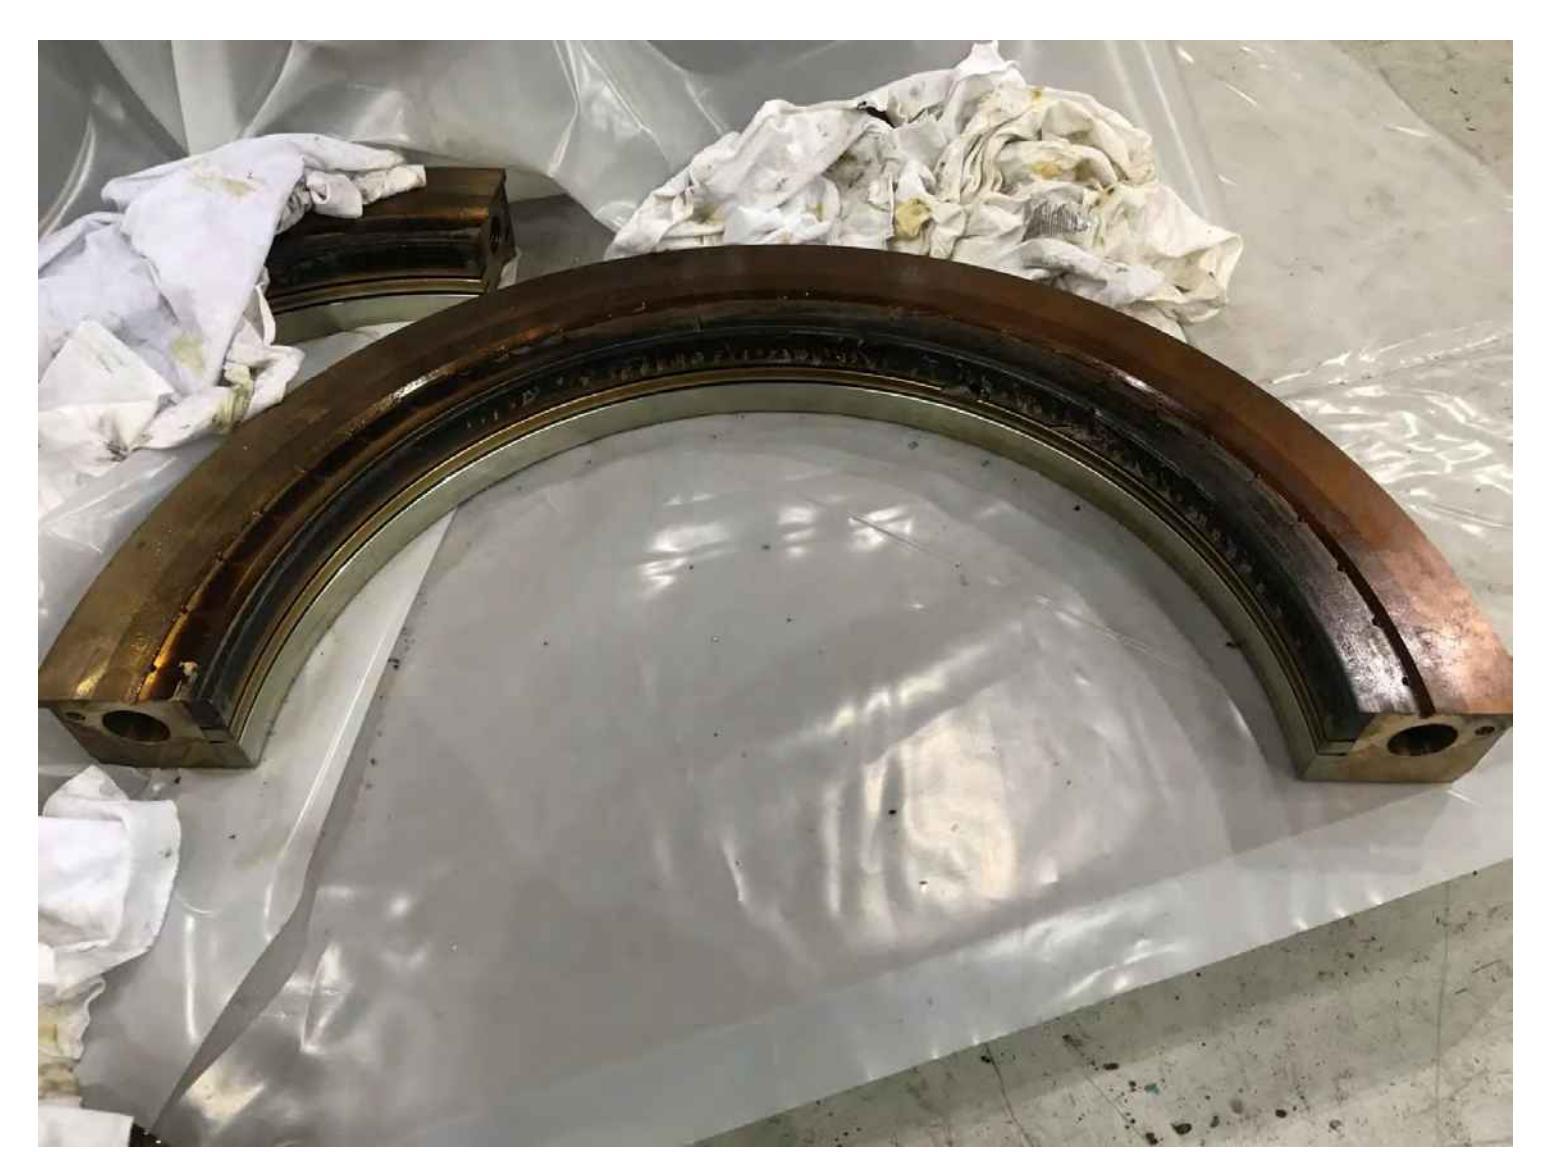
Hydrogen Seal Ring Condition Confidential

Collector End Hydrogen Seal Ring Condition – As Found

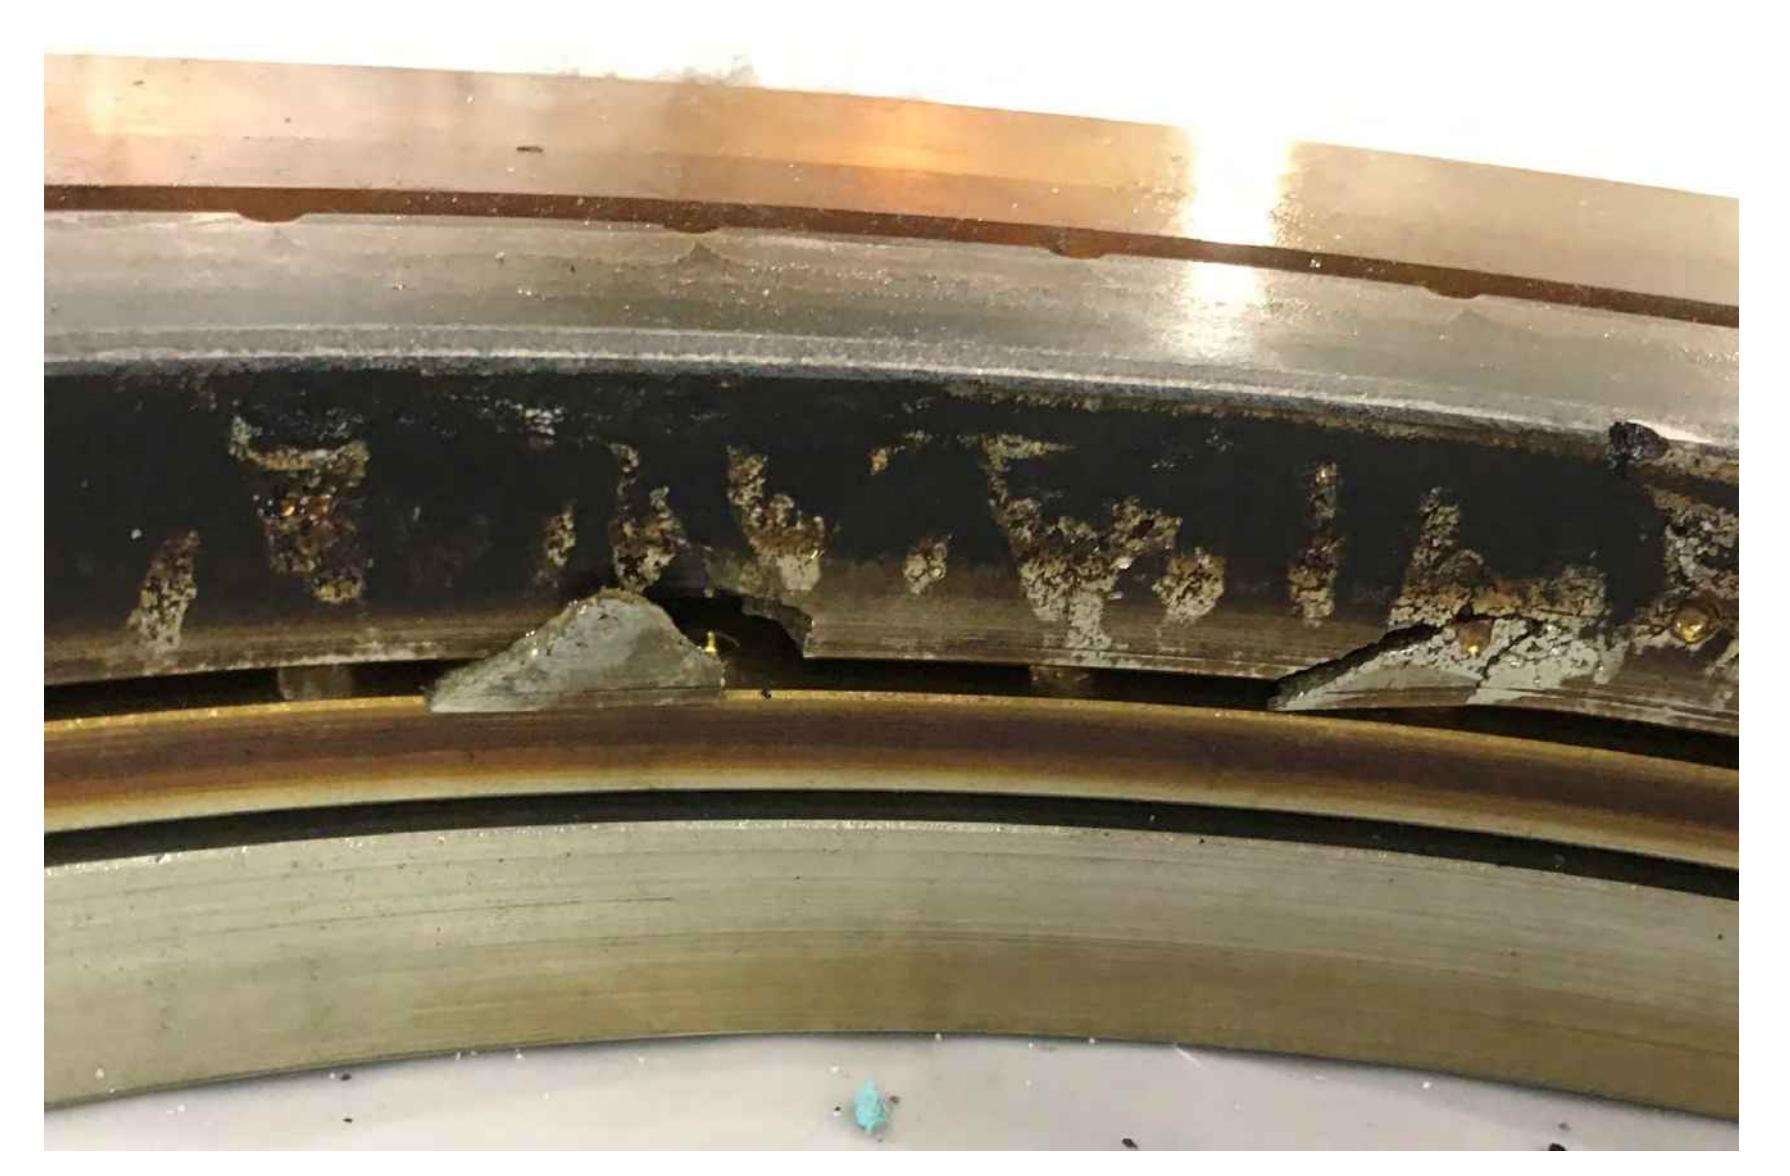
Hydrogen Seal Ring Condition Confidential

Collector End Hydrogen Seal Ring Condition – As Found

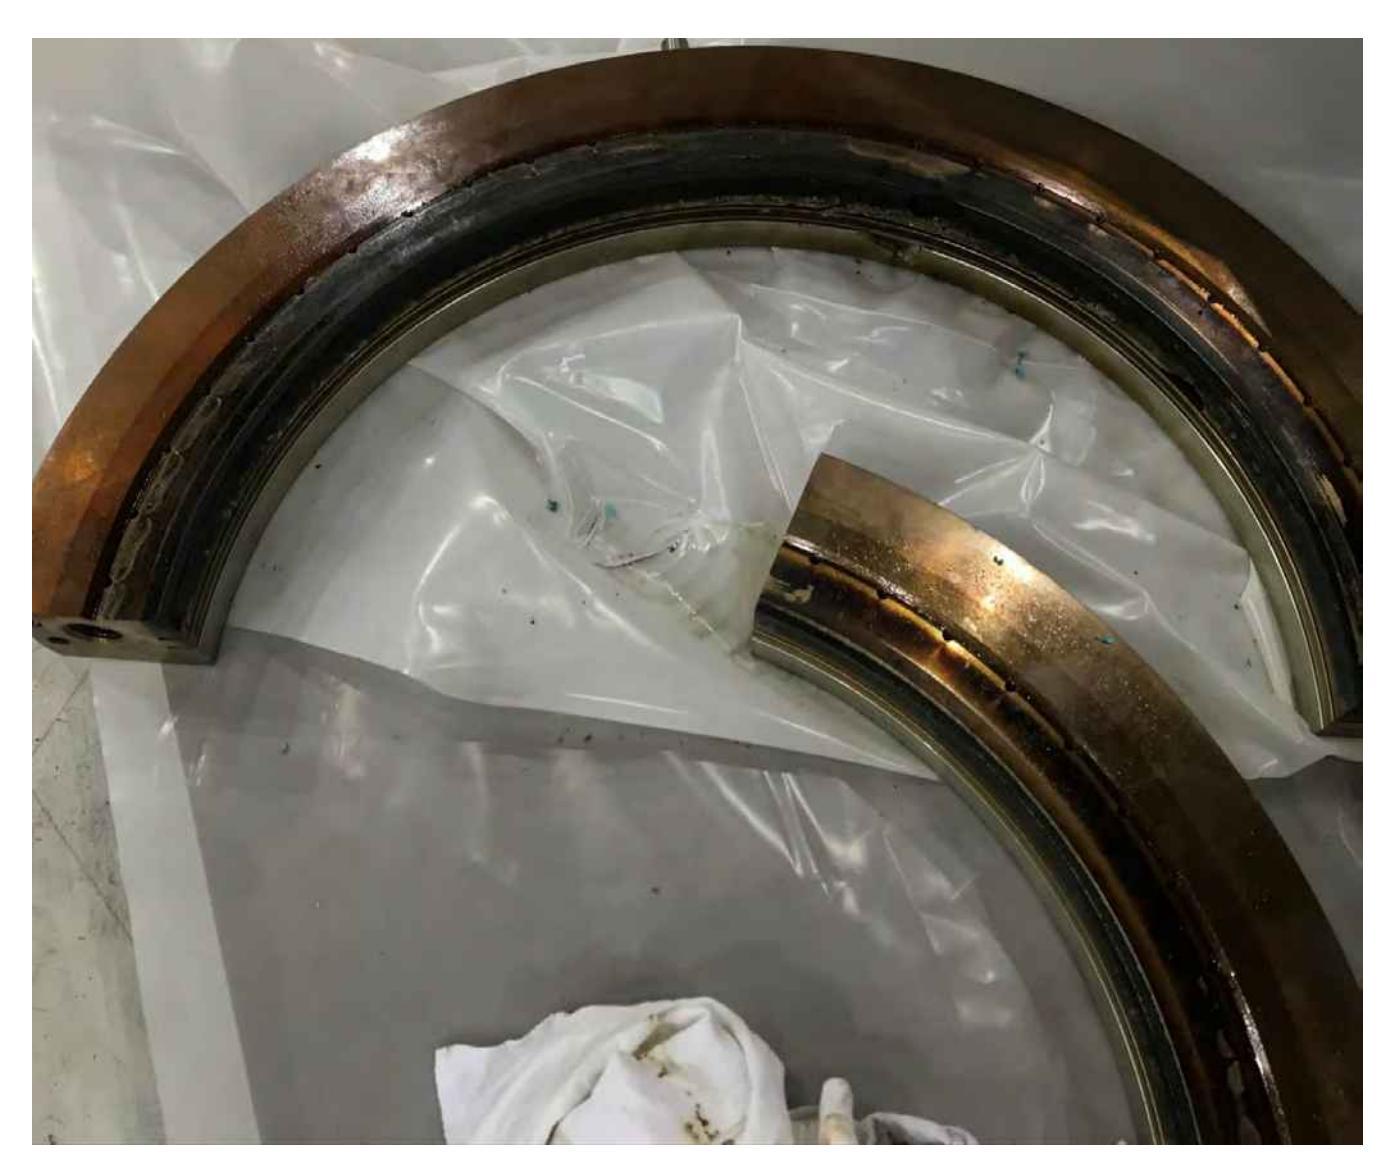
Hydrogen Seal Ring Condition Confidential

Turbine End Hydrogen Seal Ring Condition – As Found

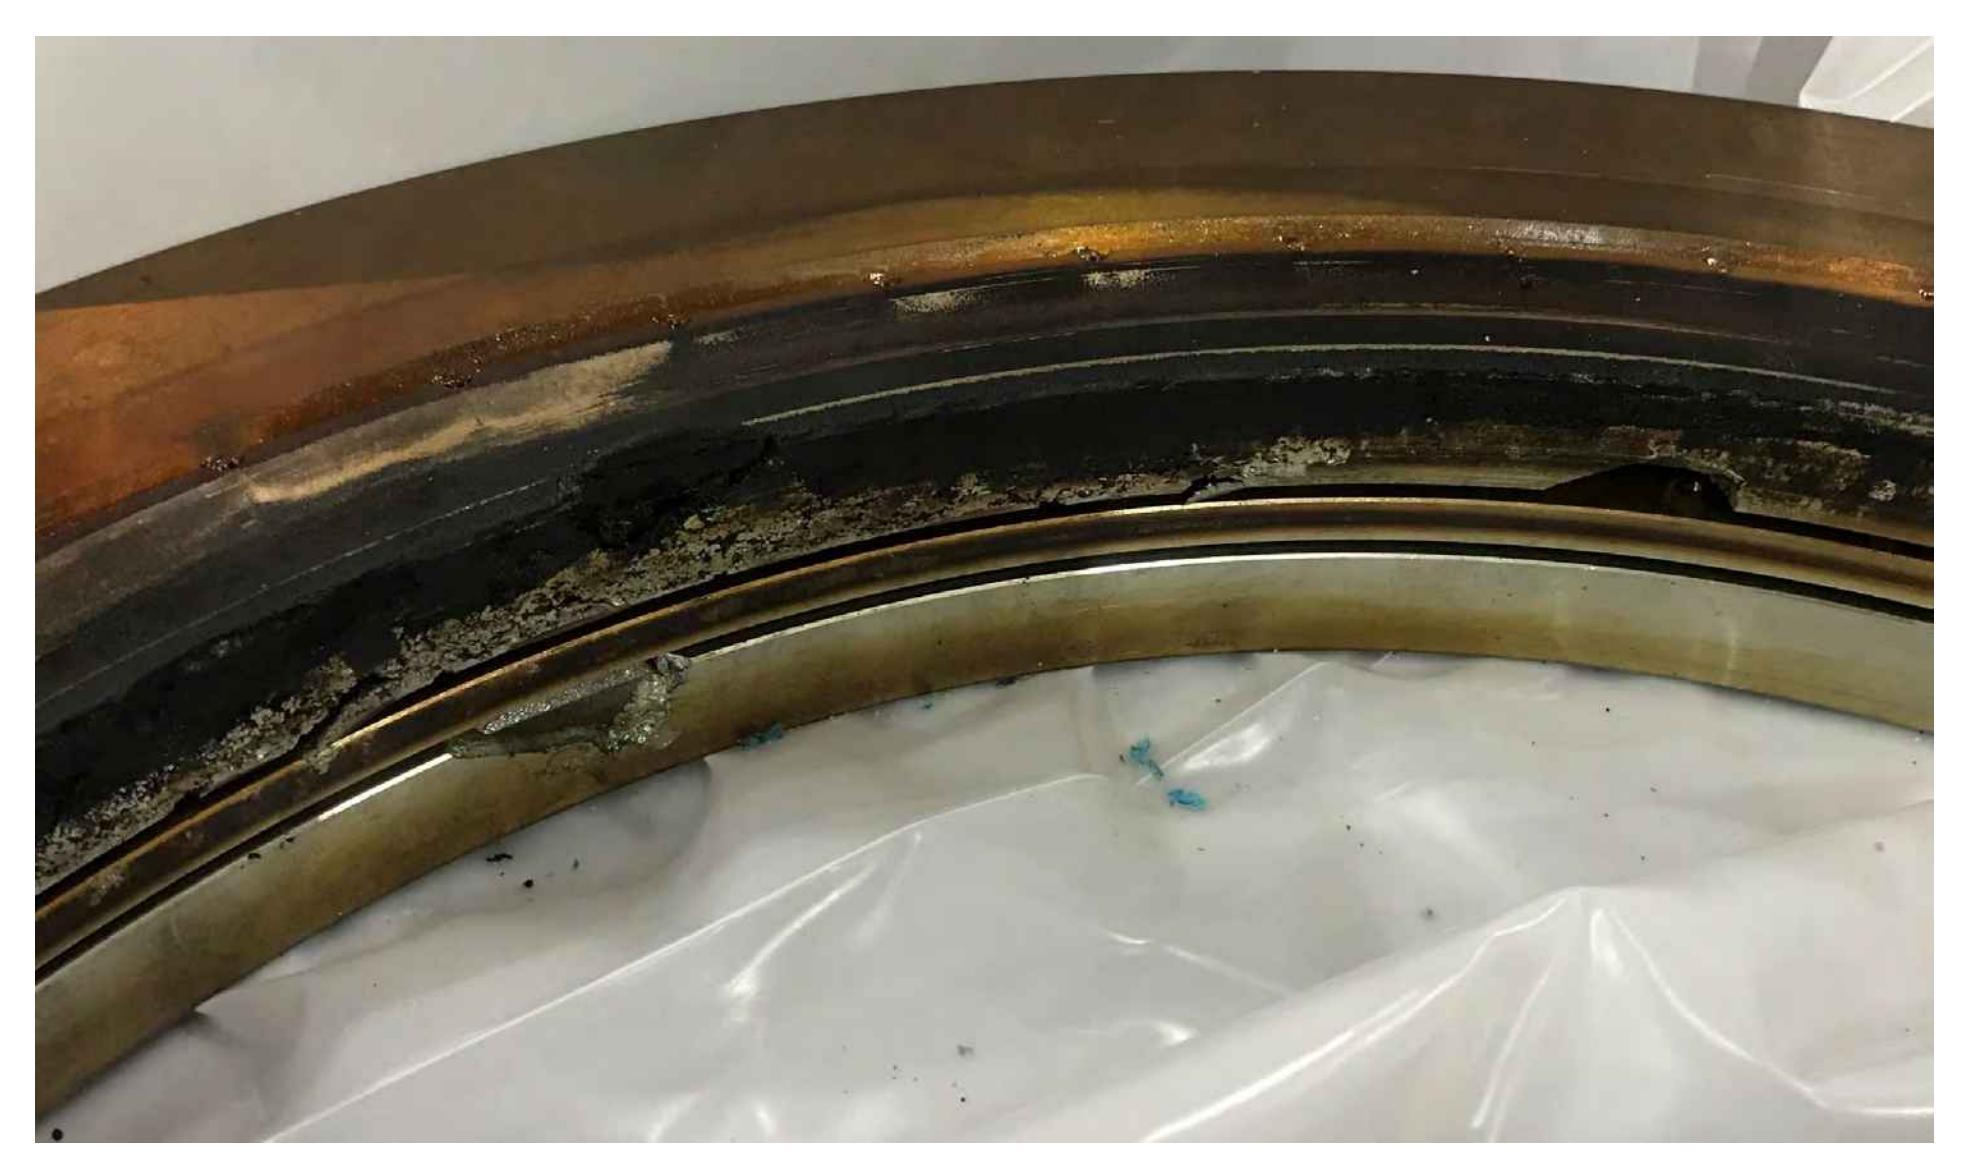
Hydrogen Seal Ring Condition Confidential

Turbine End Hydrogen Seal Ring Condition – As Found
