STAFF REPORT

PROCEEDING NO. 20I-0437E

IN THE MATTER OF THE INVESTIGATION INTO THE HISTORY AND CONTINUING OPERATIONS OF THE PUBLIC SERVICE COMPANY OF COLORADO COMANCHE UNIT 3 GENERATING STATION PURSUANT TO DECISION NO. C20-0505.

March 1, 2021

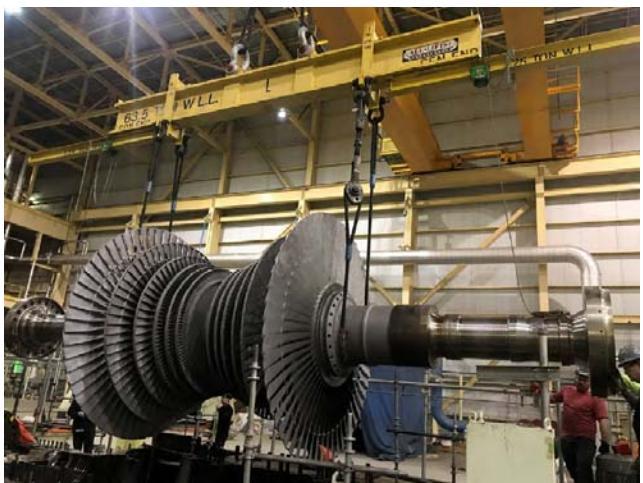
Figure 3. Comanche 3 low pressure B (LPB) rotor.

A full train inspection of the steam turbine was planned for the fall of 2020, but Comanche 3 was removed from service on January 13, 2020 to investigate a step change in and noise was observed coming from the Low Pressure Turbine B. This indicated a significant equipment issue and initiated the January 2020 forced outage. Inspection of the turbine revealed rubbing on eight of the high pressure rotating blade shrouds with work hardening on three of shrouds and a section of the shroud was missing. In addition, the inspection revealed significant seal damage in the lower portion of the casing.⁹

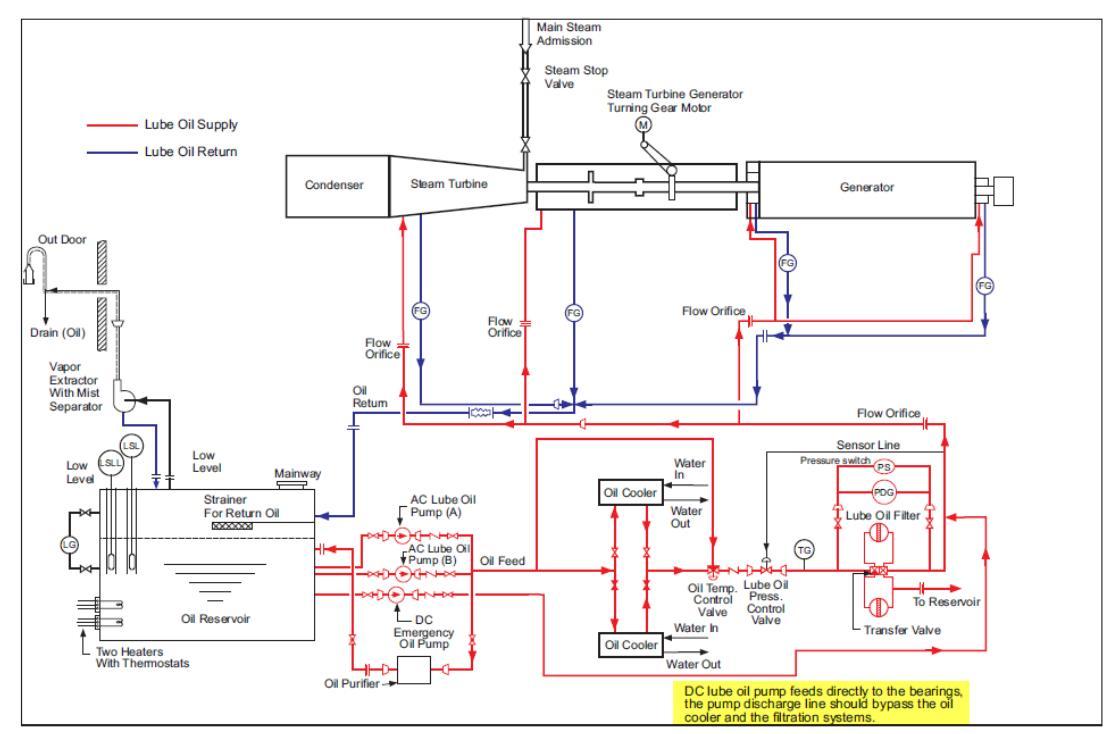
Figure 4. Typical steam turbine lubricating system.⁸

A small interruption of the lube oil to the turbine can cause catastrophic damage. Every TLO system has a large tank that acts as a reservoir for pumps that circulate lube oil to and from bearings and journals via a circular system of valves and piping. Key to the function of the turbine lube oil system is the ability to remove small particles of metal that become entrained in the oil from bearing wear. Thus, TLO systems have lube oil strainers or filters that remove particles that require regular changing and servicing. In addition, the heat that the lube oil picks up as it passes through bearings must be removed before that same oil is passed through the bearings again. To do this, heat exchanges are included in the system. Normally, a TLO system consists of a lube oil tank, two main lube oil pumps (A & B), an emergency backup lube oil pump, and ancillary equipment needed to maintain the function of the system including transfer valves, filters (strainers), and turbine lube oil coolers to maintain constant temperature. A typical flow diagram of a TLO system is shown in Figure 4.

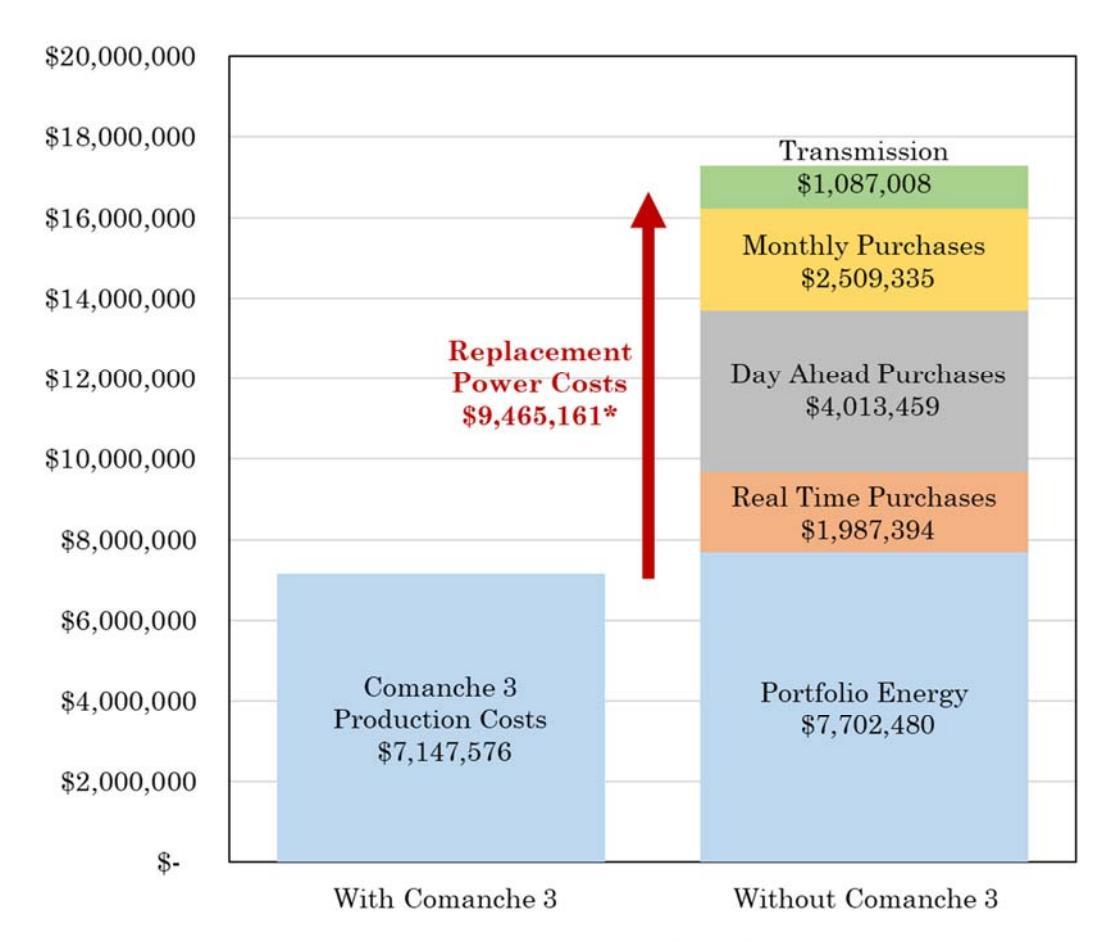
Each of these components contribute to the costs that would not otherwise have been incurred if Comanche 3 was operating. To illustrate, Figure 17 provides a breakdown of the cost components for the month of August 2020 as an example. The left bar reflects the estimated cost had Comanche 3 been operational and the right bar provides an estimate of the cost of the replacement resources. During this month, PSCo incurred \$7.7 million in portfolio energy costs, \$2 million in real-time purchases, \$4 million in day-ahead purchases, \$2.5 million in monthly purchases, and \$1.1 million in transmission purchases, totaling \$17.7 million in costs necessary to replace Comanche 3's power. If Comanche 3 were online, it would have produced the energy needed to offset these costs, but the unit would have incurred its own set of production costs. These were estimated to total \$7.1 million. The incremental costs incurred by ratepayers is the difference between these two. After a few minor modeling adjustments to reflect outage probabilities and wind uncertainty, incremental power replacement costs due to Comanche 3 outage for the month of August come to \$9,465,161. This is the same method used to determine the incremental replacement costs for each month from June through December 2020, the results of which were previously shown in Table 2.

*Reported replacement costs do not exactly equal the difference in the two bars, due to a \$686,939 downward model adjustment to reflect Comanche's forced outage probability and wind production uncertainty.

Figure 18. Replacement power cost estimates for Comanche 3 outage, August 2020.

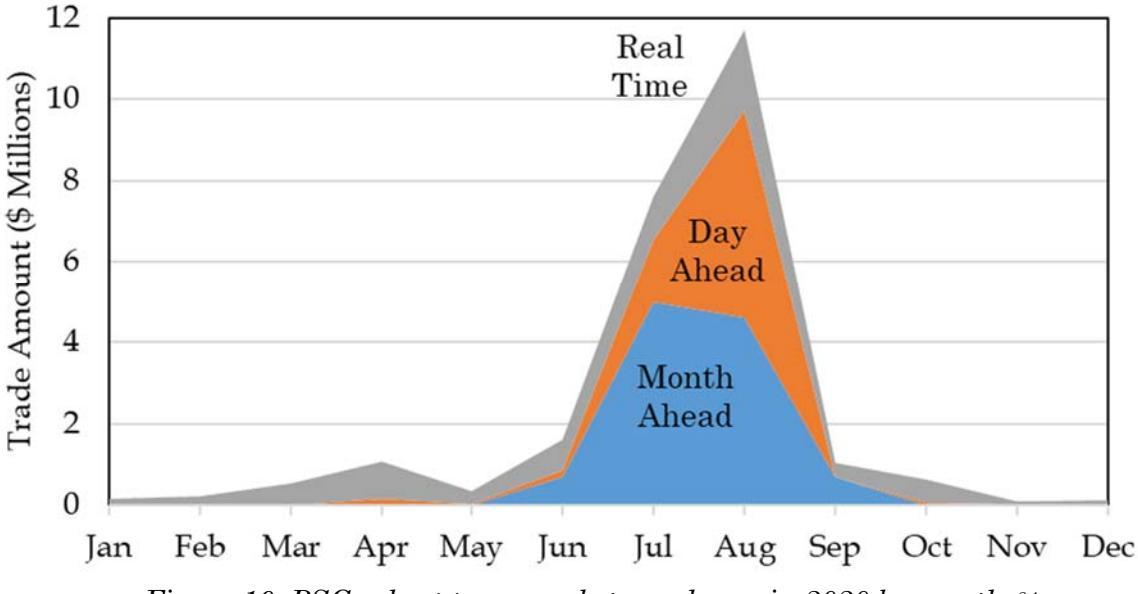
PSCo purchased \$25 million worth of external energy through short term transactions in 2020, compared to \$9.9 million in 2019, and \$4.9 million in 2018. Most of these purchases occurred in July and August, as shown in Figure 18. This is consistent with the previously described Comanche 3 replacement power estimates also being largest in July and August. This data shows that the Comanche 3 outage significantly exacerbated system costs during the summer, causing PSCo to purchase relatively large amounts of expensive energy on the spot market.

Figure 19. PSCo short term market purchases in 2020 by month.⁸⁴

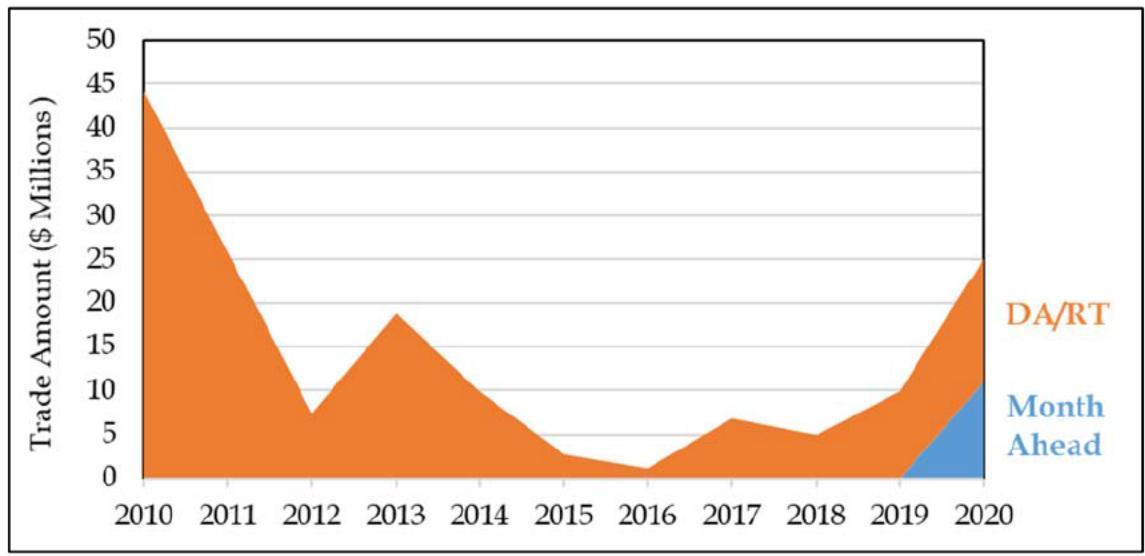
Staff also collected historic short-term market purchases data to put 2020 in a broader context. PSCo's short-term transaction volumes by year are displayed in Figure 19 below. This shows 2020's market purchases increased over several of the previous years, continuing a growing trend beginning in 2016. However, PSCo reported larger volumes of day-ahead/real-time ("DA/RT") purchases in earlier years, such that purchases in 2010 were significantly higher than what was experienced in 2020. Staff was not able to investigate the full reason behind these high 2010 to 2013 volumes, in part because PSCo's legacy accounting system prevented them from providing more detailed data on the historic transactions.

Figure 20. PSCo short term transaction volumes by year.

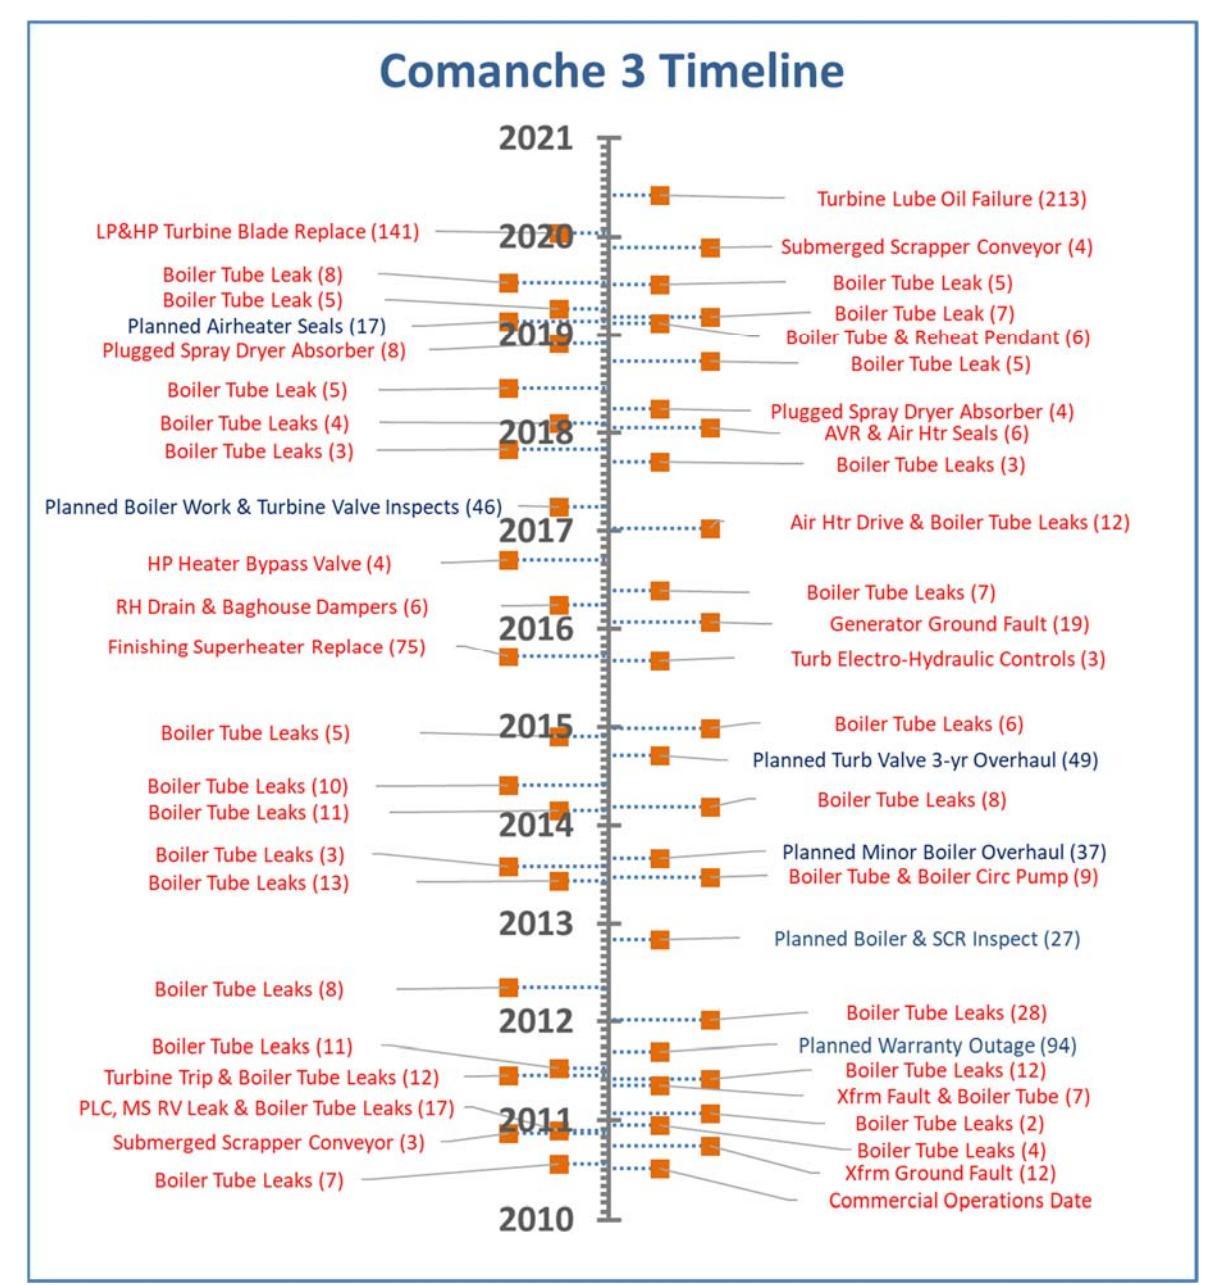
The following figure is a timeline that summarizes the major outages (defined as occurring for three days or more) that occurred for Comanche Unit 3 since its Commercial Operation Date ("COD") of July 6, 2010. The number of days the unit was unavailable is shown in parentheses for each outage listed. The planned outages are indicated in blue to differentiate them from the unplanned/non-routine outages.

Figure 21. Comanche 3 outages timeline.

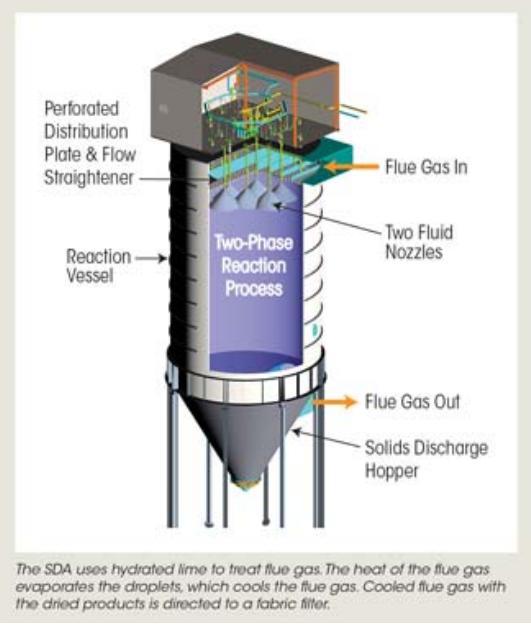
Figure 23. Typical SDA diagram.

This outage was caused by debris which plugged the gas dispersion. The debris was cleared from the gas disperser and bottom of the vessel during the outage.⁹⁴ Comanche 3 was in an outage state for 8 days returning to service on December 7, 2018. Replacement power costs for this outage were estimated at \$1.4M.

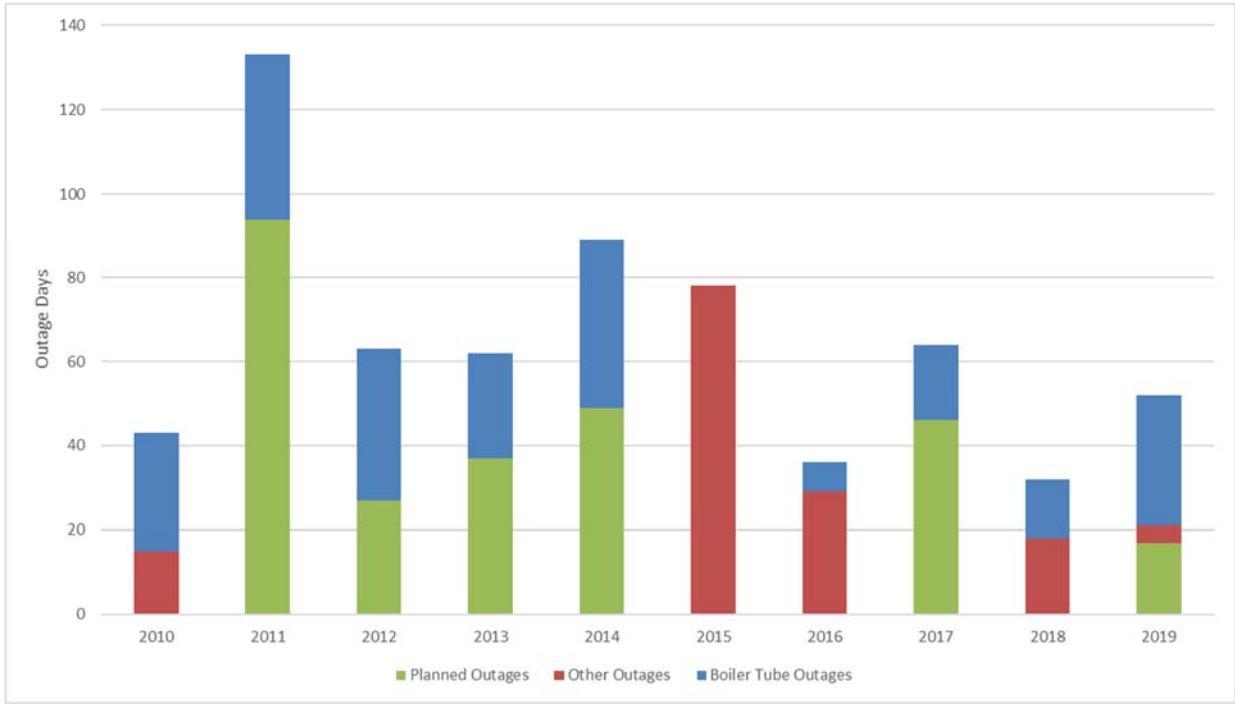
The same data provided above is also presented in graphic form below in Figure 25. What is noteworthy is that planned outages accounted for 26.8 percent of the total outages averaging at 24.5 days per year. The non-routine or unplanned outages, excluding boiler tube outages, accounted for 49.5 percent of the total outages averaging at 45.3 days per year. Last, outages to repair boiler tube leaks accounted for 23.7 percent of the total outages averaging at 24.5 days per year. In total, Comanche 3 has been experiencing outages at an average rate of 91.5 days per year or roughly 25 percent of the time. This is a very troubling metric and should be considered in the modeling or benchmarking of the unit going forward.

Figure 24. Graphical illustration of Table 5.

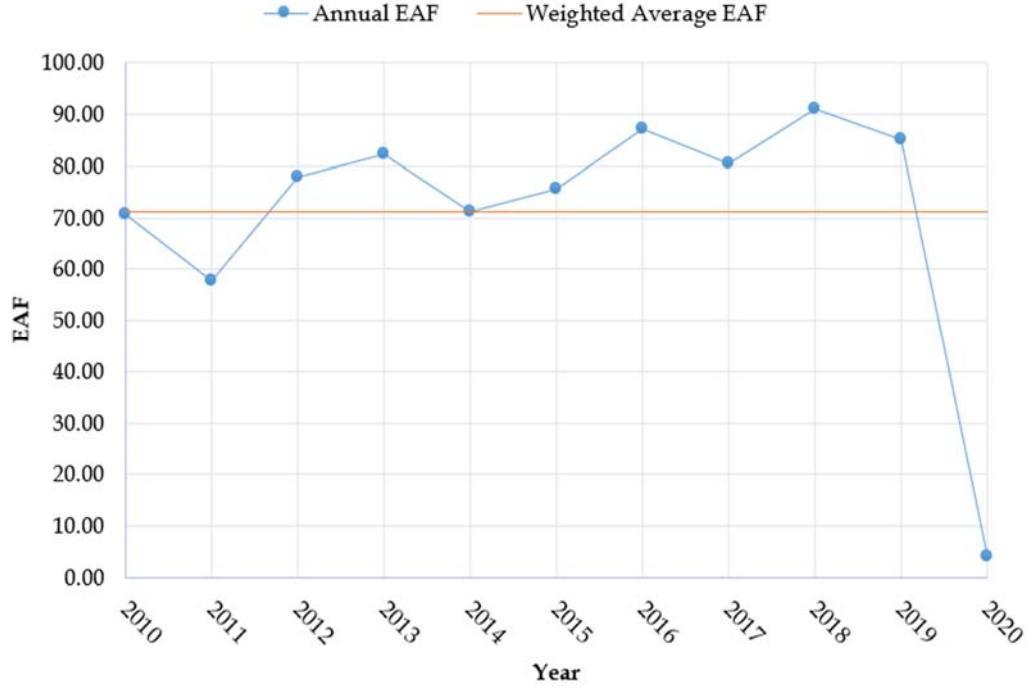
Figure 25. Change in EAF of Comanche 3 from 2010 through October 2020.

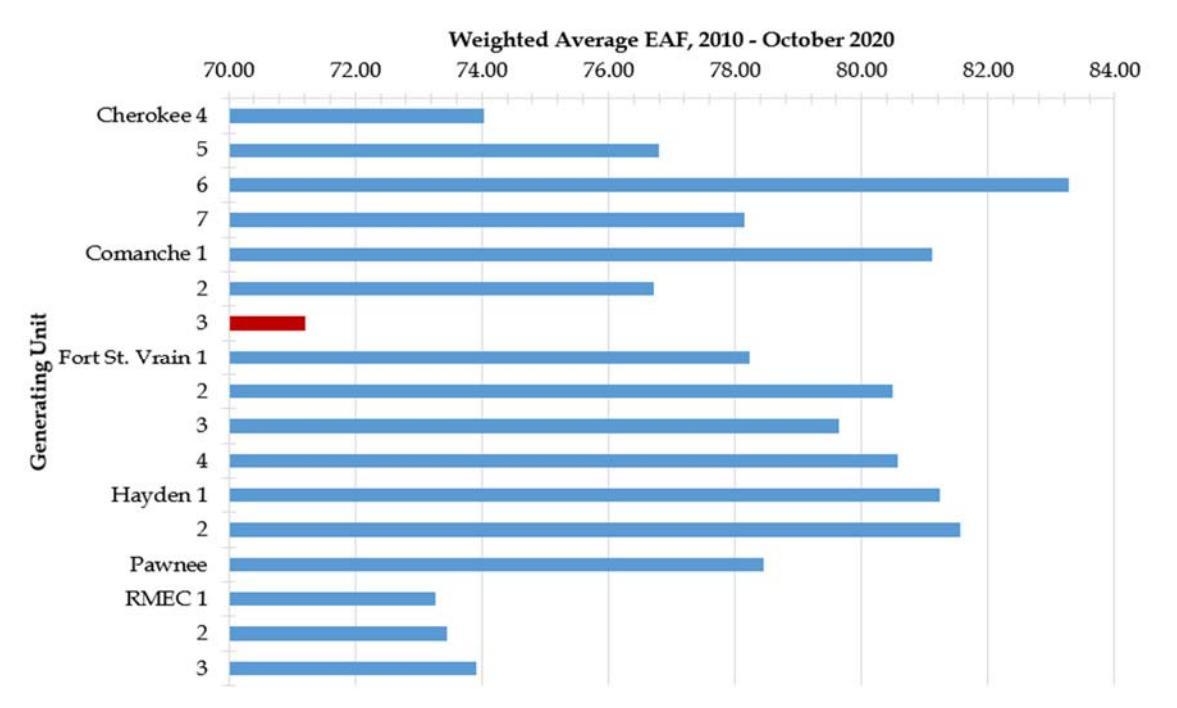
Further, when compared to other PSCo-owned coal and gas-fueled units that operate on either a single steam cycle or a combined cycle, Comanche 3 had the lowest weighted average EAF from 2010 through October 2020. Although newer units should be expected to have higher AFs and EAFs compared to older units, the opposite is true for Comanche 3; the Company's older units have a greater weighted average EAF, as shown in Table 7 and Figure 27 below.

Figure 26. Graphical illustration of weighted average EAF data of PSCo generating units. Note that Comanche 3 clearly has the lowest weighted average EAF of all the units.

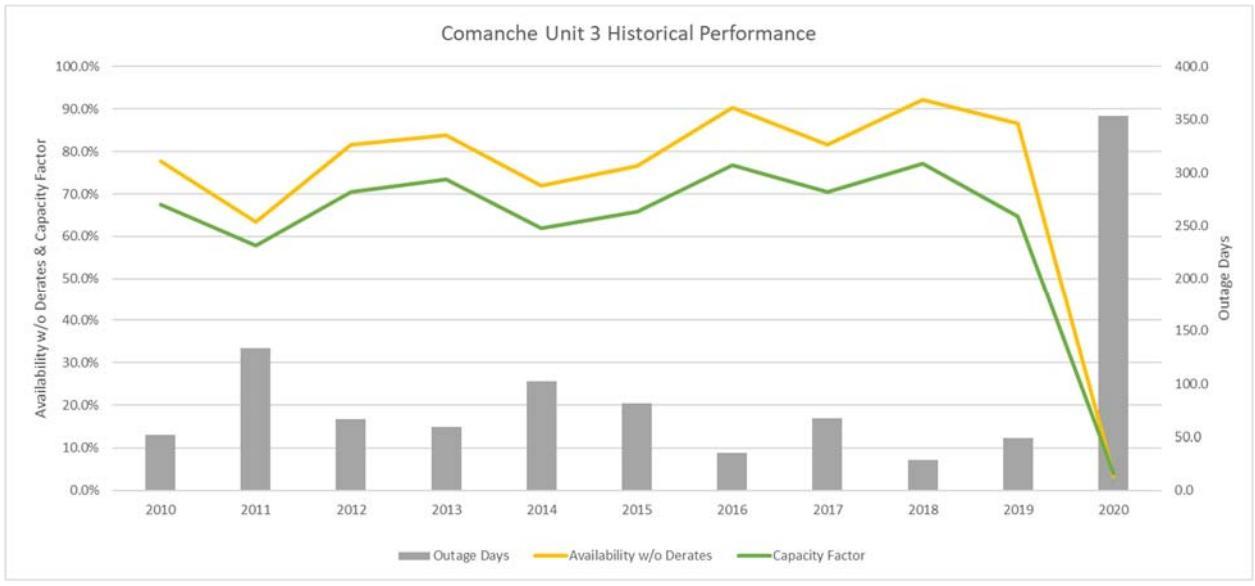
Finally, Staff also used historical hourly generation data for Comanche 3 to determine the general availability without consideration for unit derates (presented as a percentage of hours per year that the unit was online and generating), the actual capacity factors for the unit (based on historical hourly generation data), and the number of days each years that the unit was in an outage condition (zero generation). The results, shown in Figure 28, trend closely to the EAF analysis above.

Figure 27. Comanche 3 historical hourly generation data.
