Comanche 3 QCP - Major Outage

TURBINE ROTOR INSPECTION

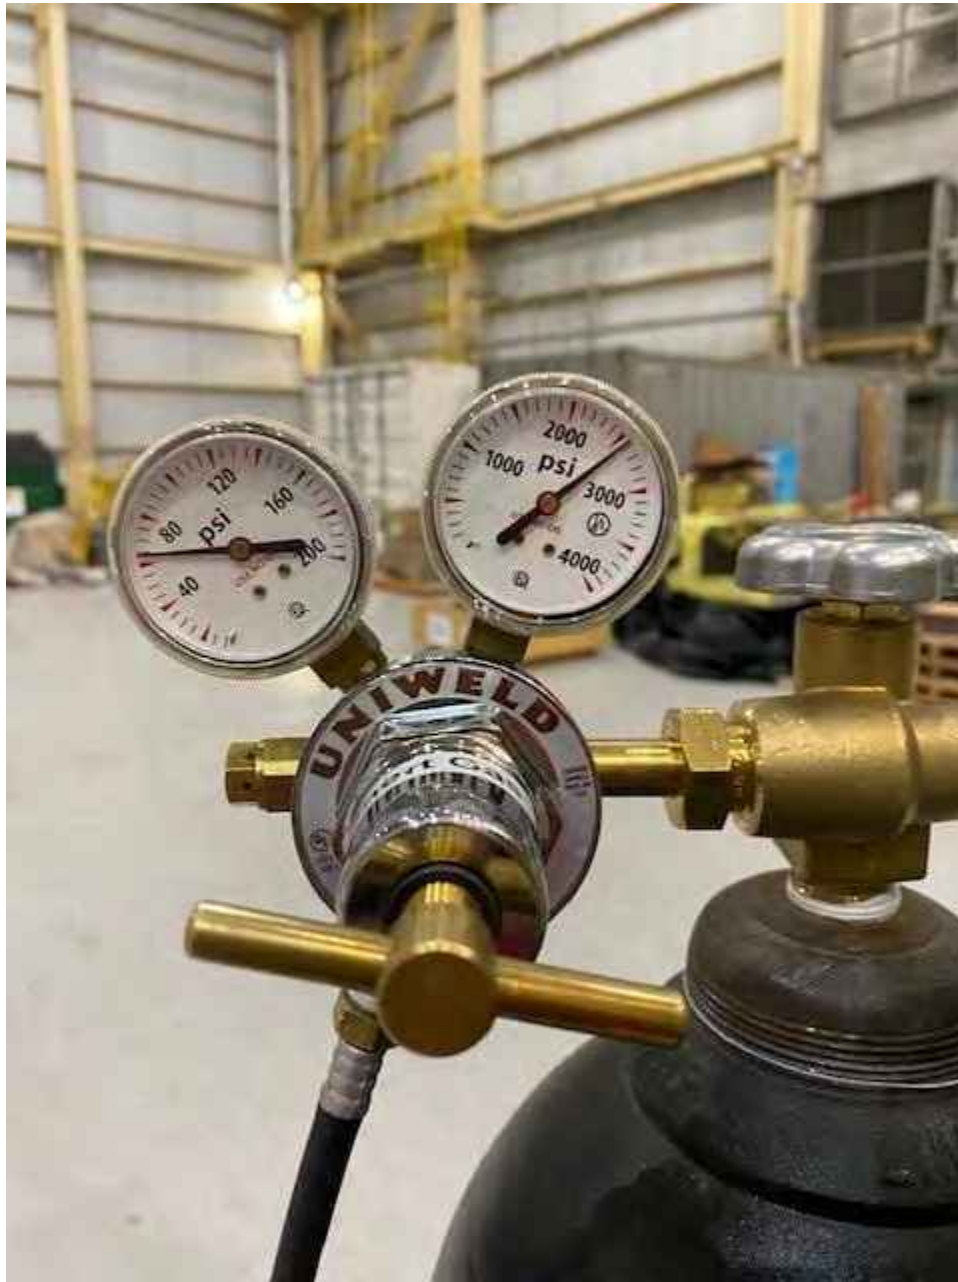
Bore Pressure Test

Part Condition: Good

Using Nitrogen, the Bore was pressurized at 60 psi for 2 hours. Pressure remained the same throughout the test, indicating that the Chevron seals are in good working order.

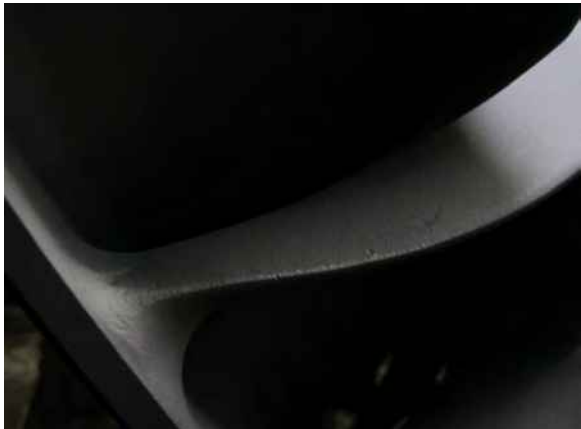
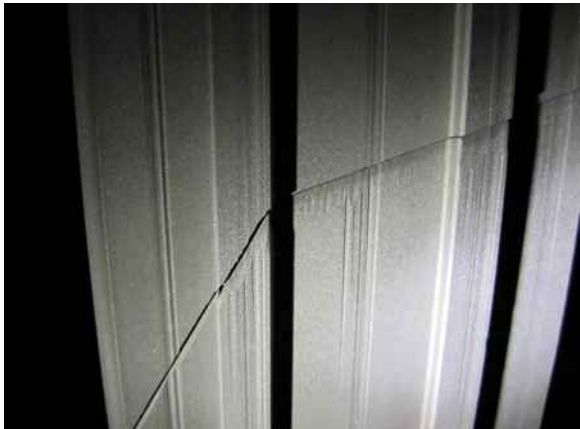
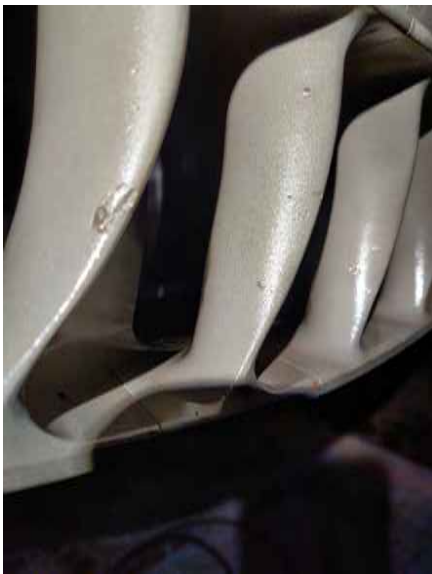
CUSTOMER:		FCSS	
PO #:	4900073380	SURFACE CONDITION:	Oxide Blasted
MATERIAL DESCRIPTION:		Comanche Unit 3 HPIP VT Results Page 11	
Stage	Description		
10	<ul style="list-style-type: none"> • Rubbing on all shrouds. • Foreign object damage to leading edge. • Erosion on shroud edge.

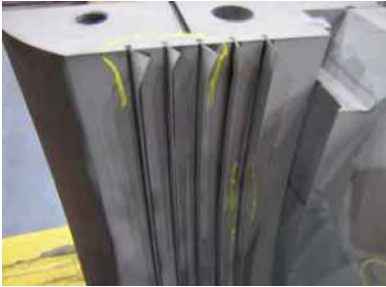
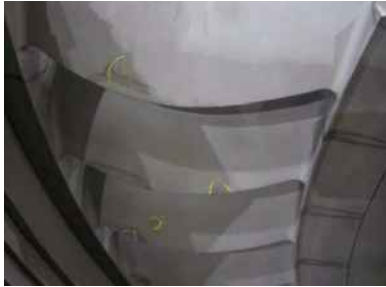
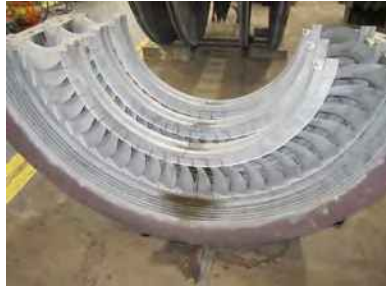
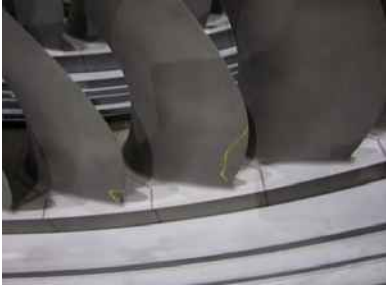
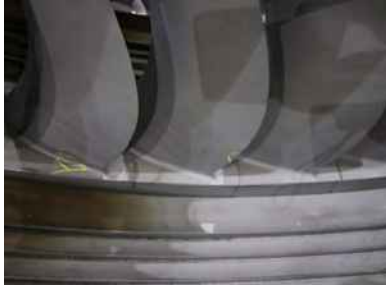
CUSTOMER:		FCSS	
PO #: 4900073380		SURFACE CONDITION: Oxide Blasted	
MATERIAL DESCRIPTION:		HPIP Stationary Components	
Stage	Description		
15U	<ul style="list-style-type: none"> Foreign object damage found on trailing edges. Spill strips damaged.

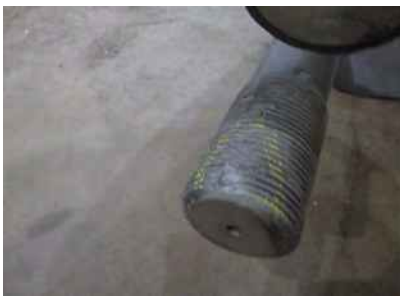
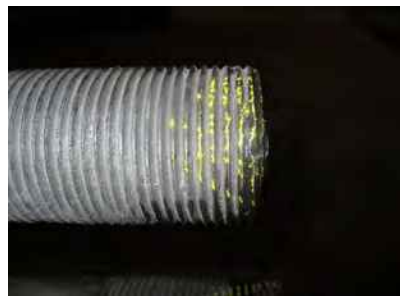
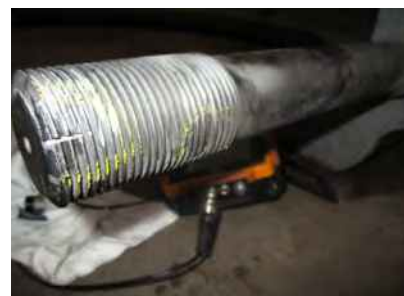
Visual inspection of the HP and IP Inner Casings L/H resulted in the following:

- HP minor mechanical damage steam inlet
- IP mechanical damage in steam inlet
- IP damaged threads on studs #L71, L72 and R71

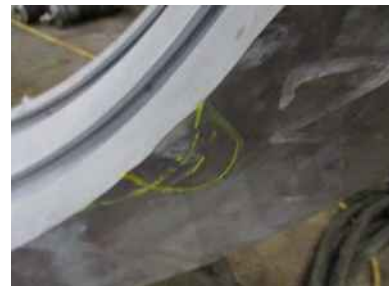
- HP Dummy Rings U/H and L/H
- N3 inner L/H
- N1 inner L/H: some mechanical damage see picture

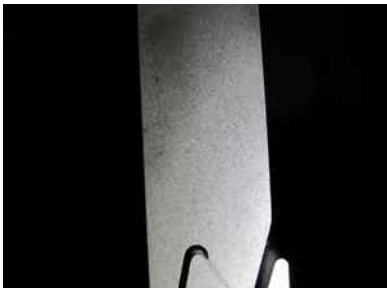
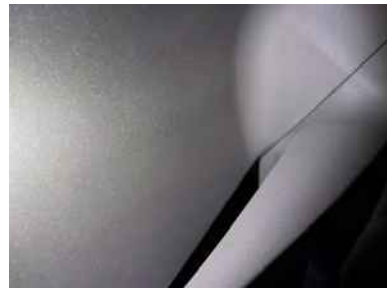
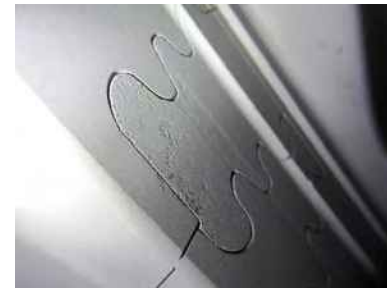
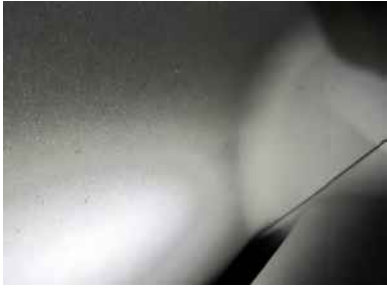
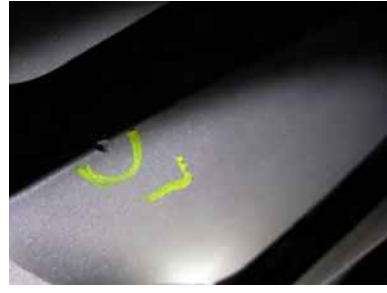
CUSTOMER:		FCSS	
PO #: 4900073380		SURFACE CONDITION: Oxide Blasted	
MATERIAL DESCRIPTION:		Comanche Unit 3 LPA VT Results Page 9	
Stage		Description	
L-2 G		<ul style="list-style-type: none"> Erosion/pitting present Light pitting found on wheel dovetails and body. Above foreign object damage found on blade #7

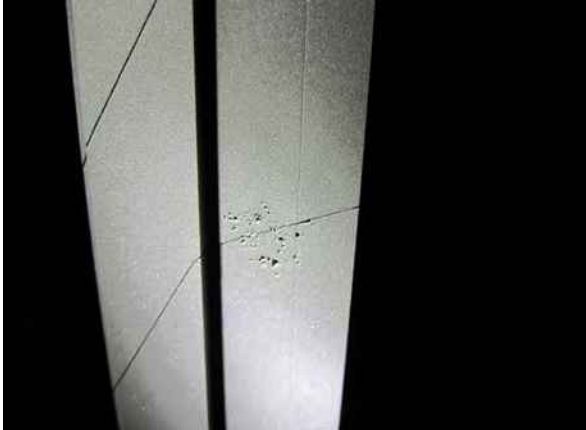
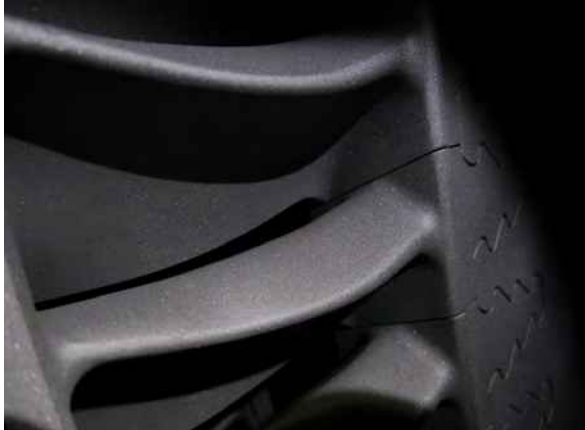
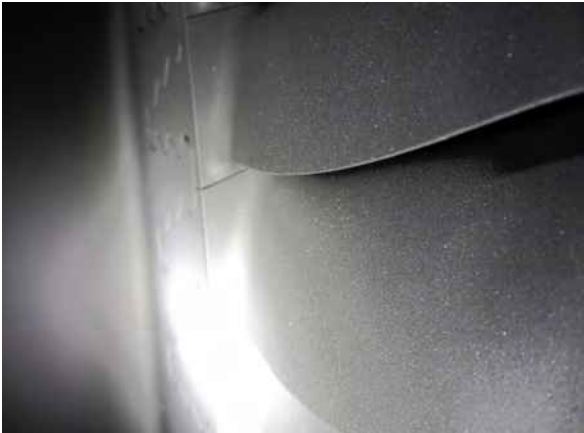
CUSTOMER:		FCSS	
PO #:	4900073380	SURFACE CONDITION:	Oxide Blasted
MATERIAL DESCRIPTION:		Comanche Unit 3 LPA VT Results Page 12	
Stage	Description		
L-5 G	<ul style="list-style-type: none"> • Light foreign object damage found on leading edges. • Pitting found on all blades.

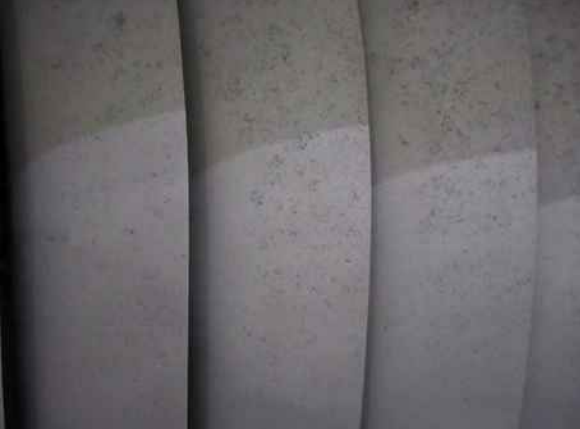
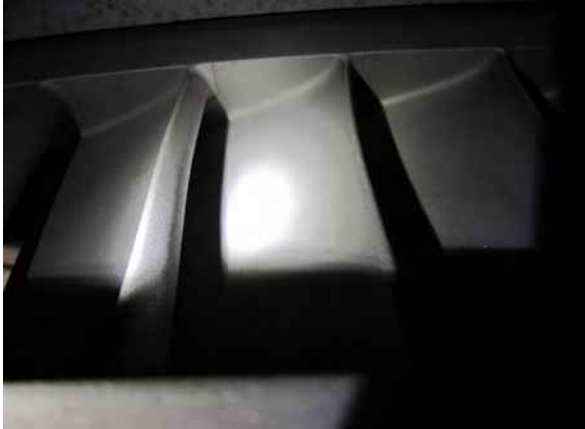
CUSTOMER:		FCSS	
PO #:	4900073380	SURFACE CONDITION:	Oxide Blasted
MATERIAL DESCRIPTION:		LPA Stationary Components	
Stage	Description		
4TU	<ul style="list-style-type: none"> Pitting on all surfaces.

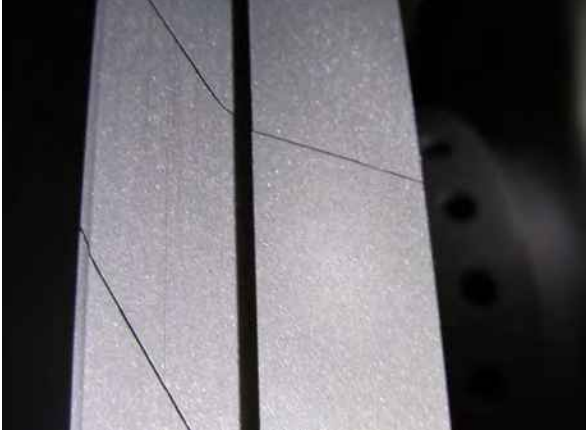
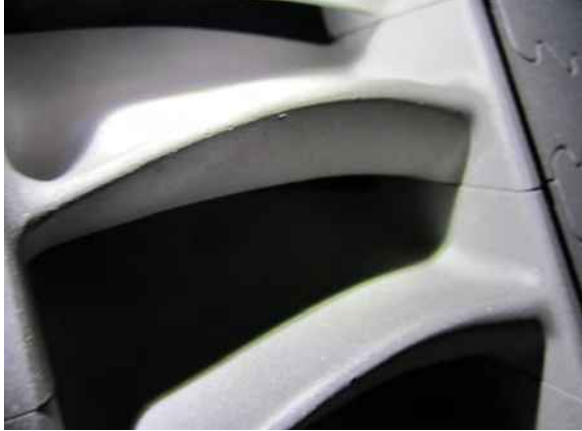
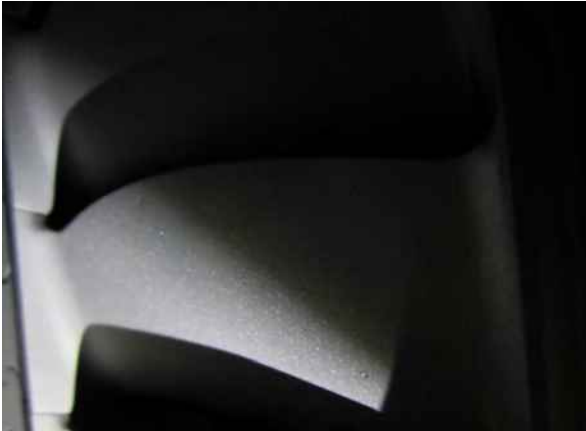
CUSTOMER:		FCSS	
PO #:	4900073380	SURFACE CONDITION:	Oxide Blasted
MATERIAL DESCRIPTION:		Comanche Unit 3 LPB VT Results Page 1	
Stage	Description		
L-5 T	<ul style="list-style-type: none"> Erosion/pitting present Light foreign object damage present.

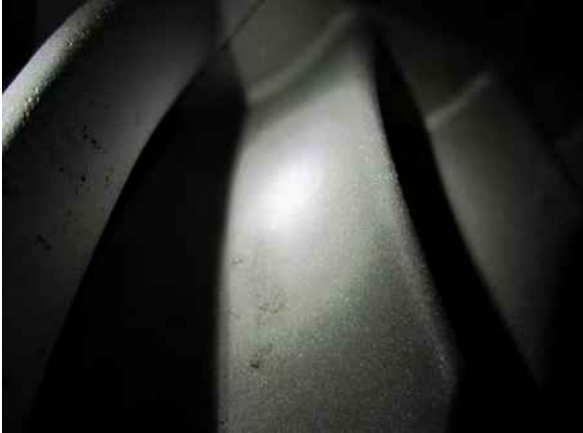
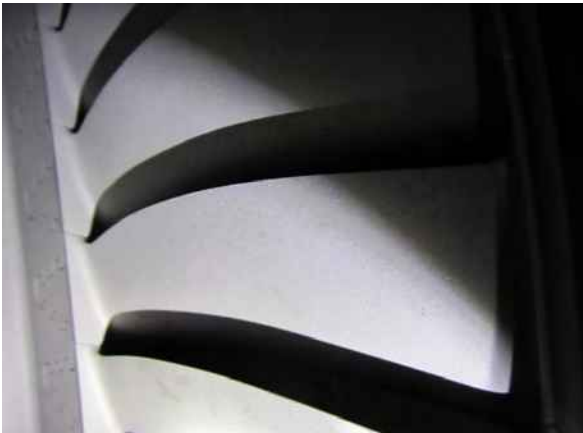
CUSTOMER:		FCSS	
PO #: 4900073380		SURFACE CONDITION: Oxide Blasted	
MATERIAL DESCRIPTION:		Comanche Unit 3 LPB VT Results Page 1	
Stage		Description	
L-3 T		<ul style="list-style-type: none"> Erosion/pitting present Light foreign object damage present. Deposits under covers.

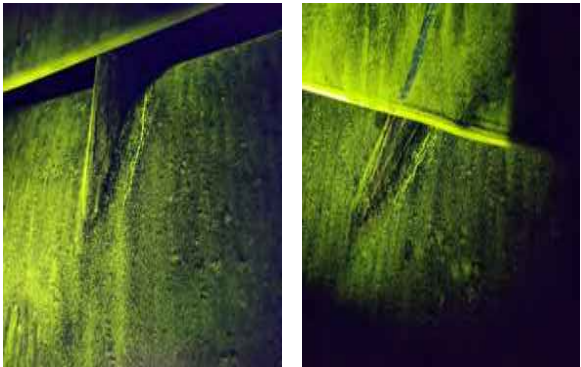
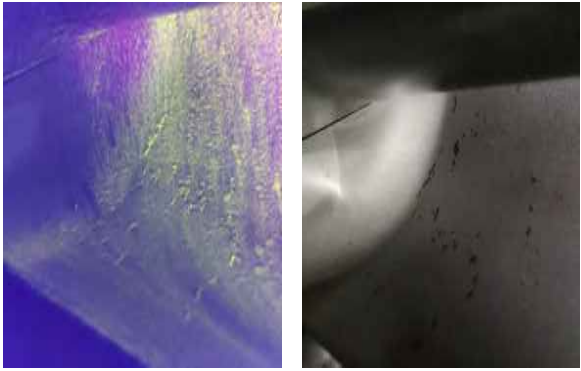
CUSTOMER:		FCSS	
PO #: 4900073380		SURFACE CONDITION: Oxide Blasted	
MATERIAL DESCRIPTION:		Comanche Unit 3 LPB MT Results Page 1	
Stage		Description	
L-1 G	<ul style="list-style-type: none"> 1-1.5" crack-like indications on discharge side of all snubbers. Multiple crack-like indications found on all blades on admission side towards root in corrosion areas Examples shown below

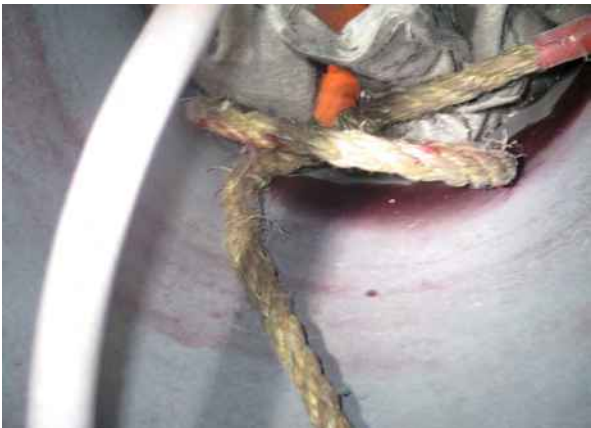
CUSTOMER:		FCSS	
PO #:	4900073380	SURFACE CONDITION:	In Service / Cleaned
MATERIAL DESCRIPTION:		Governor Valves Seats and Corners	
		Description	
<ul style="list-style-type: none"> • R/S #2 indication on the seat • L/S #1 indication corner of the seat

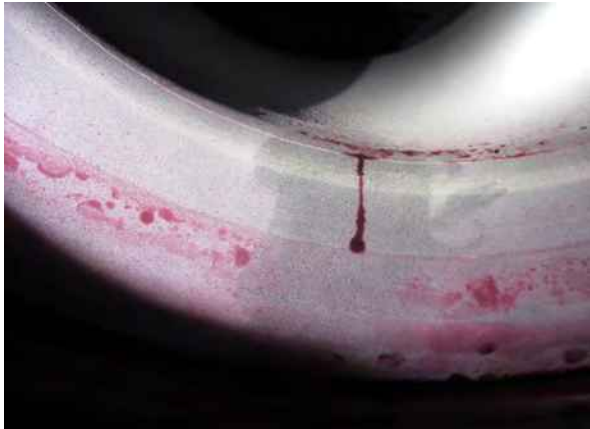
- R/S Seat: Cracklike indication through the seat - see pictures next page
- R/S Seal weld: No reportable indications
- R/S Strainer grooves: No reportable indications
- R/S Swirl Dam:: No reportable indications
- L/S Seat: No reportable indications
- L/S Seal weld: No reportable indications
- L/S Strainer grooves: No reportable indications
- L/S Swirl Dam:: No reportable indications

CUSTOMER:		FCSS	
PO #:	4900073380	SURFACE CONDITION:	In Service / Cleaned
MATERIAL DESCRIPTION: Throttle Valves R/S and L/S Seats, Seal Welds, Strainer Grooves and Swirl Dams			
Description			
	<ul style="list-style-type: none"> R/S Seat: Cracklike indication through the seat

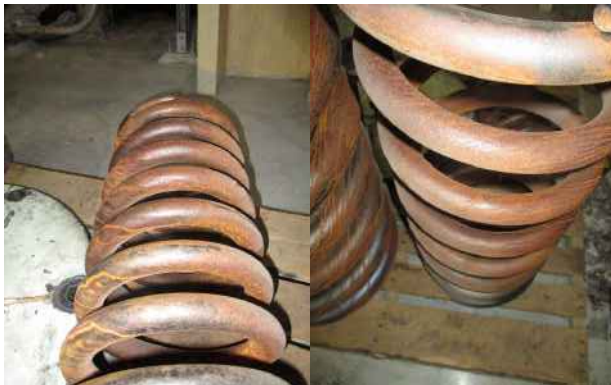
Visual inspection of the Throttle Valves R/S L/S Springs (3 per Valve) resulted in the following:

- General corrosion on all springs

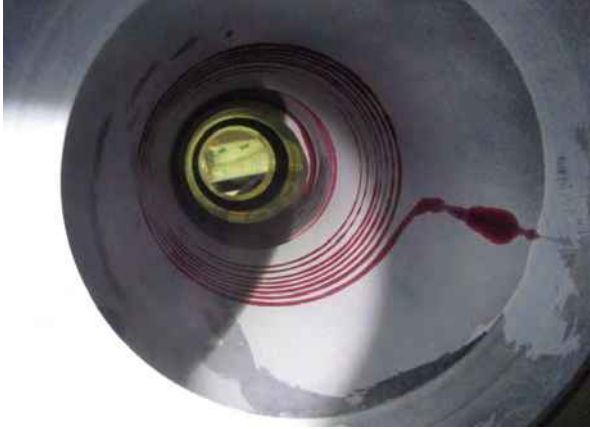
- R/S Seat: No reportable indications
- R/S Bushing: Cracklike indication spiraling from seat into the bushing - see pictures next page
- L/S Seat: No reportable indications
- L/S Bushing: No reportable indications

CUSTOMER:		FCSS	
PO #:	4900073380	SURFACE CONDITION:	In Service / Cleaned
MATERIAL DESCRIPTION: Throttle Valves R/S and L/S Seats, Seal Welds, Strainer Grooves and Swirl Dams			
Description			
	<ul style="list-style-type: none"> R/S Bushing: Cracklike indication spiraling from seat into the bushing

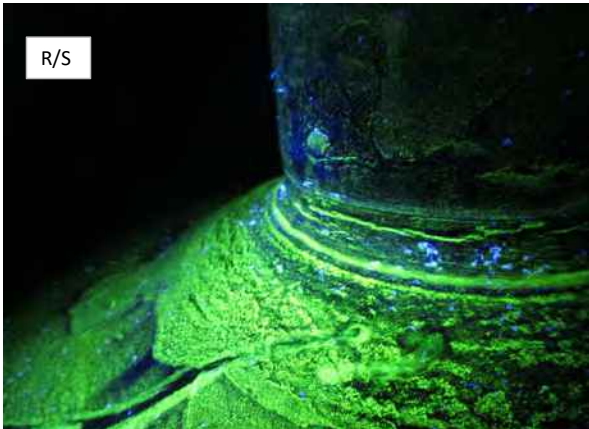
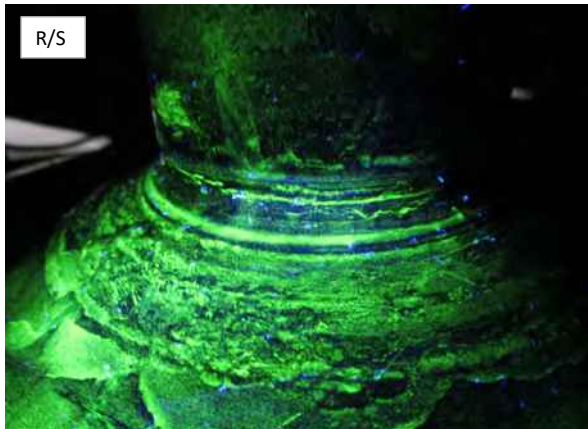
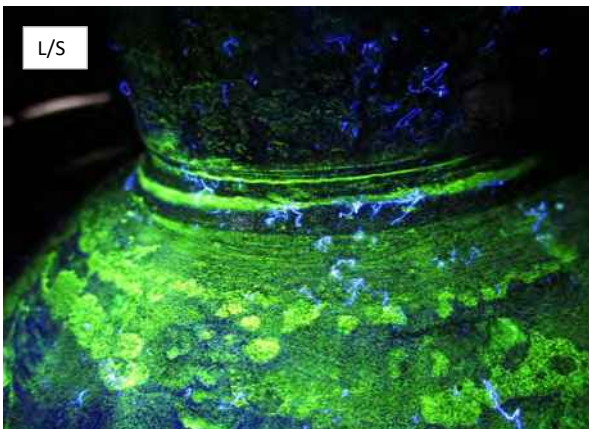
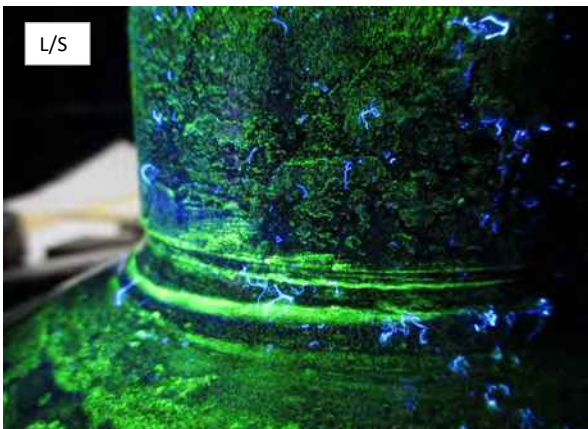
- R/S Cracklike indications circular for 360 degrees - see pictures next page
- L/S Cracklike indications circular for 180 degrees - see pictures next page

CUSTOMER:		FCSS	
PO #:	4900073380	SURFACE CONDITION:	In Service / Cleaned
MATERIAL DESCRIPTION:		Reheat Stop Valves R/S L/S Disk Arm Connections	
Description			
	<ul style="list-style-type: none"> R/S Cracklike indications circular for 360 degrees L/S Cracklike indications circular for 180 degrees 		
<div style="display: flex; flex-wrap: wrap;"> <div style="width: 50%;">

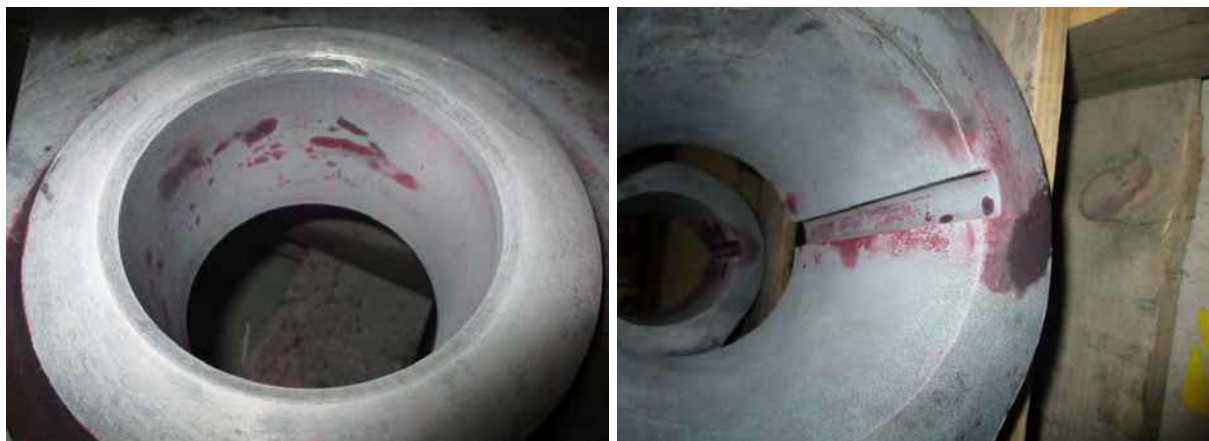
Penetrant inspection of the Reheat Stop Valves Disk Yoke Keyways (4), Bushings, Nuts resulted in the following:

- Some bleedout in keyways and bushings - see example pictures

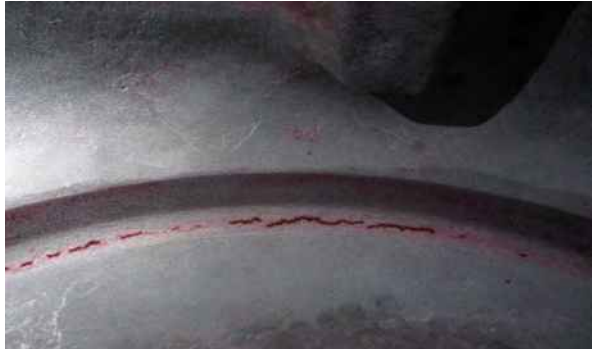
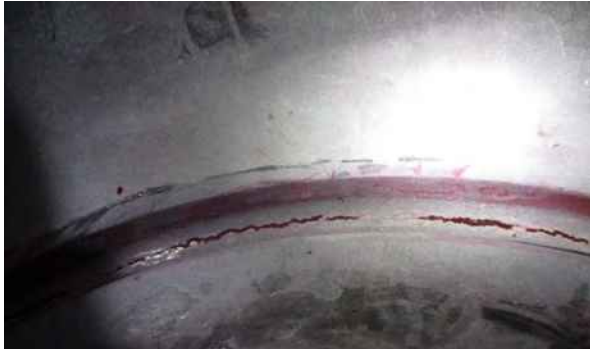
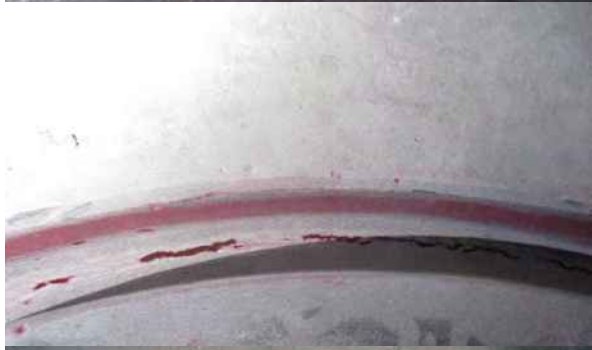
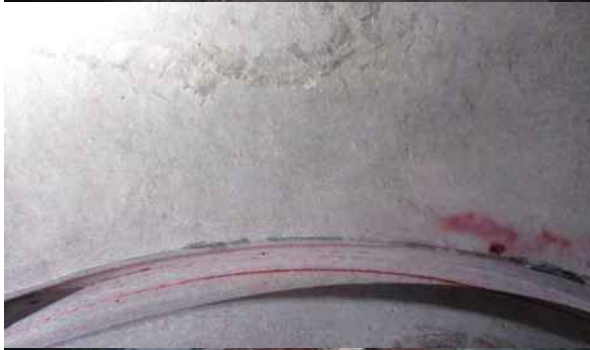
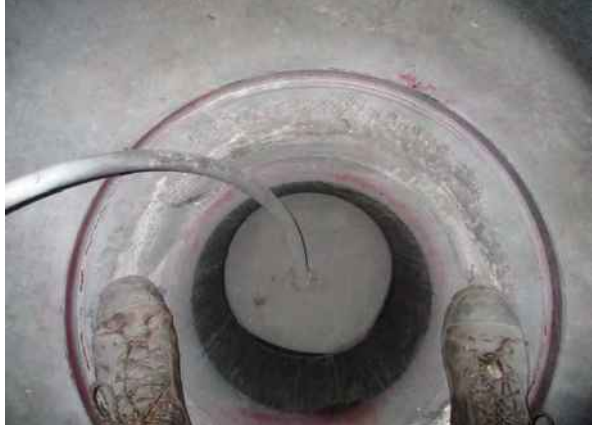
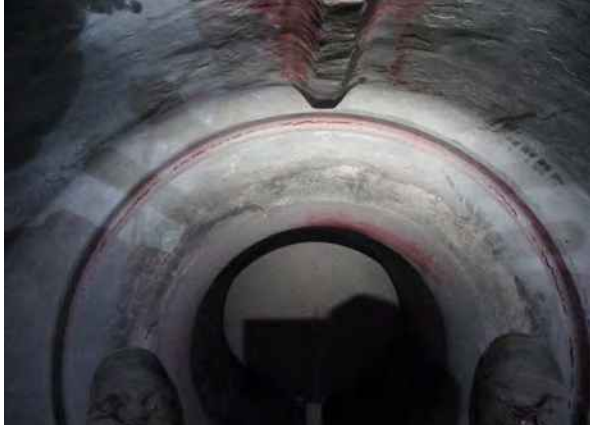
CUSTOMER:		FCSS	
PO #:	4900073380	SURFACE CONDITION:	In Service / Cleaned
MATERIAL DESCRIPTION: Intercept Valves R/S and L/S Outbound and Inbound Seats, Swirl Dams, and Strainer Grooves			
Description			
<ul style="list-style-type: none"> R/S Inbound Strainer Groove: linear indication covering ~270 degree of the circumference

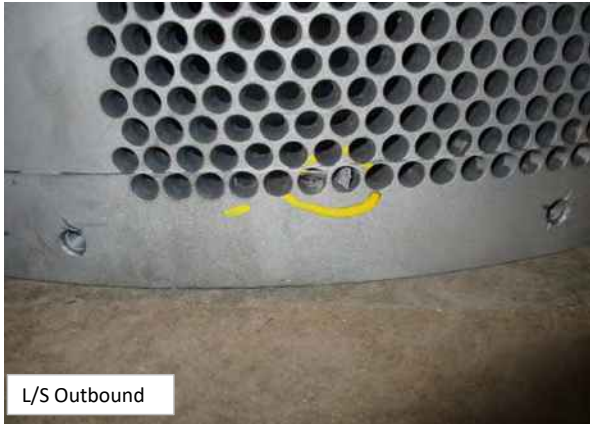
<p>L/S Outbound</p>

CUSTOMER:		FCSS	
PO #:	4900073380	SURFACE CONDITION:	In Service / Cleaned
MATERIAL DESCRIPTION:		Intercept Valves R/S L/S Outbound Inbound Strainers	
Description			
<ul style="list-style-type: none"> • L/S Outbound: Foreign object in one location; screen misaligned/dropped • R/S Outbound Foreign object in 2 locations

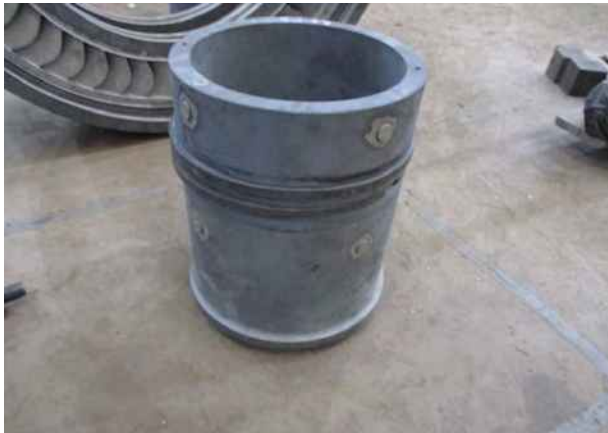
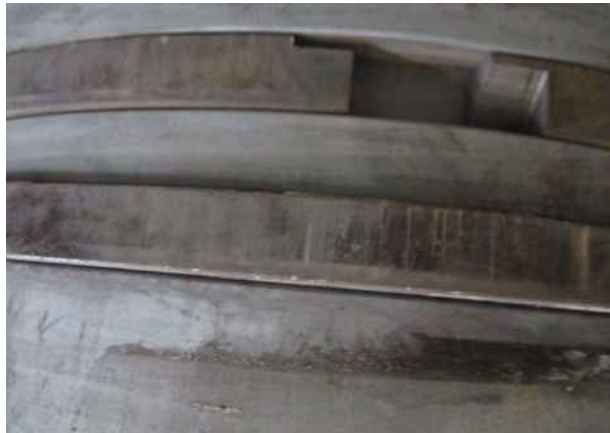
Visual inspection of the (4) Intercept Valves Plugs Washers (2 per plug) resulted in no reportable indications.

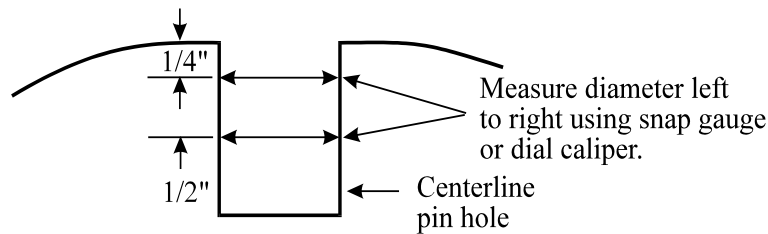
TLA CENTERLINE PIN HOLE REPAIR

DATE:	COMPONENT: IP #2 Blade Ring	WORK DONE BY:
COMMENTS:

UPPER CENTERLINE HOLE DIAMETER LEFT to RIGHT

Repair Work Required			
LEFT SIDE: Add 0.004"			
RIGHT SIDE: Remove 0.011"			
Reading Location	As Found Before Repairs	After Working Left Side	After Working Right Side
1/4"			
1/2"

Repair Work Required			
LEFT SIDE: Add 0.007"			
RIGHT SIDE: Remove 0.008"			
Reading Location	As Found Before Repairs	After Working Left Side	After Working Right Side
1/4"			
1/2"

- Note:
1. Measure centerline hole diameter left to right before starting repairs
 2. Weld up and grind one side to decrease hole size as called for in "Repair Work Required". Welded area should be about 3/8" wide and 5/8" deep.
 3. Grind second side to increase hole diameter as called for in "Repair Work Required"

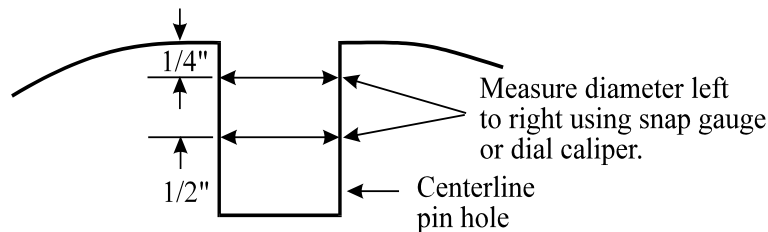
TLA CENTERLINE PIN HOLE REPAIR

DATE:	COMPONENT: N2 Inner Gland	WORK DONE BY:
COMMENTS:

UPPER CENTERLINE HOLE DIAMETER LEFT to RIGHT

Repair Work Required			
LEFT SIDE: Remove 0.003"			
RIGHT SIDE: Add 0.007"			
Reading Location	As Found Before Repairs	After Working Left Side	After Working Right Side
1/4"			
1/2"

Repair Work Required			
LEFT SIDE: No change			
RIGHT SIDE: Add 0.010"			
Reading Location	As Found Before Repairs	After Working Left Side	After Working Right Side
1/4"			
1/2"

- Note:
1. Measure centerline hole diameter left to right before starting repairs
 2. Weld up and grind one side to decrease hole size as called for in "Repair Work Required". Welded area should be about 3/8" wide and 5/8" deep.
 3. Grind second side to increase hole diameter as called for in "Repair Work Required"

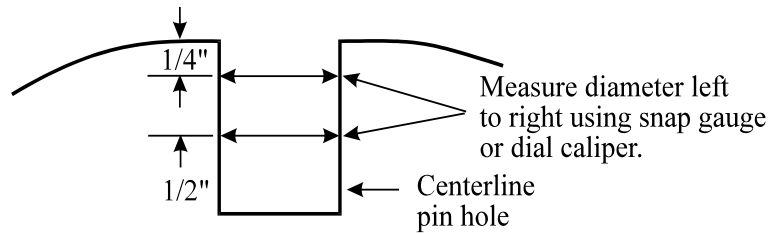
TLA CENTERLINE PIN HOLE REPAIR

DATE:	COMPONENT: LPA 1st Stage Center Flow	WORK DONE BY:
COMMENTS:

UPPER CENTERLINE HOLE DIAMETER LEFT to RIGHT

Repair Work Required			
LEFT SIDE: Add 0.006"			
RIGHT SIDE: Remove 0.009"			
Reading Location	As Found Before Repairs	After Working Left Side	After Working Right Side
1/4"			
1/2"

Repair Work Required			
LEFT SIDE: Add 0.009"			
RIGHT SIDE: Remove 0.006"			
Reading Location	As Found Before Repairs	After Working Left Side	After Working Right Side
1/4"			
1/2"

- Note:
1. Measure centerline hole diameter left to right before starting repairs
 2. Weld up and grind one side to decrease hole size as called for in "Repair Work Required". Welded area should be about 3/8" wide and 5/8" deep.
 3. Grind second side to increase hole diameter as called for in "Repair Work Required"

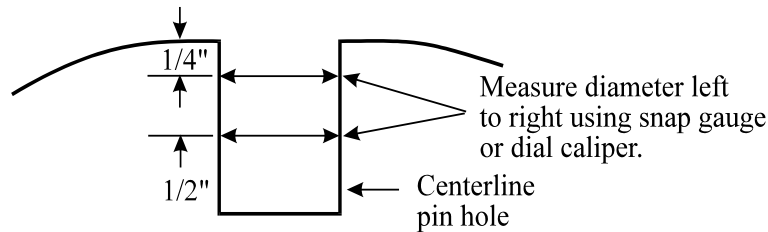
TLA CENTERLINE PIN HOLE REPAIR

DATE:	COMPONENT: LPB 4 th -2 nd Double Flow Blade Ring	WORK DONE BY:
COMMENTS:

UPPER CENTERLINE HOLE DIAMETER LEFT to RIGHT

- Note:
1. Measure centerline hole diameter left to right before starting repairs
 2. Weld up and grind one side to decrease hole size as called for in "Repair Work Required". Welded area should be about 3/8" wide and 5/8" deep.
 3. Grind second side to increase hole diameter as called for in "Repair Work Required"
