Comanche Unit 3 -Spring 2020 Outage

Full Train Major, Main Steam Valves & Generator

COMANCHE (CO) Steam Turbine ESN: SY0093272 Generator ESN: SY0350139 Job Start Date: 13 Jan 2020 Oracle Project ID: FSP-285469 | C-10344497

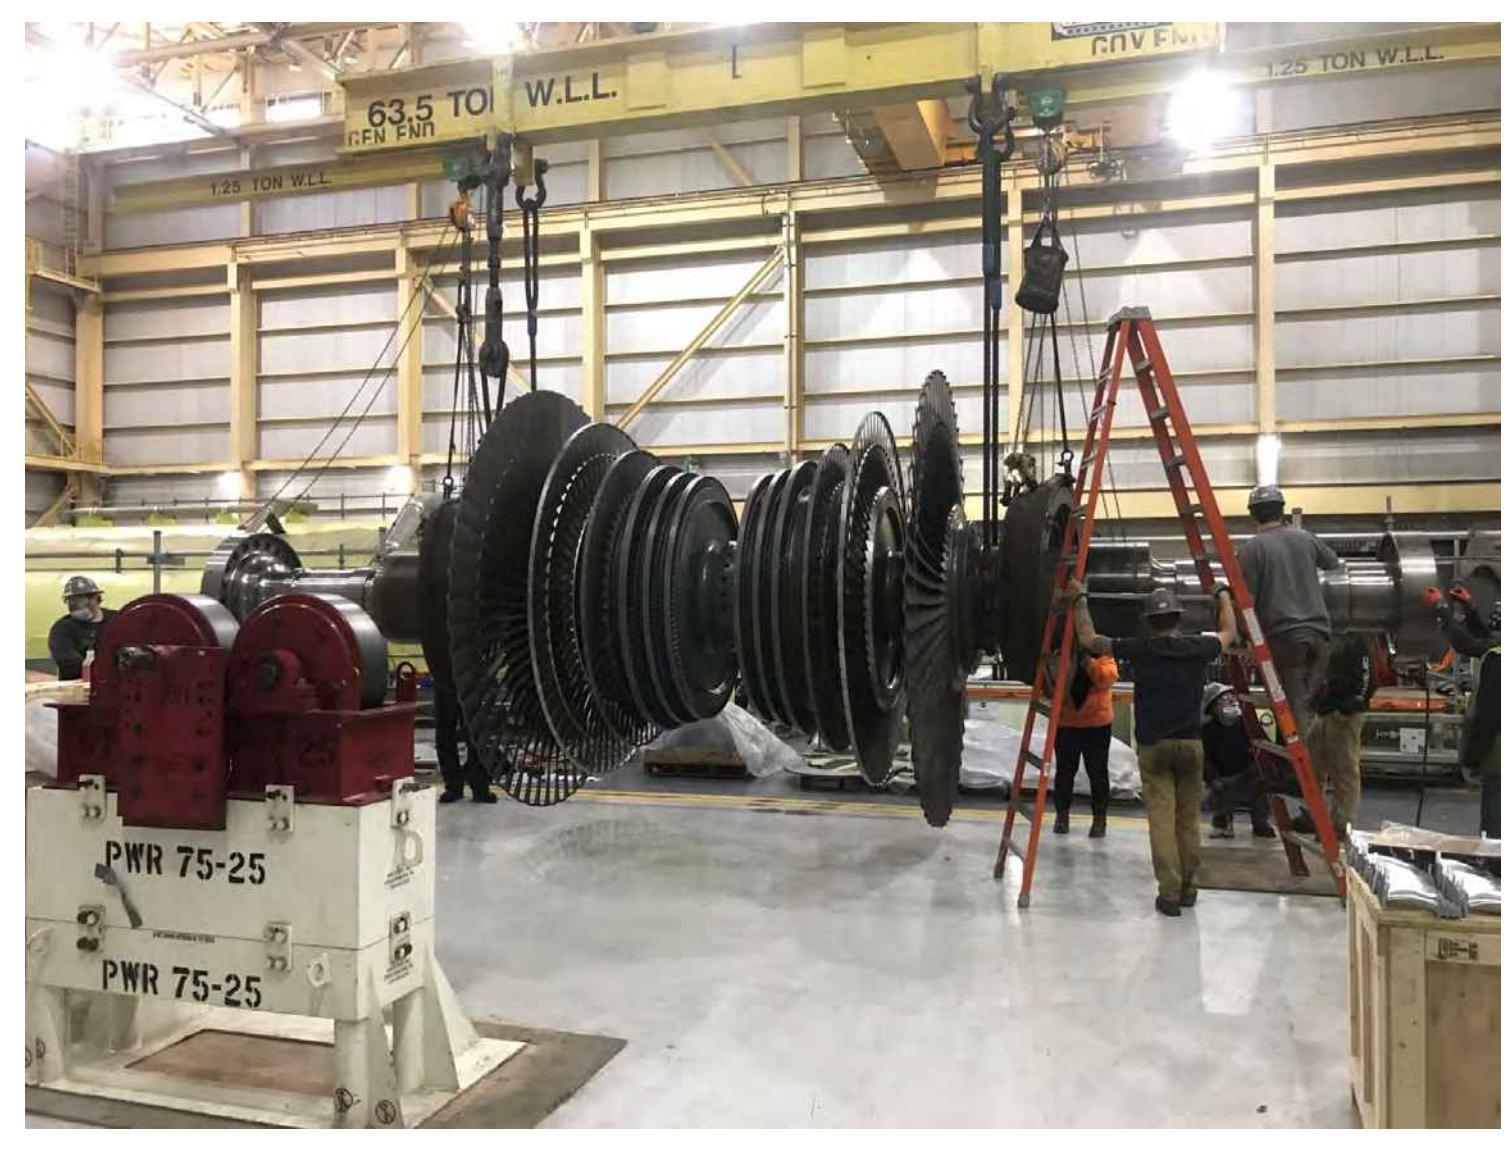
LPA Rotor

The LPA rotor was removed, grit blasted and non-destructively examined. Through the wet magnetic particle inspection, linear indications were found on all of the L-1 buckets. The buckets were removed and the serrations were glass bead blasted and non-destructively examined.

Several of the L-0 erosion shields were found to have "bleed out" during the dye penetrant examination. Erosion was found observed on all of the "Z" lock L-0 shrouds.

The L-1 buckets were replaced and the rotor was low speed balanced by Ethos Energy. More detailed observations can be found in the NDE report included in the appendix portion of this report.

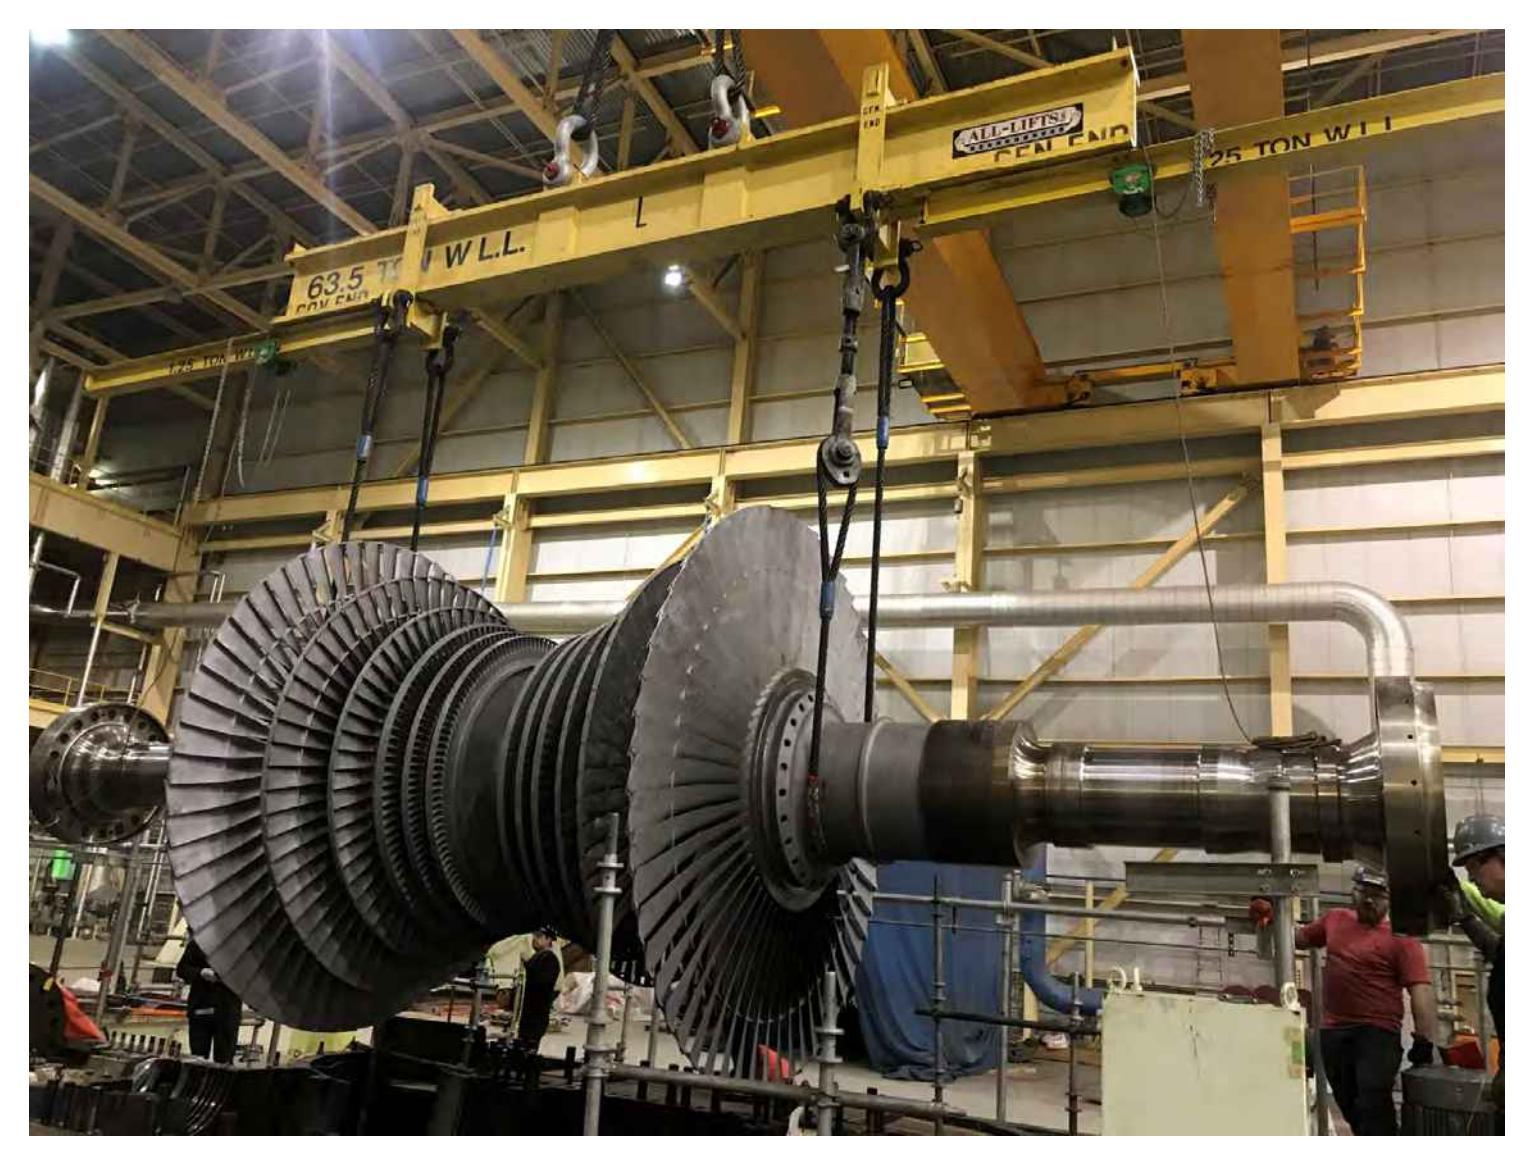
LPB Rotor

One of the generator end L-1 buckets failed in service, causing damage to the other buckets in that row, the spill strips, partitions of the adjacent blade ring, L-0 buckets and L-0 erosion shields. The LPB rotor was removed, grit blasted and non-destructively examined. Through the wet magnetic particle inspection, linear indications were found on all of the remaining L-1 buckets on both ends of the rotor. The buckets were removed and the serrations were glass bead blasted and non-destructively examined.

The L-1 buckets were replaced and the rotor was low speed balanced by Ethos Energy. Several of the L-0 erosion shields were found to have indications on the generator end due to impact damage from the failed L-1 bucket. The damaged erosion shields were removed. All significant impact damage to the generator end L-0 buckets was blended out. More detailed observations can be found in the NDE report included in the appendix section of this report.

Several of the turbine end L-0 erosion shields were found to have "bleed out" during the dye penetrant examination. Erosion was found observed on all of the "Z" lock L-0 shrouds.

The generator end L-0 buckets should be replaced at the next opportunity. Separation between several of the turbine end buckets and erosion shields was also observed, and, strong consideration should be given to replacing this row as well.

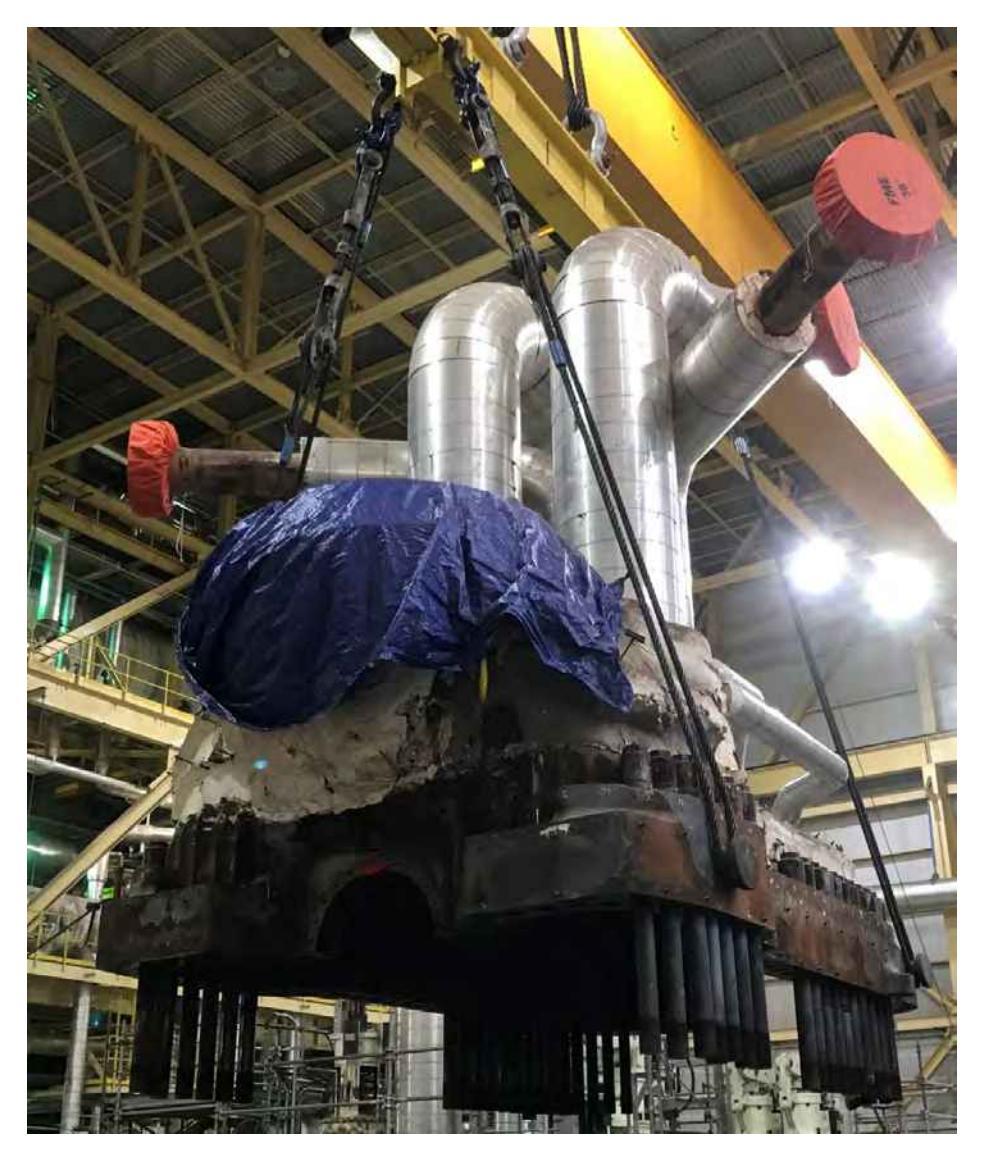
HIP Outer Cylinder Cover

At disassembly it was found that three of the four struts, which act to stiffen the cylinder cover in the area of the crossover pipe flange, were dislocated or loose. These struts enter axially through the generator end of the cylinder cover and are attached to the inner side wall. The struts are then seal welded to the exterior surface. The dislocated and broken struts were welded by APCOM/FieldCore boiler maker welders, per a welding procedure supplied by the customer.

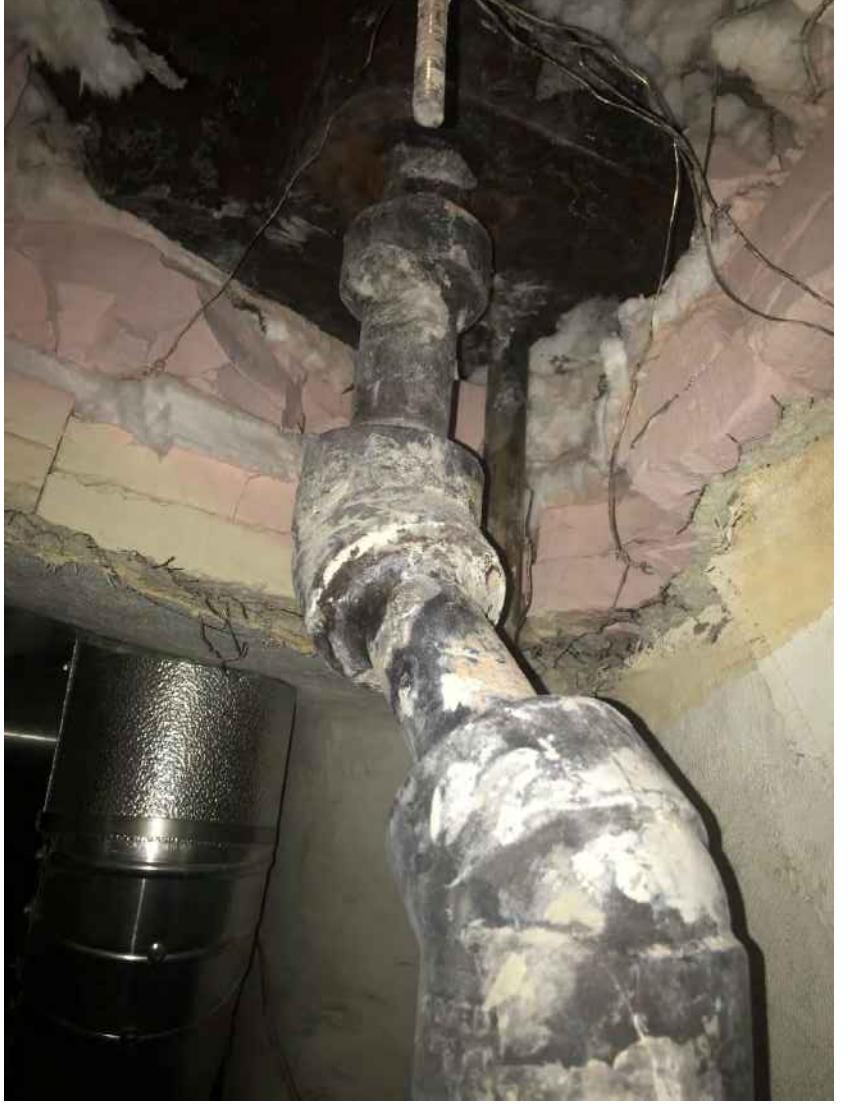
HIP Inner Drain Piping

HIP Inner Cylinder Drain Piping – As Found

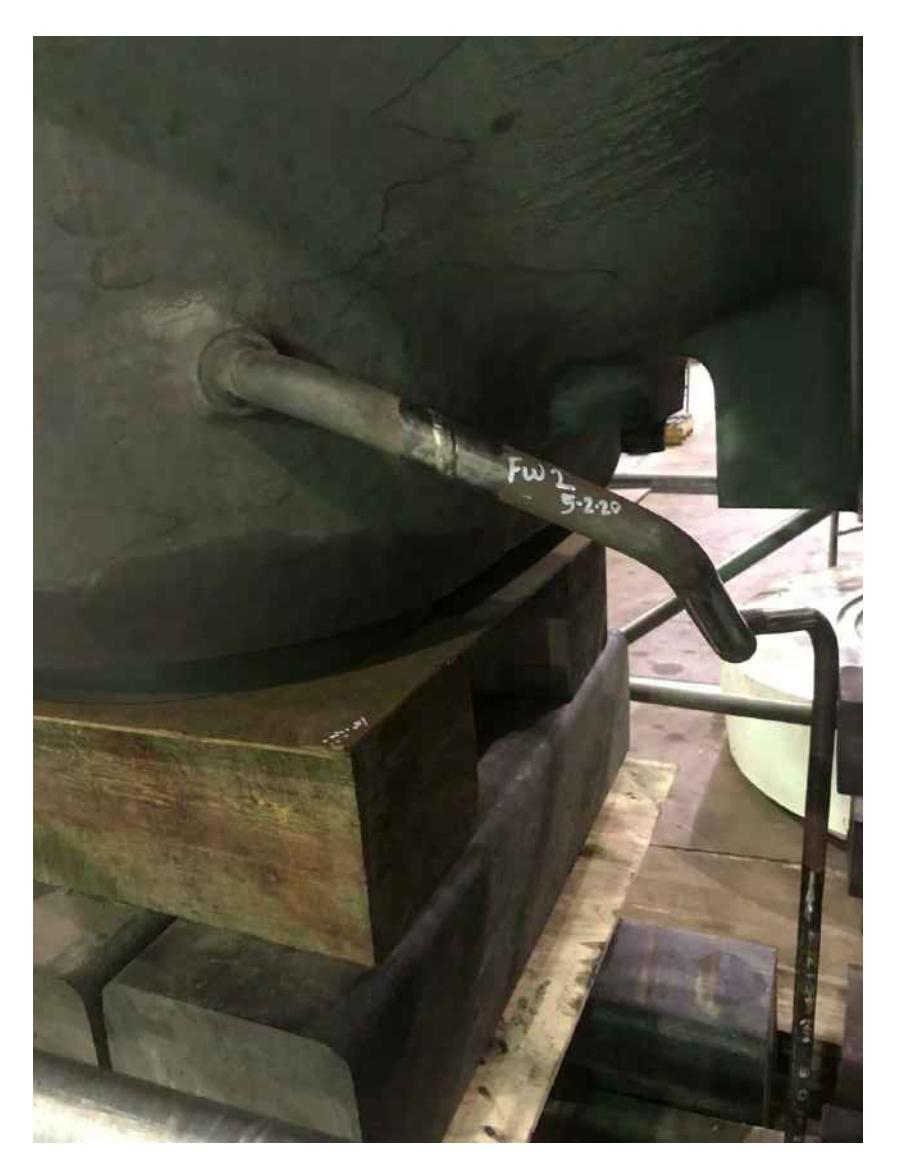
HIP Inner Drain Piping

HIP Inner Cylinder Drain Piping – New Configuration

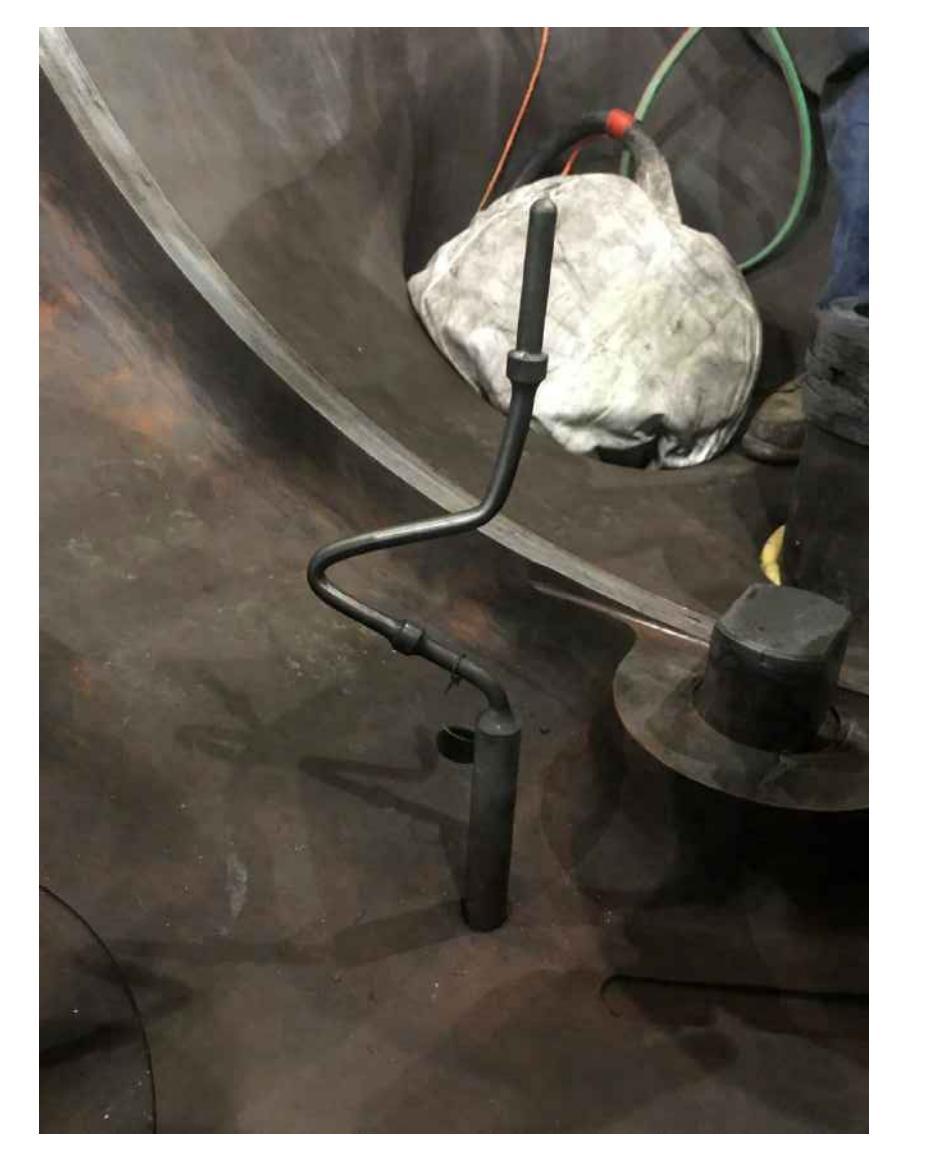
HIP First Stage Metal Temperature Thermowell

During assembly for alignment the thermowell that passes through the outer and inner cylinder bases was damaged. This thermowell houses a thermocouple that measures the first stage metal temperature. The thermowell was bent beyond repair and the thermocouple was damaged. The thermowell was PMI'ed by the customer and found to be 304 SS. The remaining section of thermowell that passes through the outer cylinder base was removed. The pieces were sent out as samples and a new thermowell was fabricated. A new "in kind" thermocouple was acquired. The new thermowell was installed at assembly. The thermowell was welded by Xcel Comanche welders using a weld procedure supplied by the customer.

Replacement First Stage Metal Temperature Thermowell

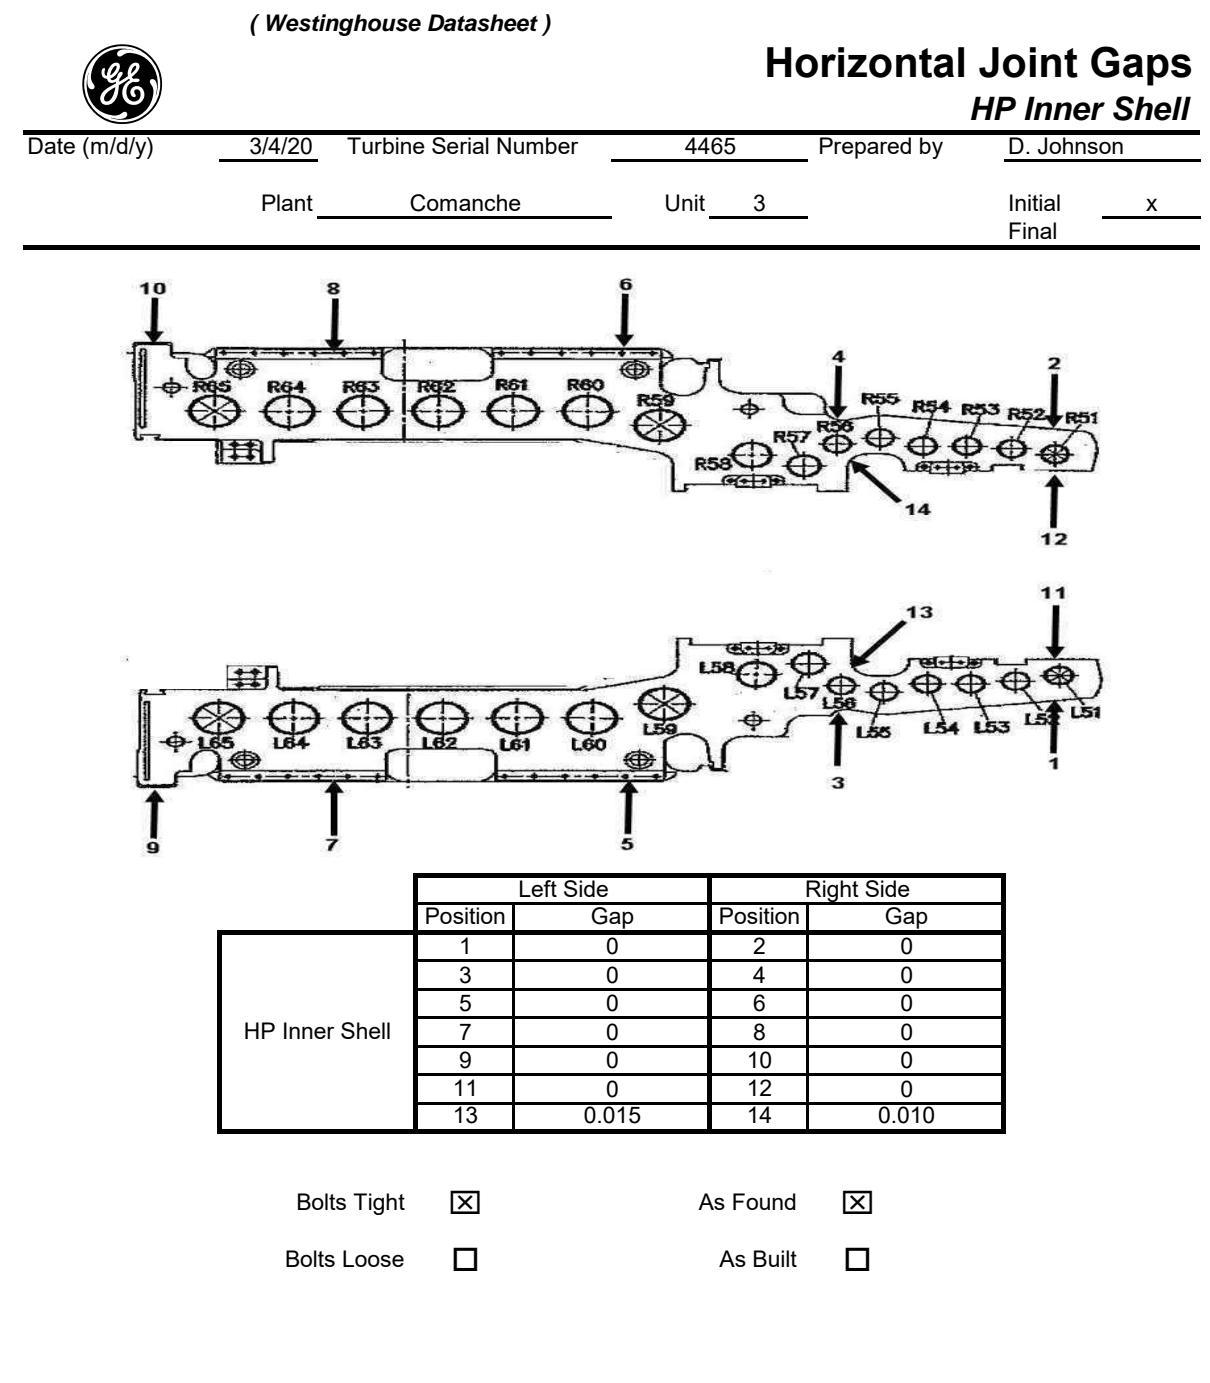
Inner Shell Distortion

Measurements taken during tops-on alignment after tightening bolts

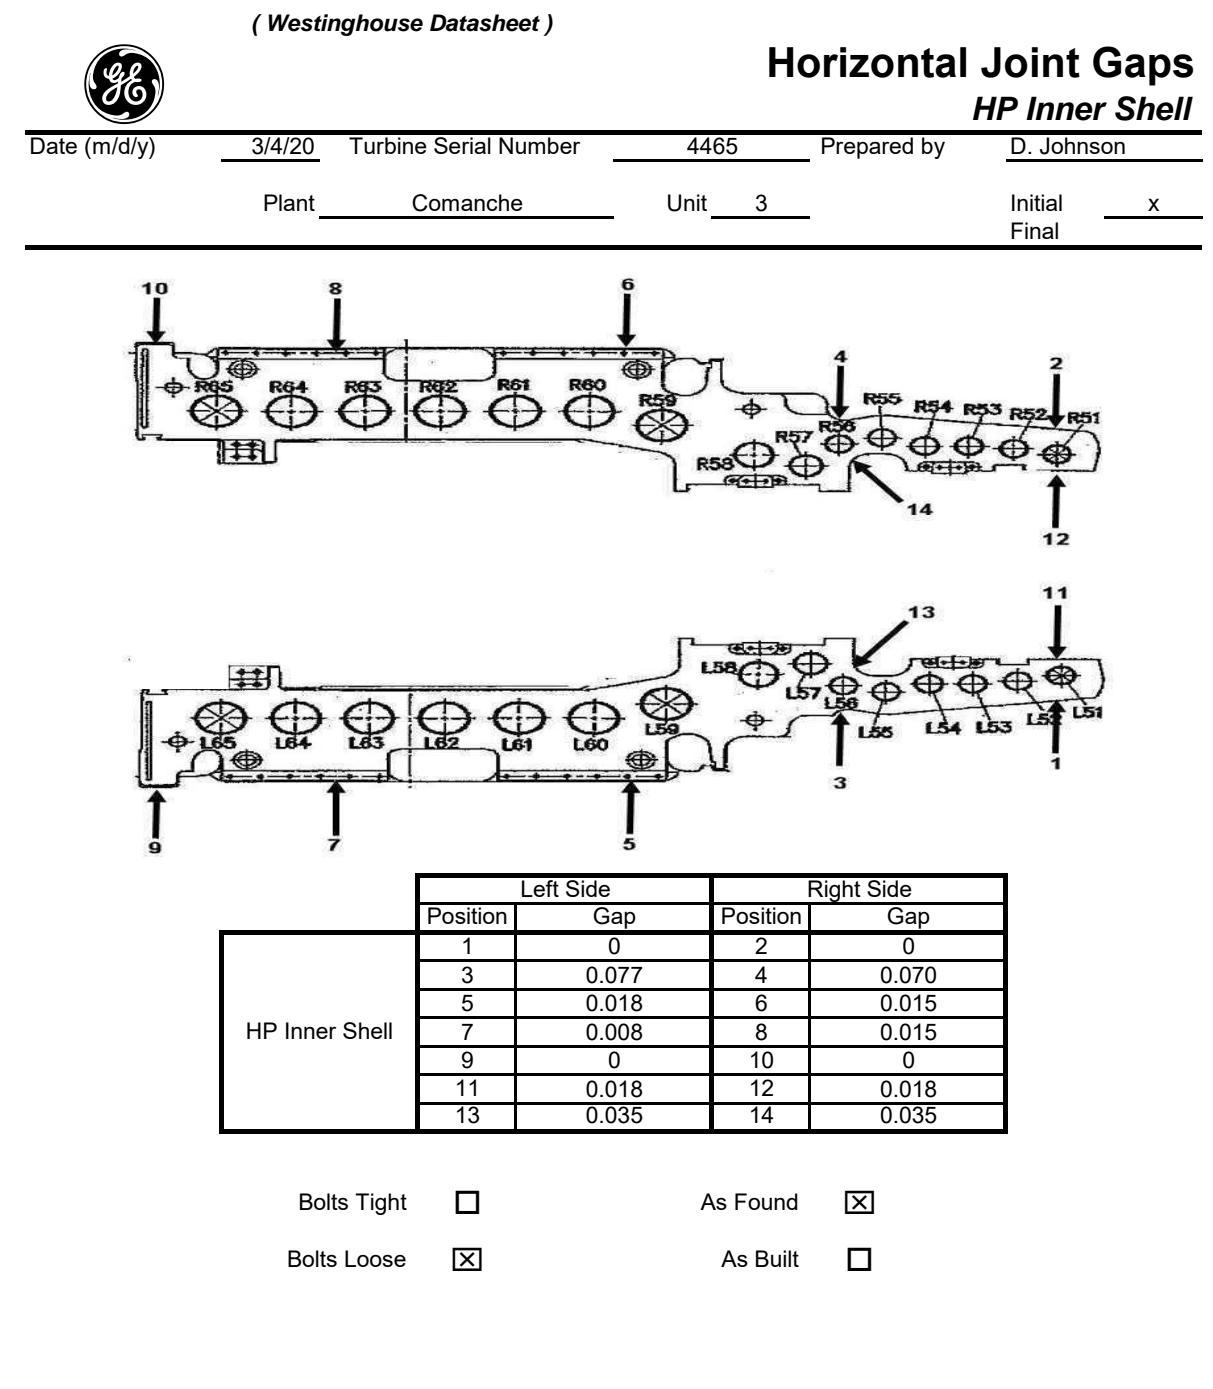
Inner Shell Distortion

Measurements taken during tops-on alignment before tightening bolts

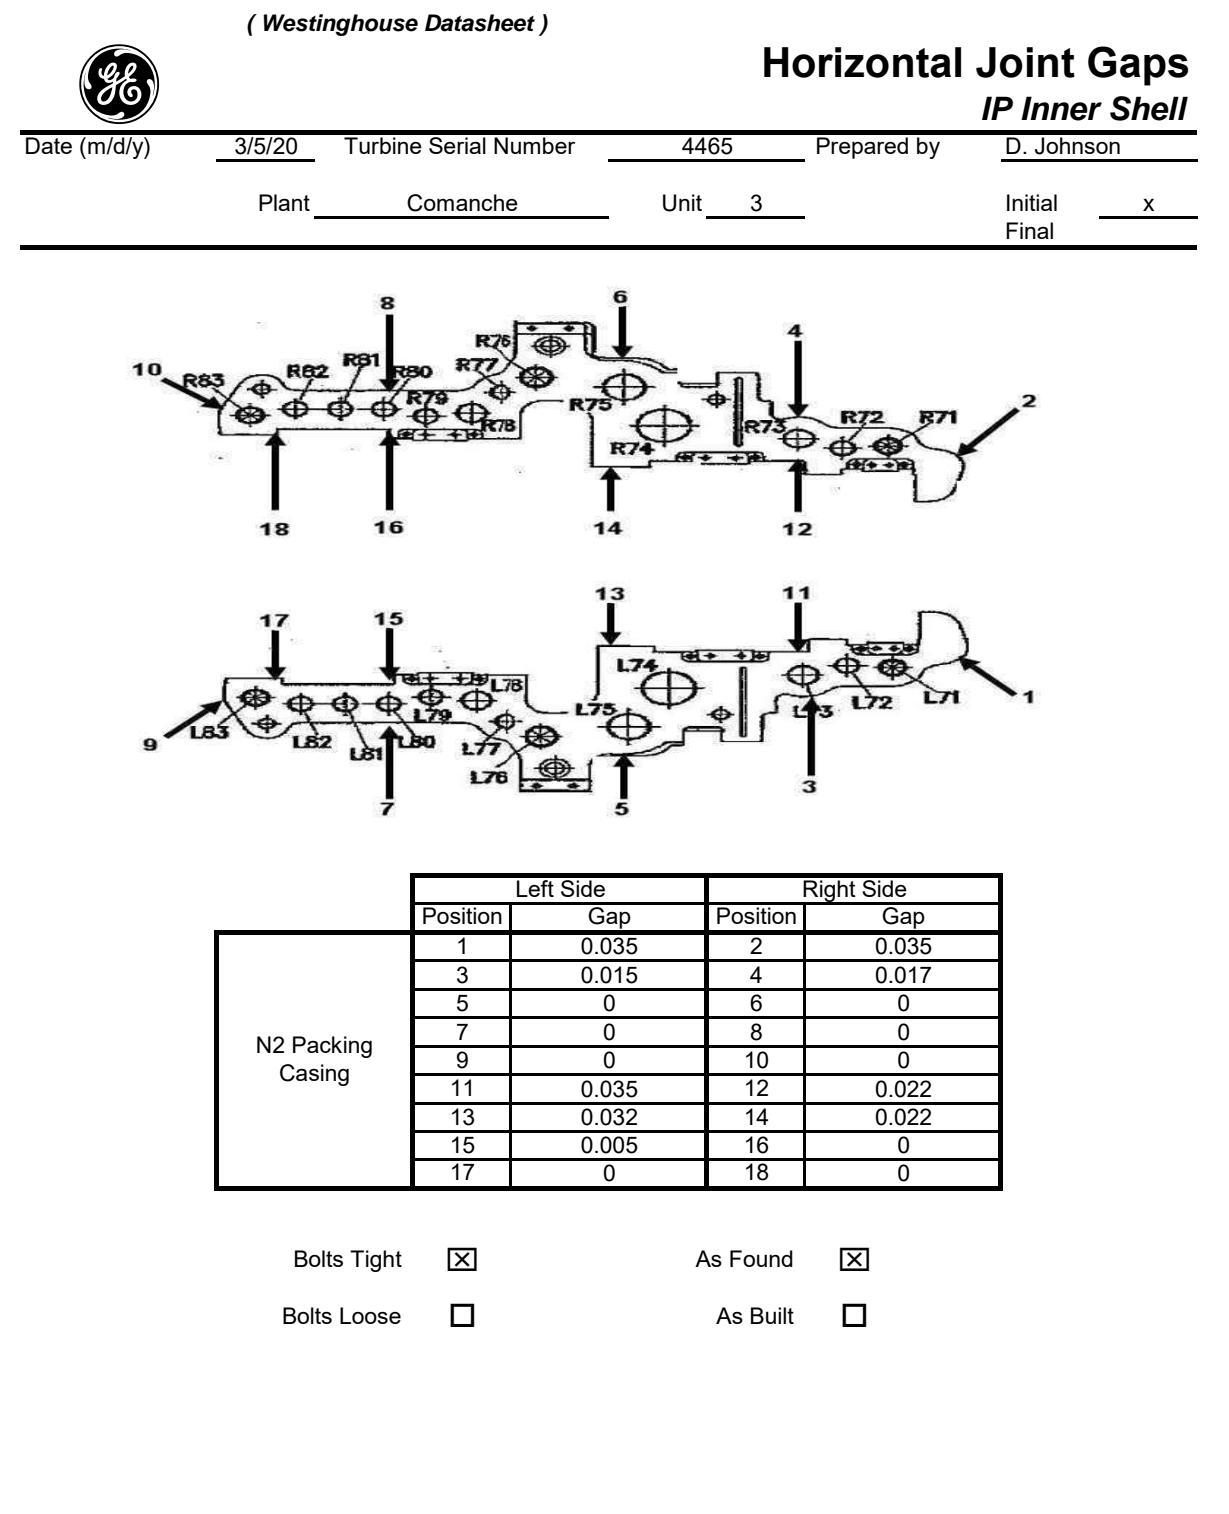
Inner Shell Distortion

Measurements taken during tops-on alignment after tightening bolts Hardware not available for locations 1-4

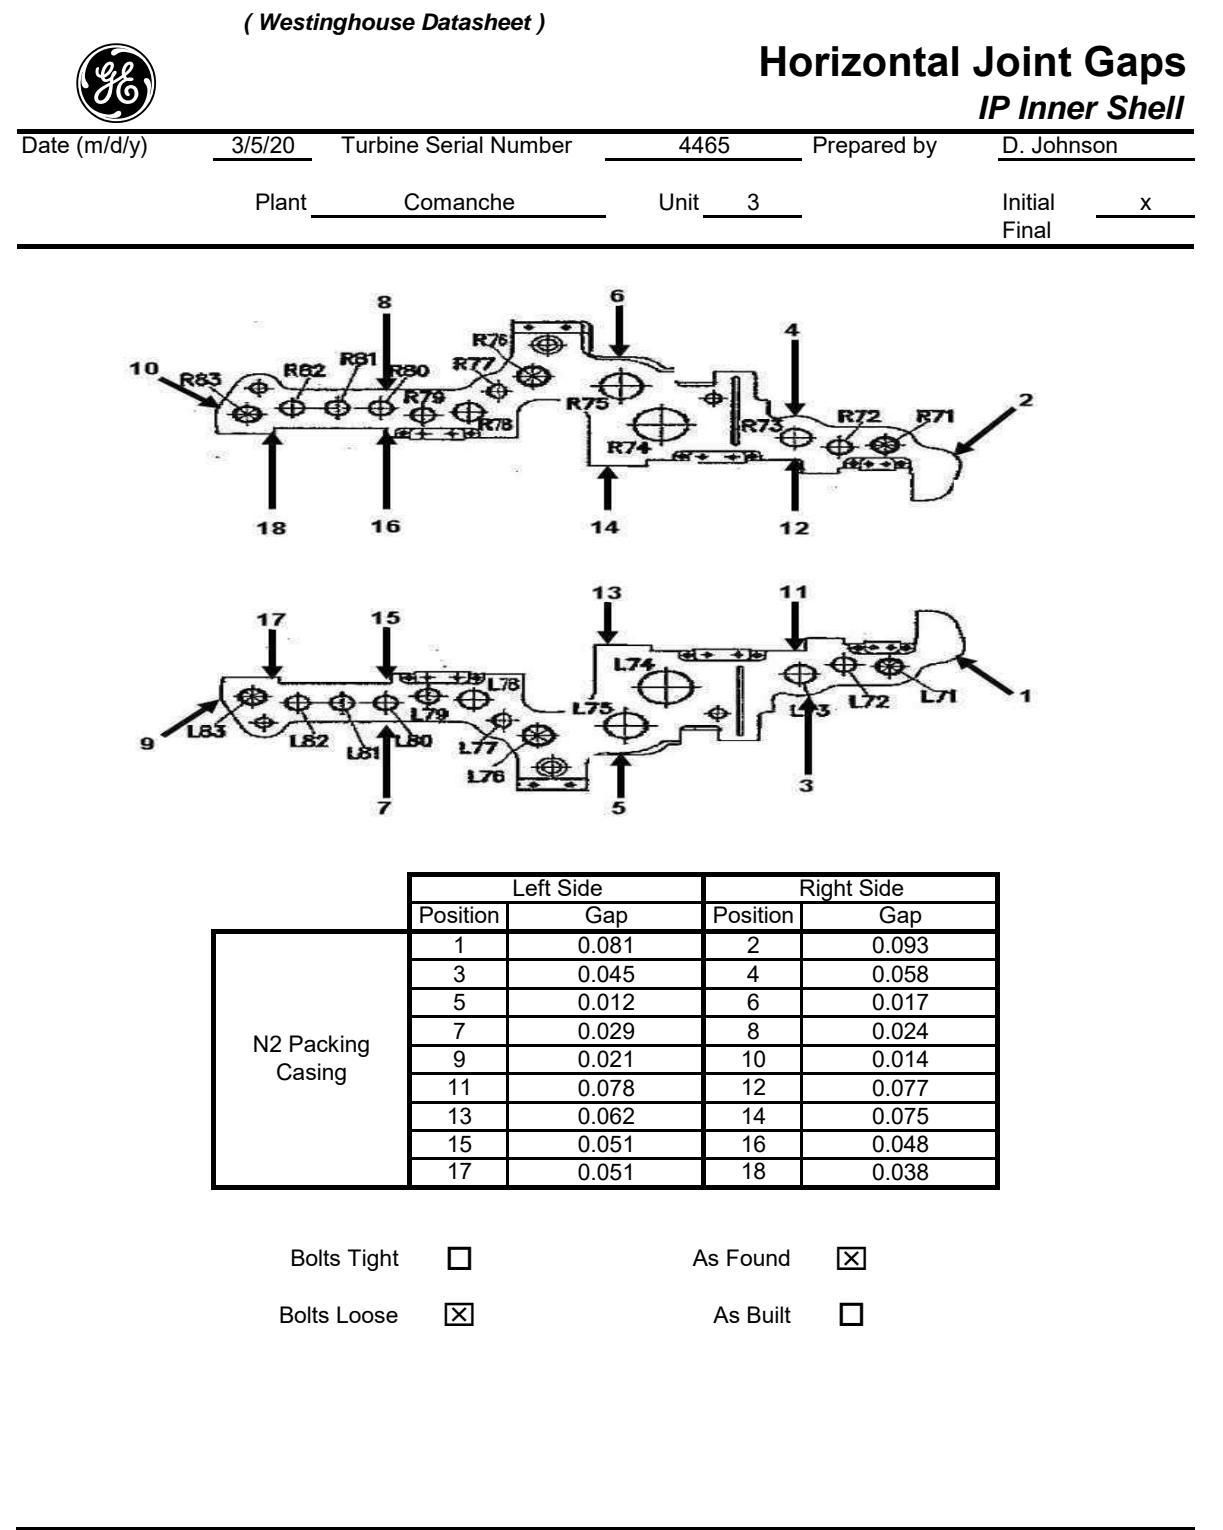
Inner Shell Distortion

Measurements taken during tops-on alignment before tightening bolts

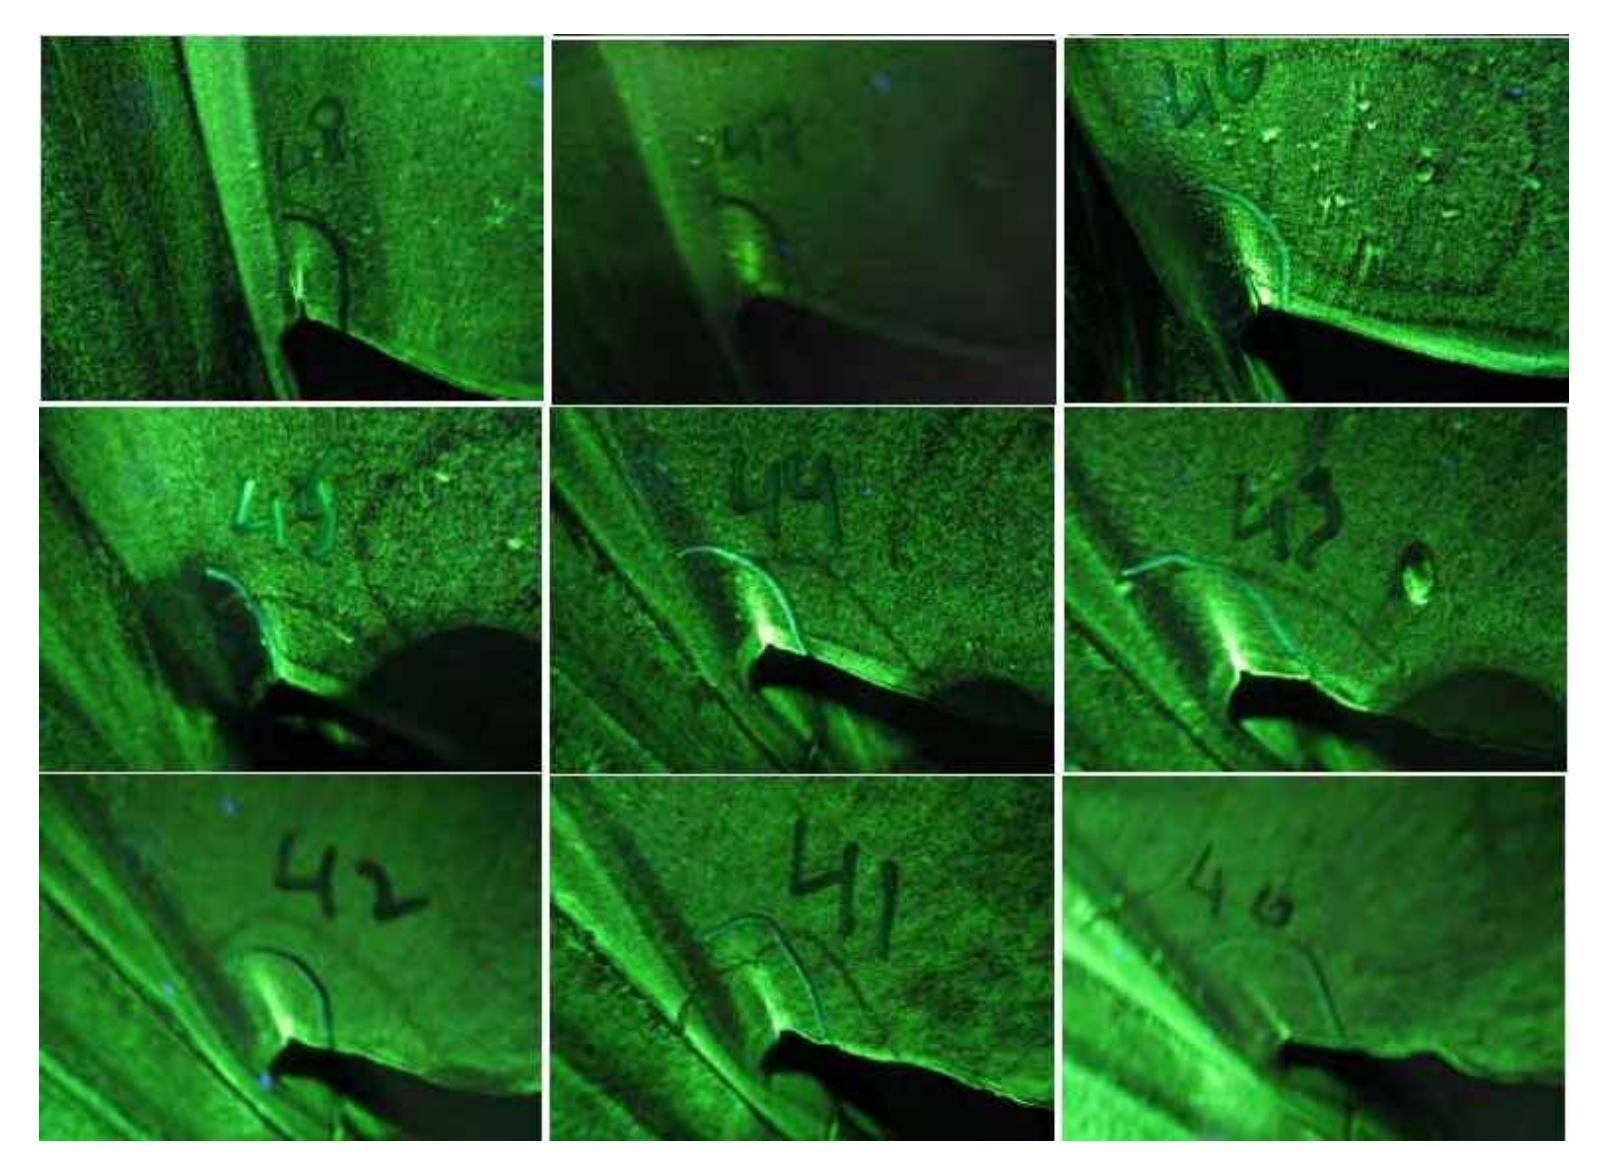
IP #1 Blade Ring

Stage 10 Partitions – Linear Indications 40-48

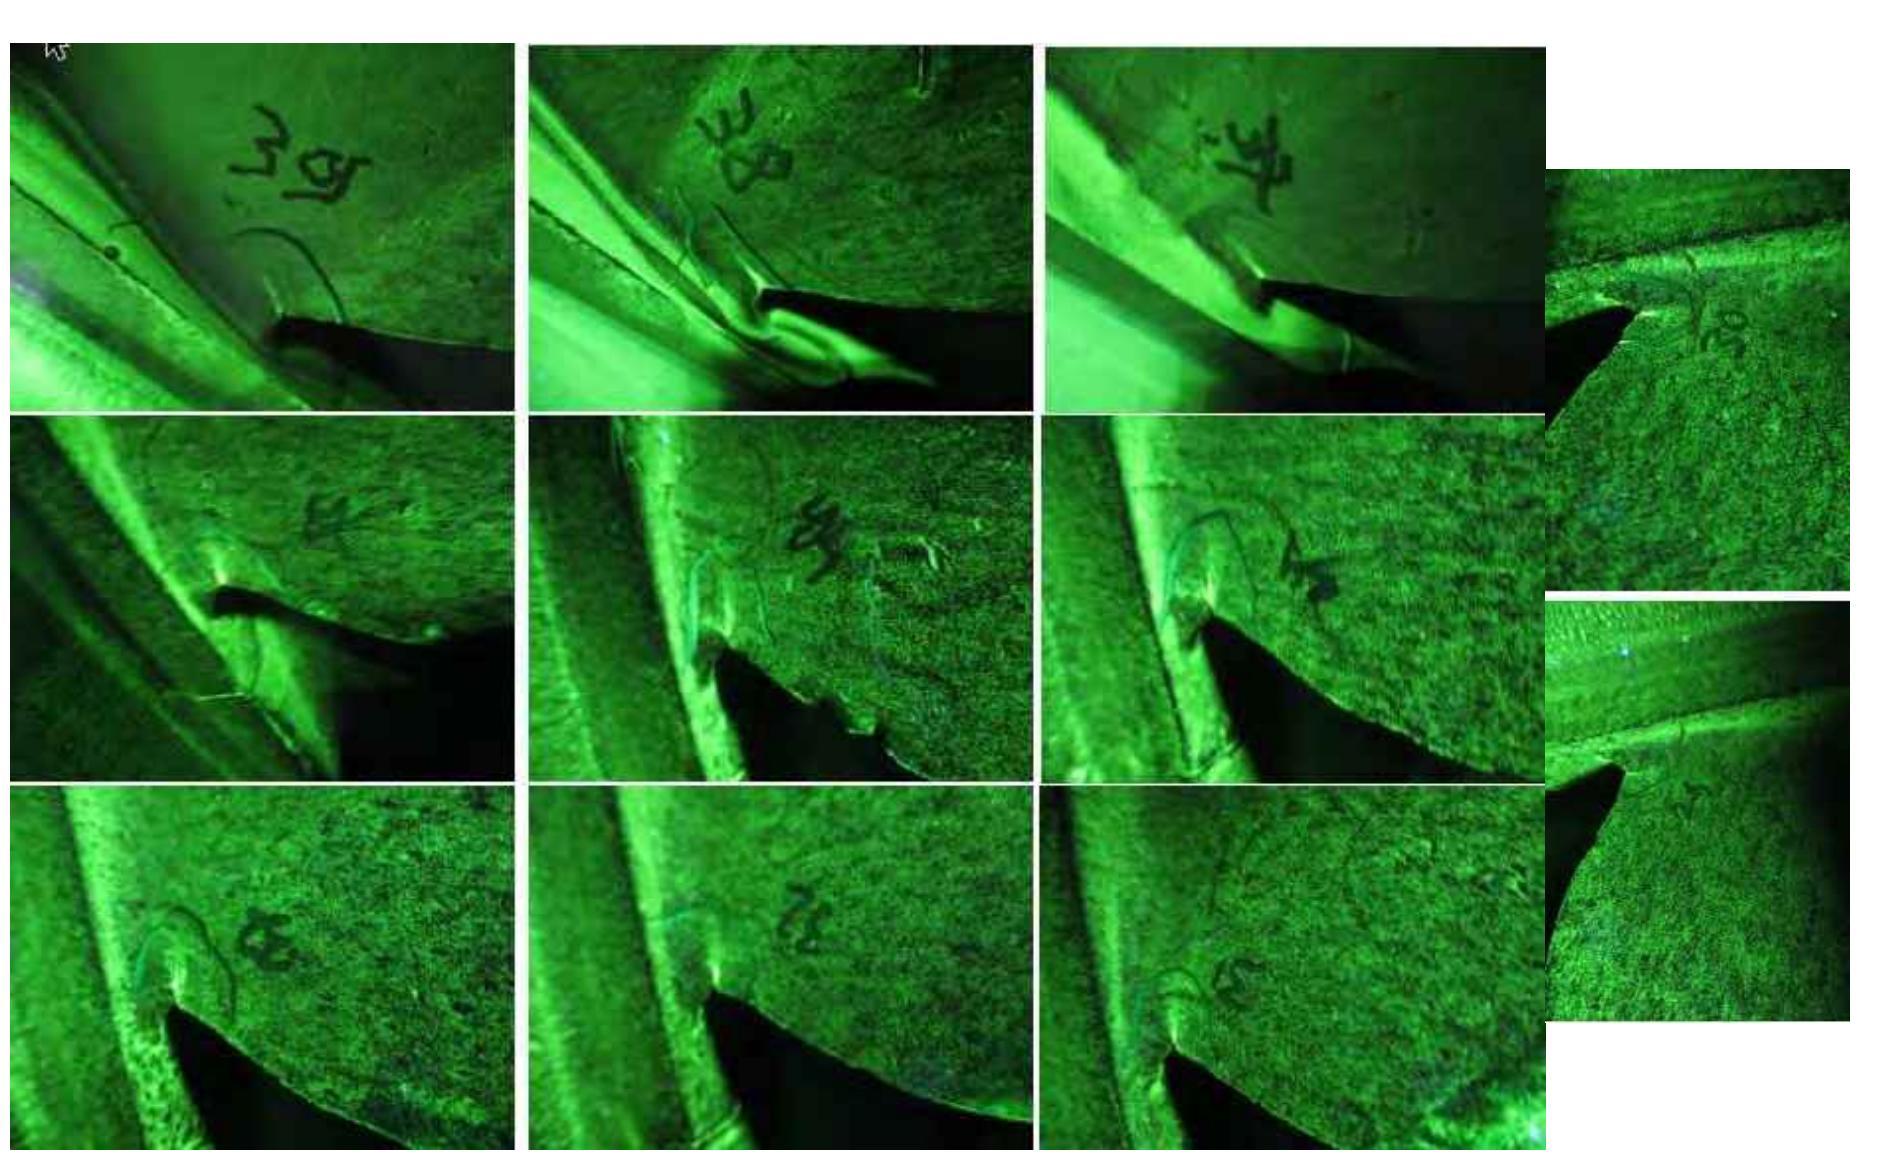
IP #1 Blade Ring

Stage 10 Partitions – Linear Indications 29-39

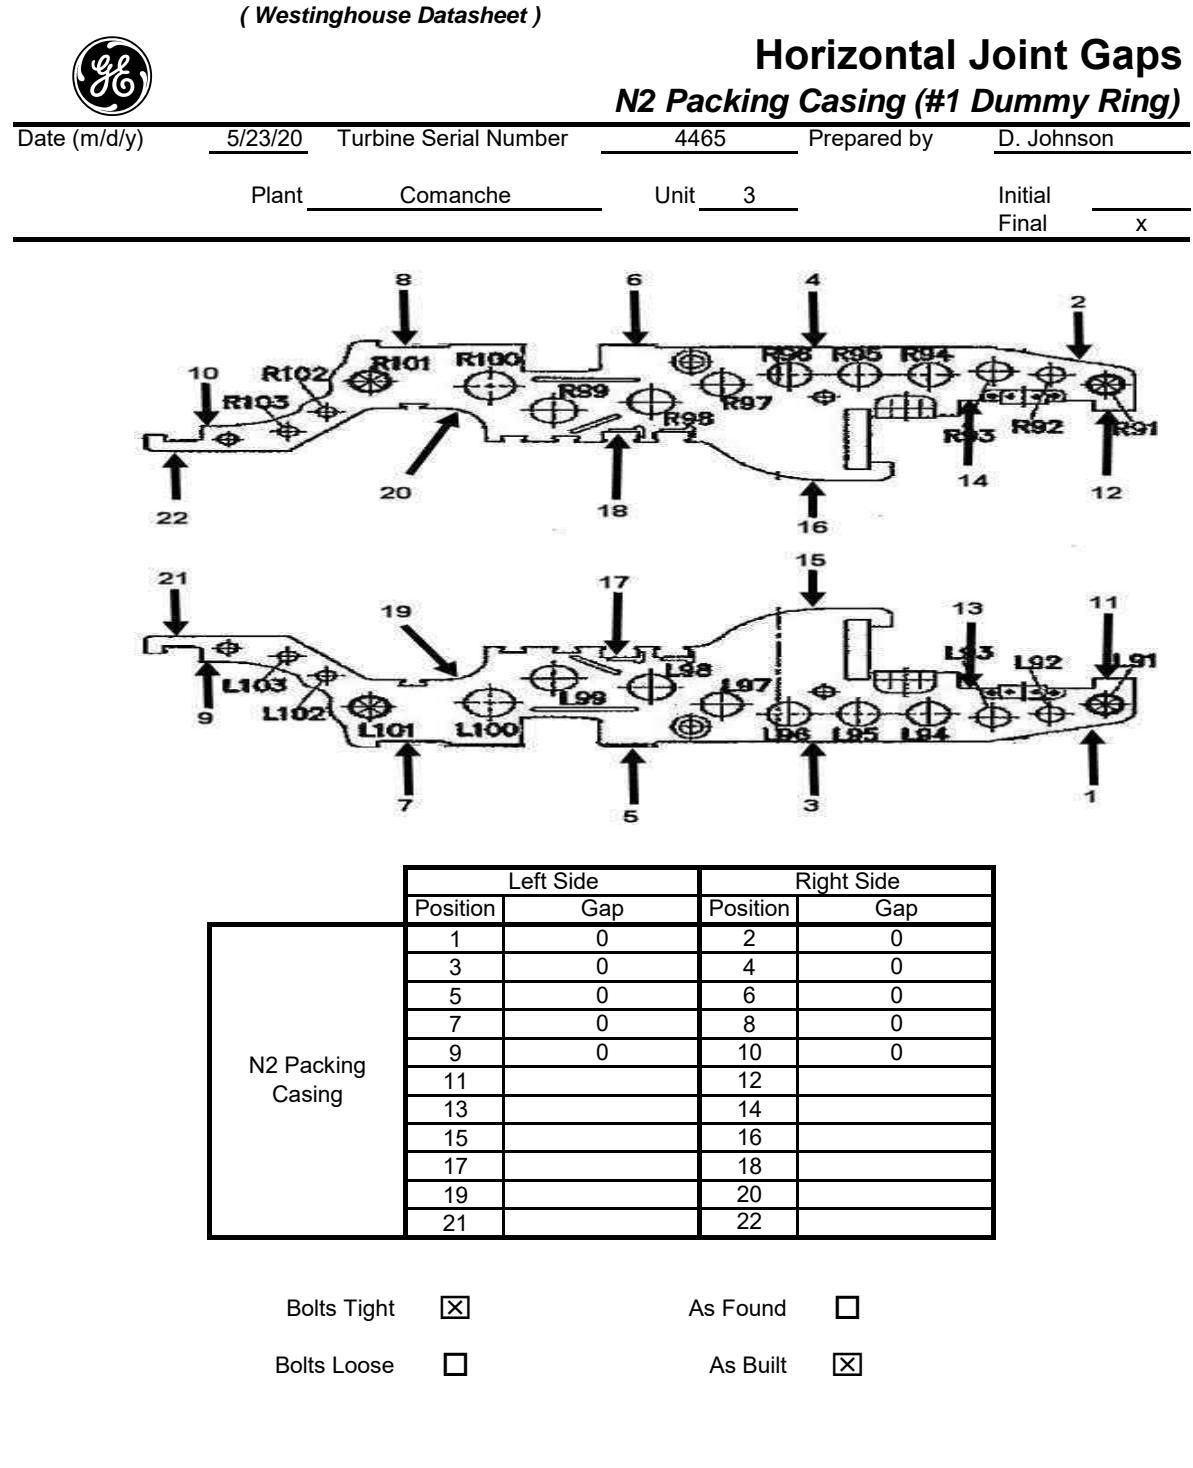
#1 Dummy Ring Distortion

Measurements taken during tops-on alignment after tightening bolts Missing hardware would not allow for the horizontal joint to be closed
