Comanche Unit 3 -Spring 2020 Outage

Full Train Major, Main Steam Valves & Generator

COMANCHE (CO) Steam Turbine ESN: SY0093272 Generator ESN: SY0350139 Job Start Date: 13 Jan 2020 Oracle Project ID: FSP-285469 | C-10344497

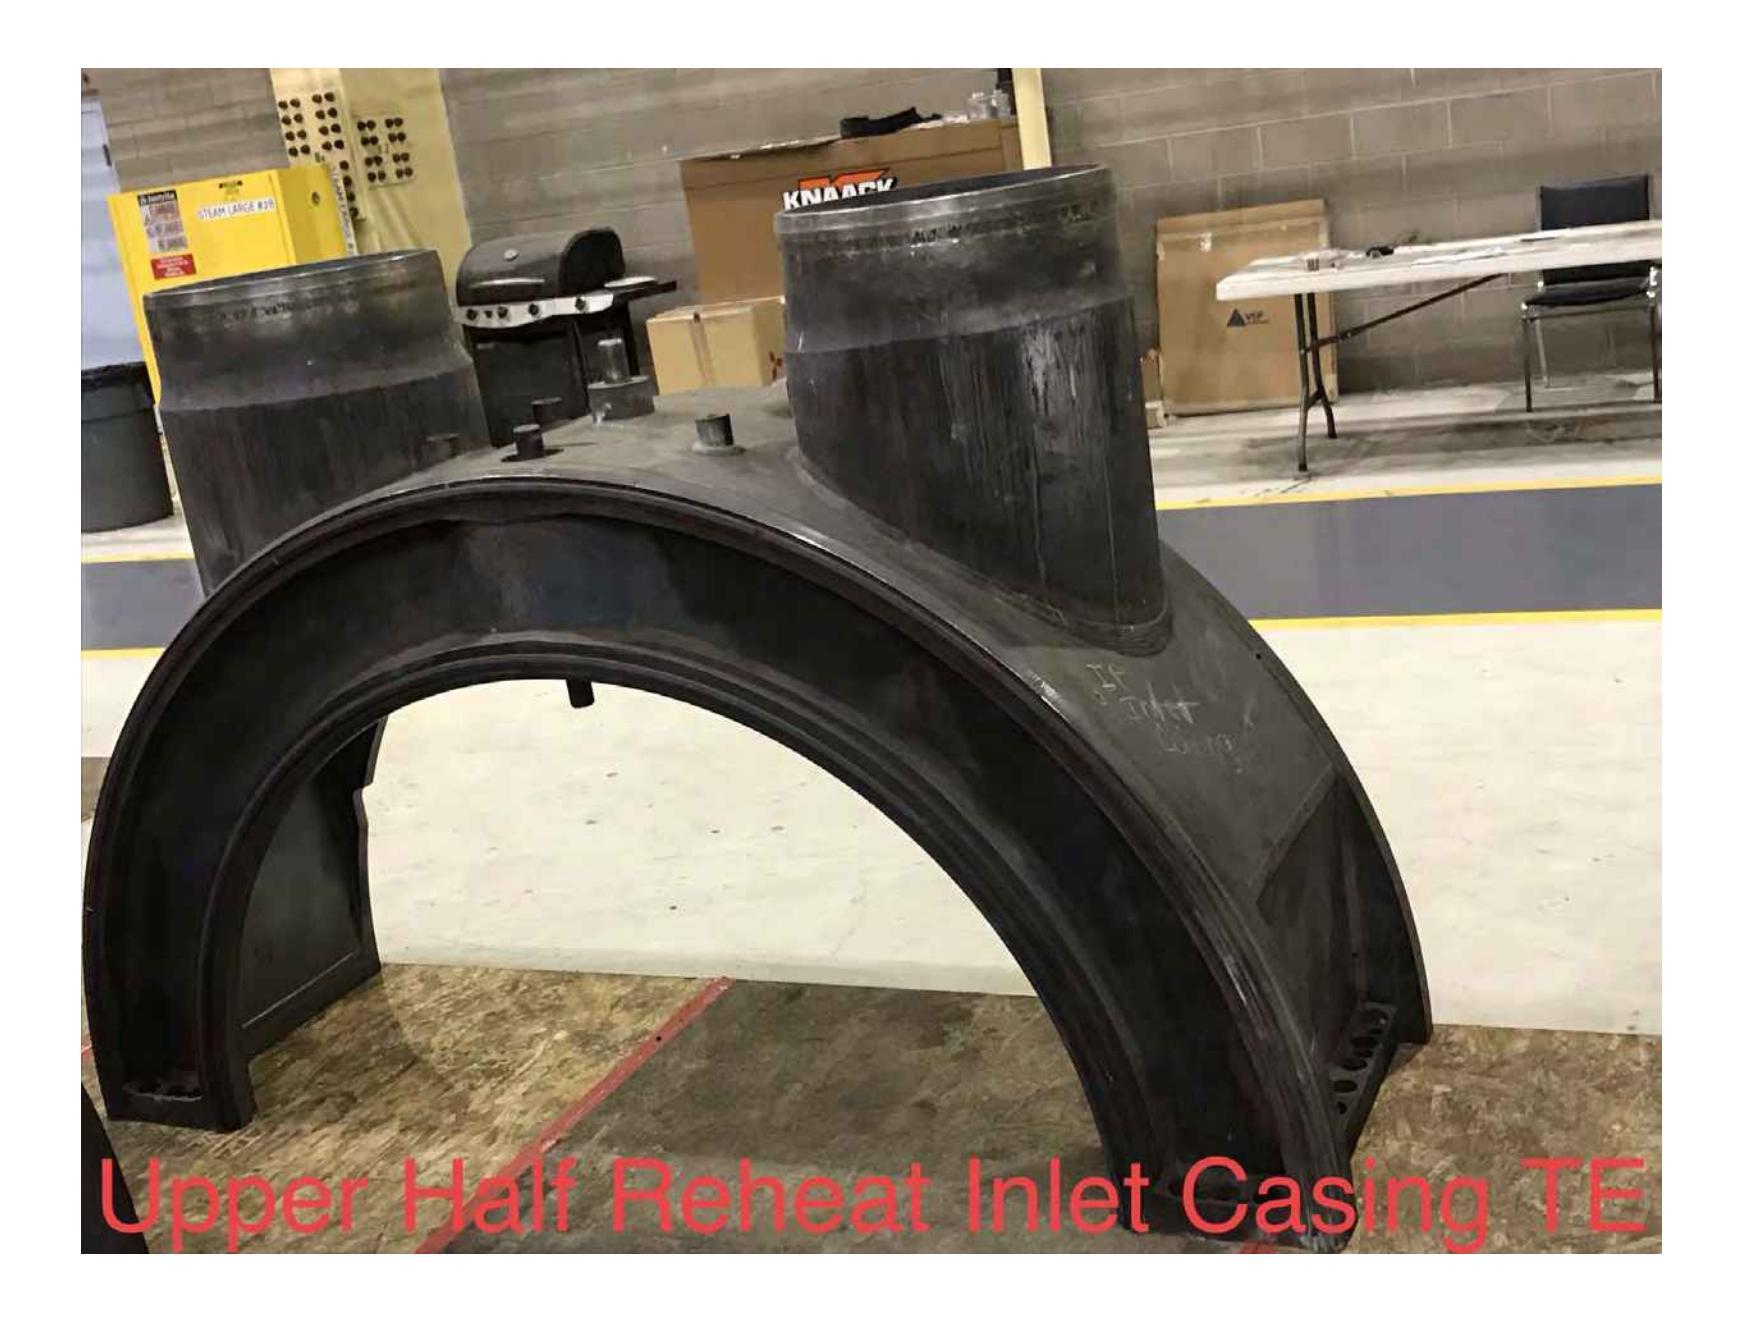
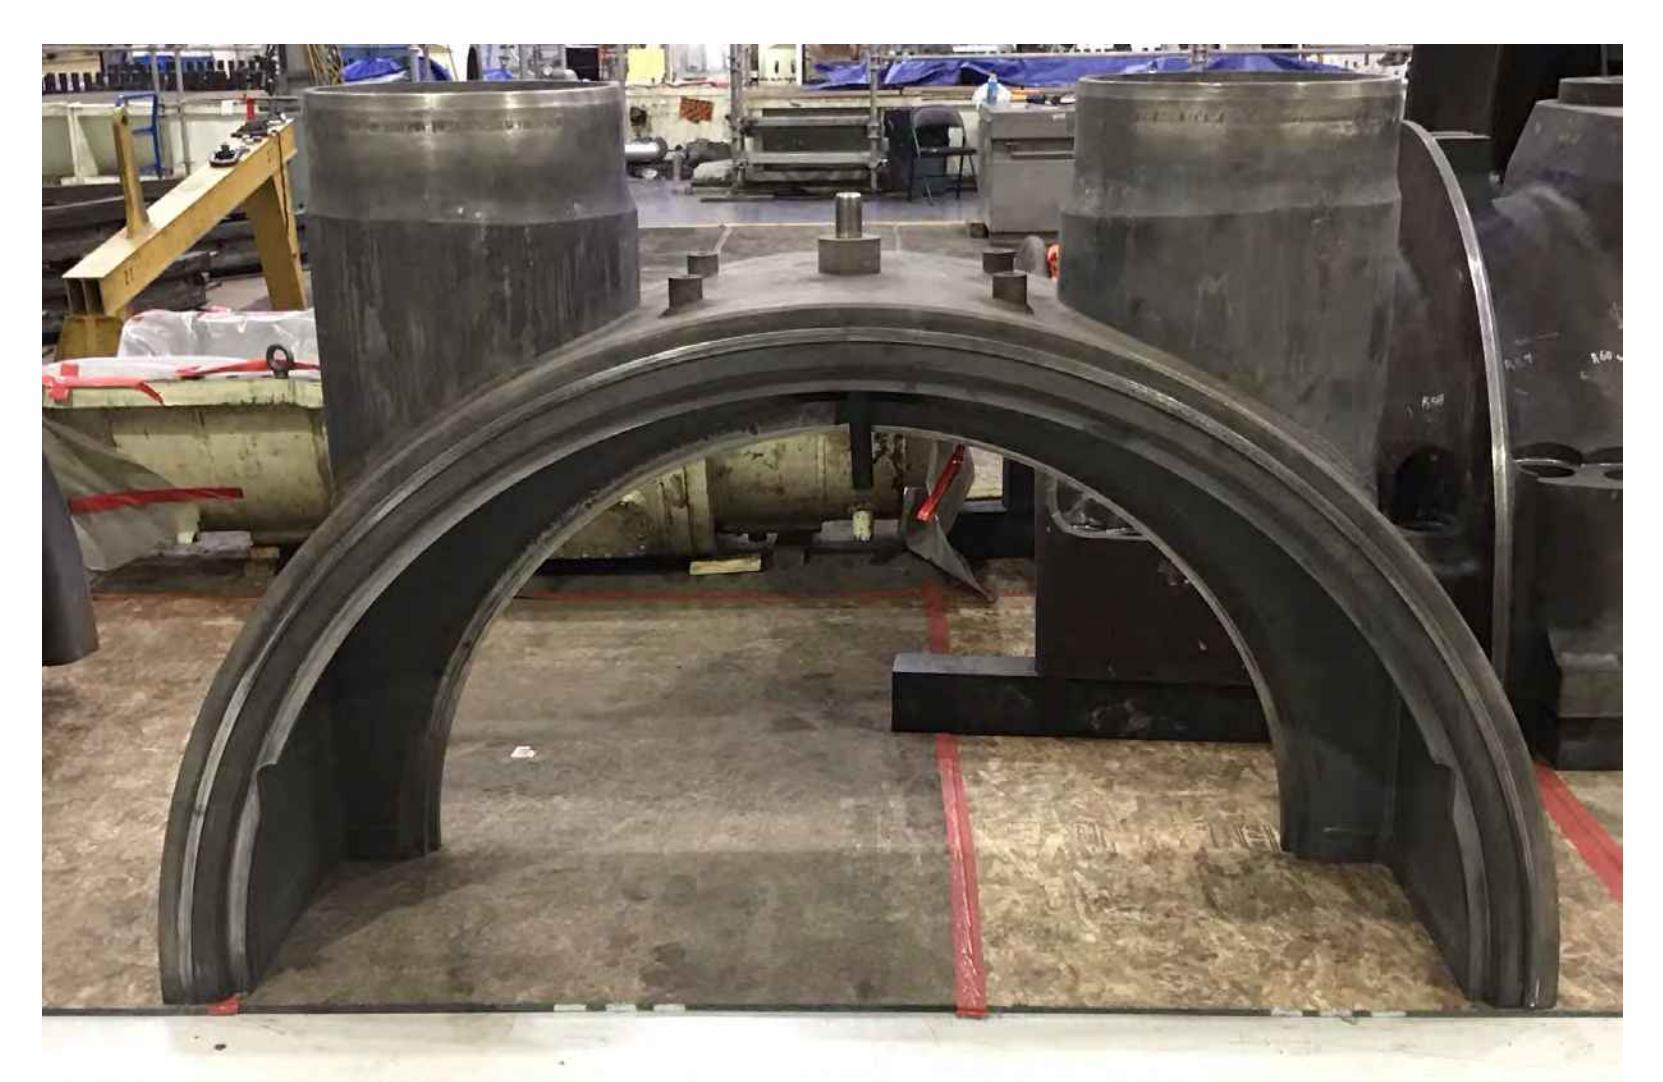
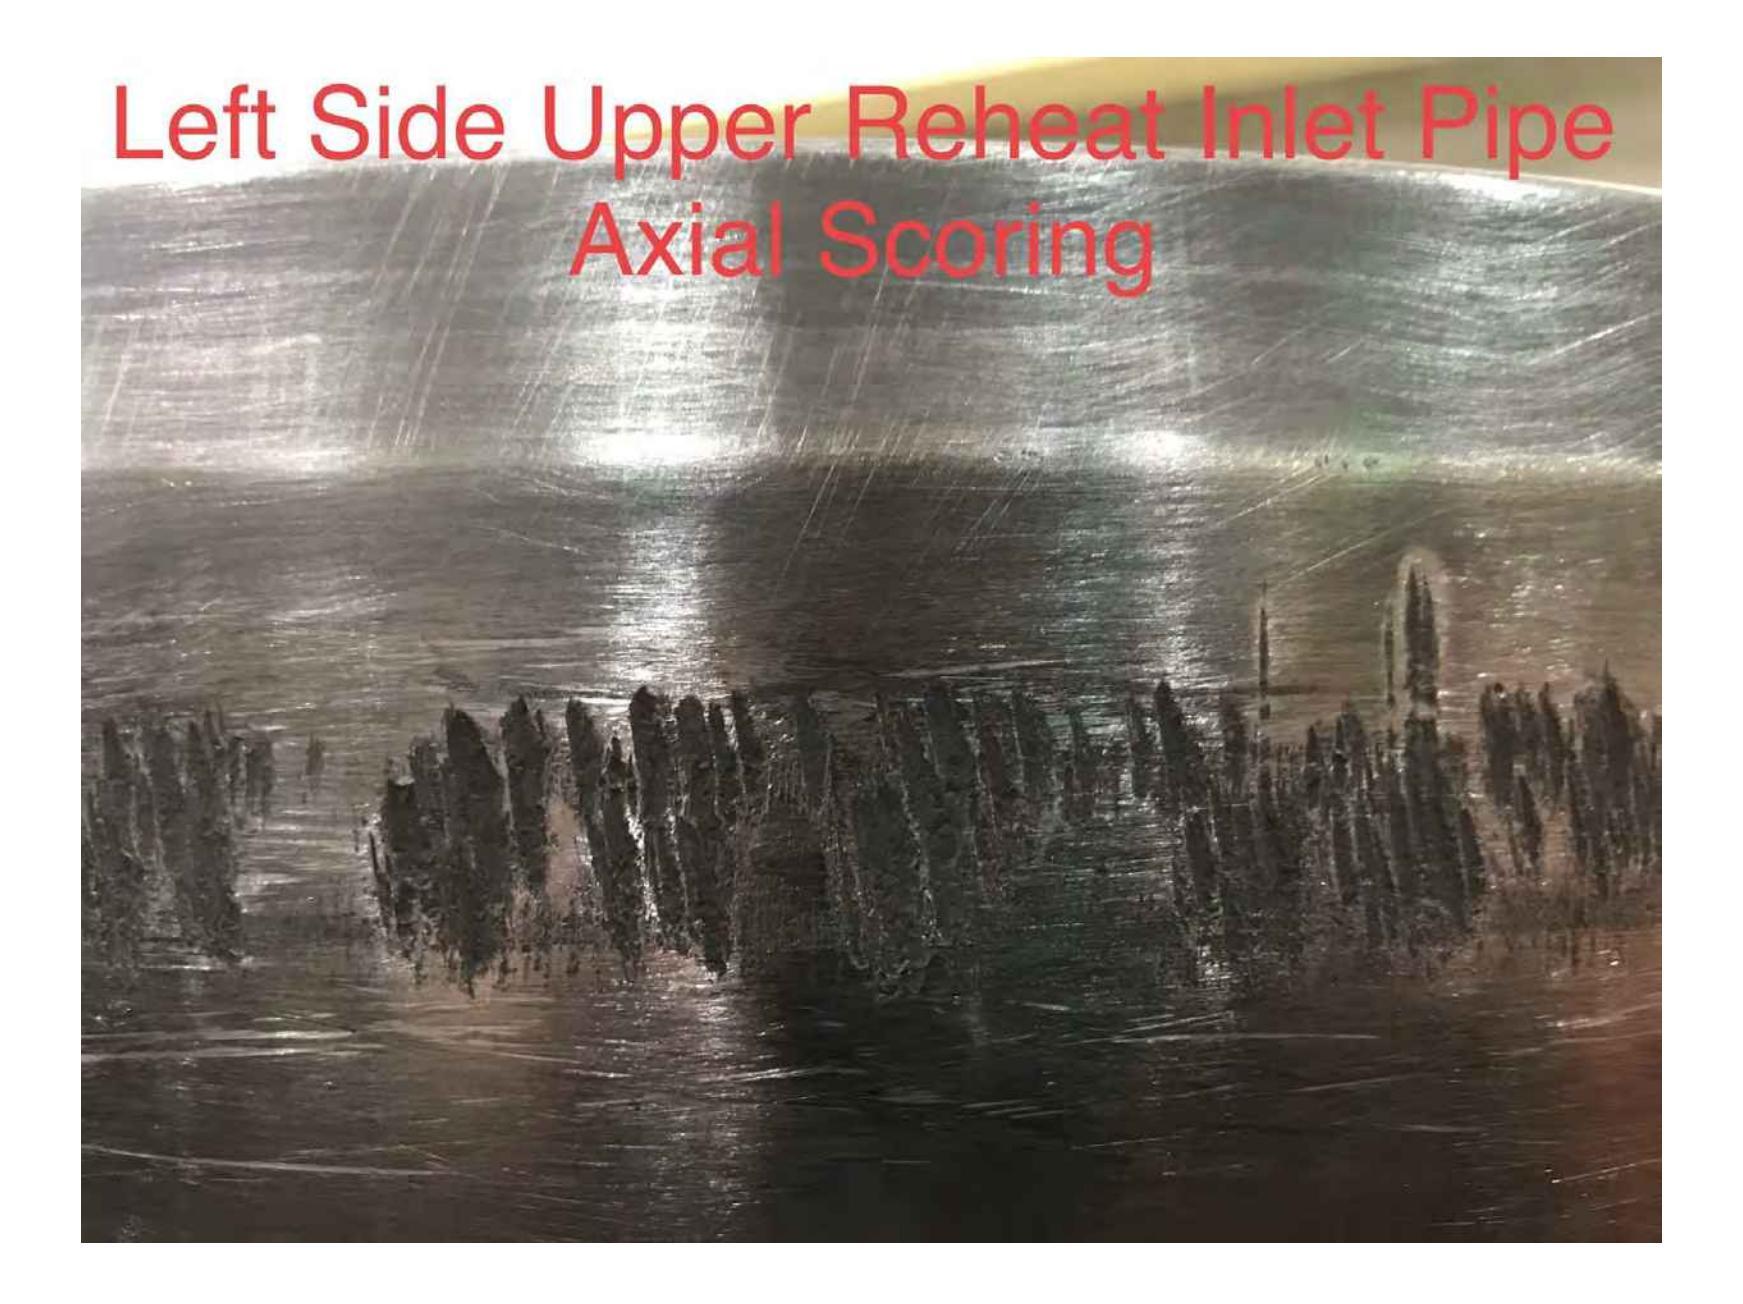
Reheat Steam Inlet Pictures

Deep axial scoring was found on all of the inlet casing pipes. Both the rings and pipes were found to be extremely out of round with excessive clearances. The average radial clearances measured were found to be in excess 0f 0.075". The rings and pipes were all found to be out of round. The exact departure from design clearance could not be determined since no OEM drawing could be found that specify design clearances. The customer PMI'ed the casing and found it to be 304 SS.

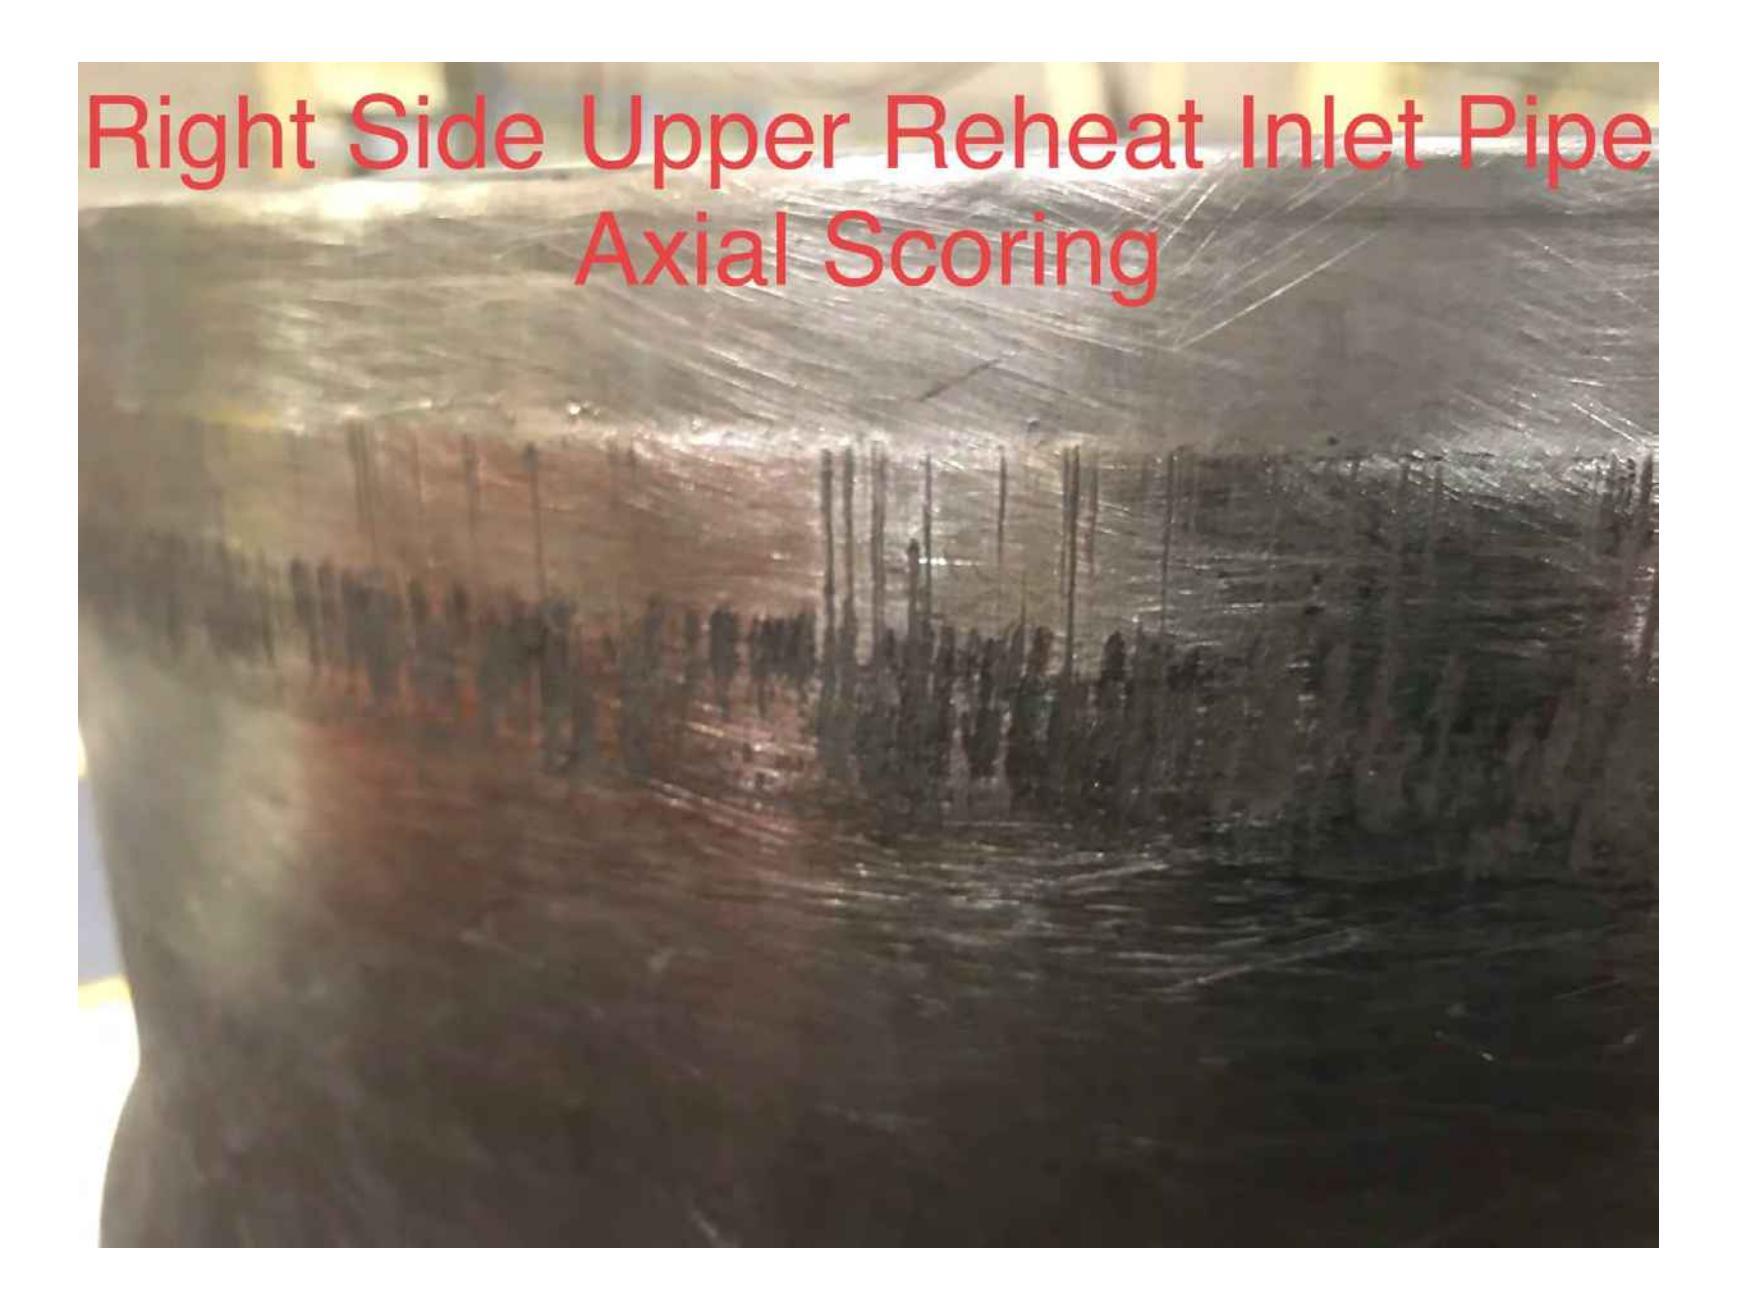
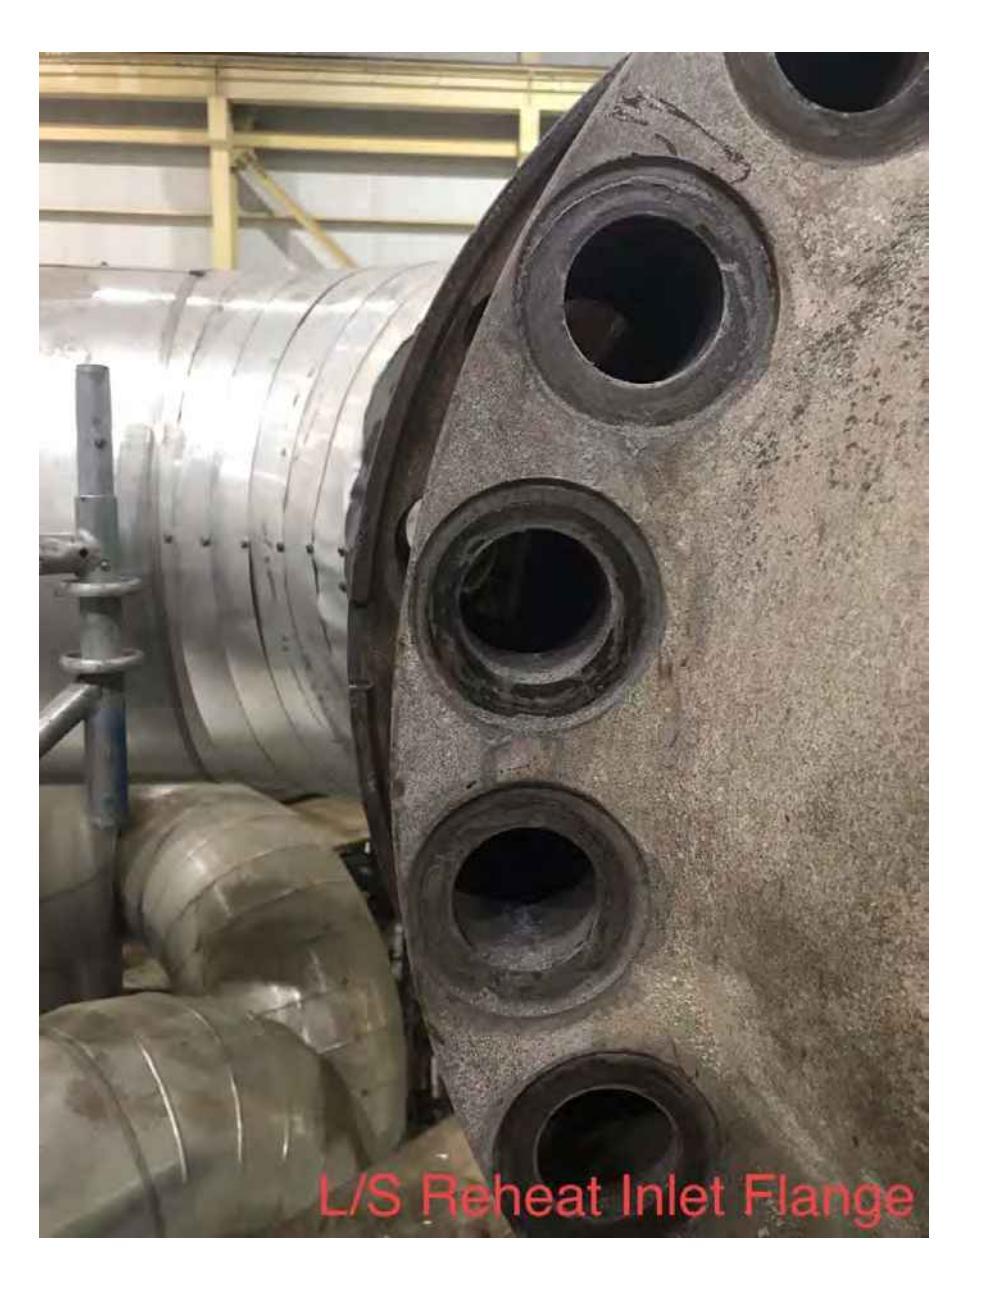
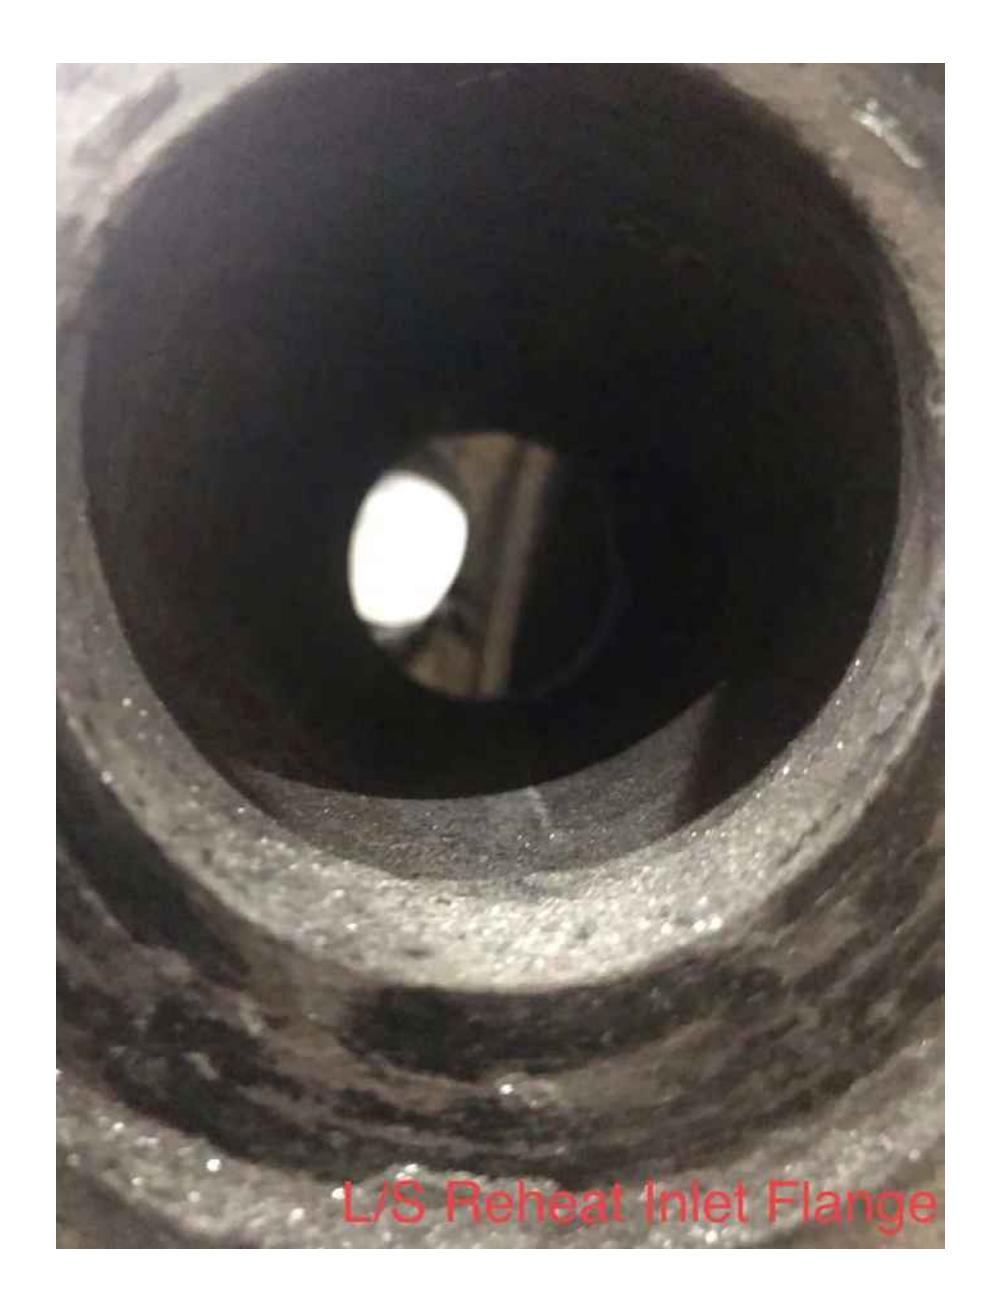
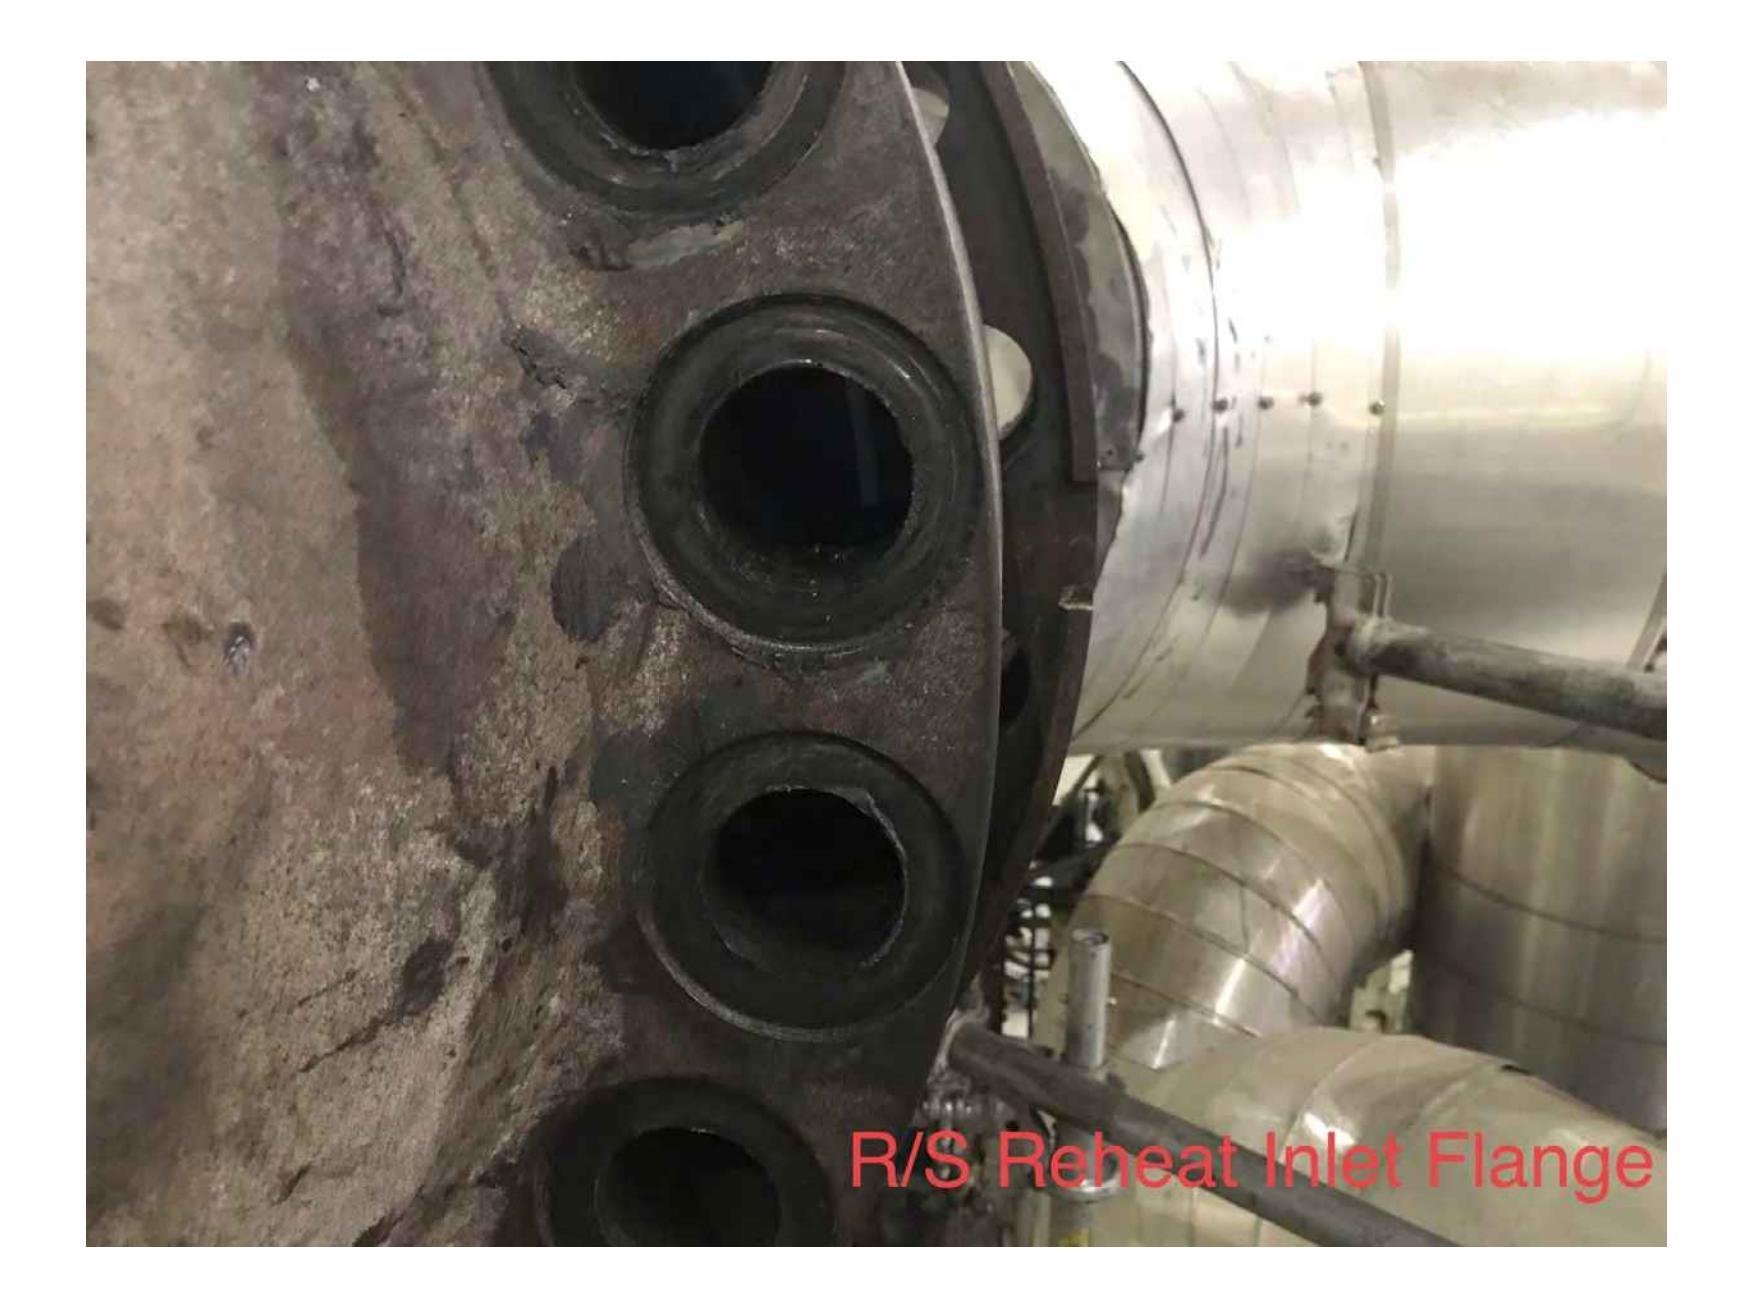
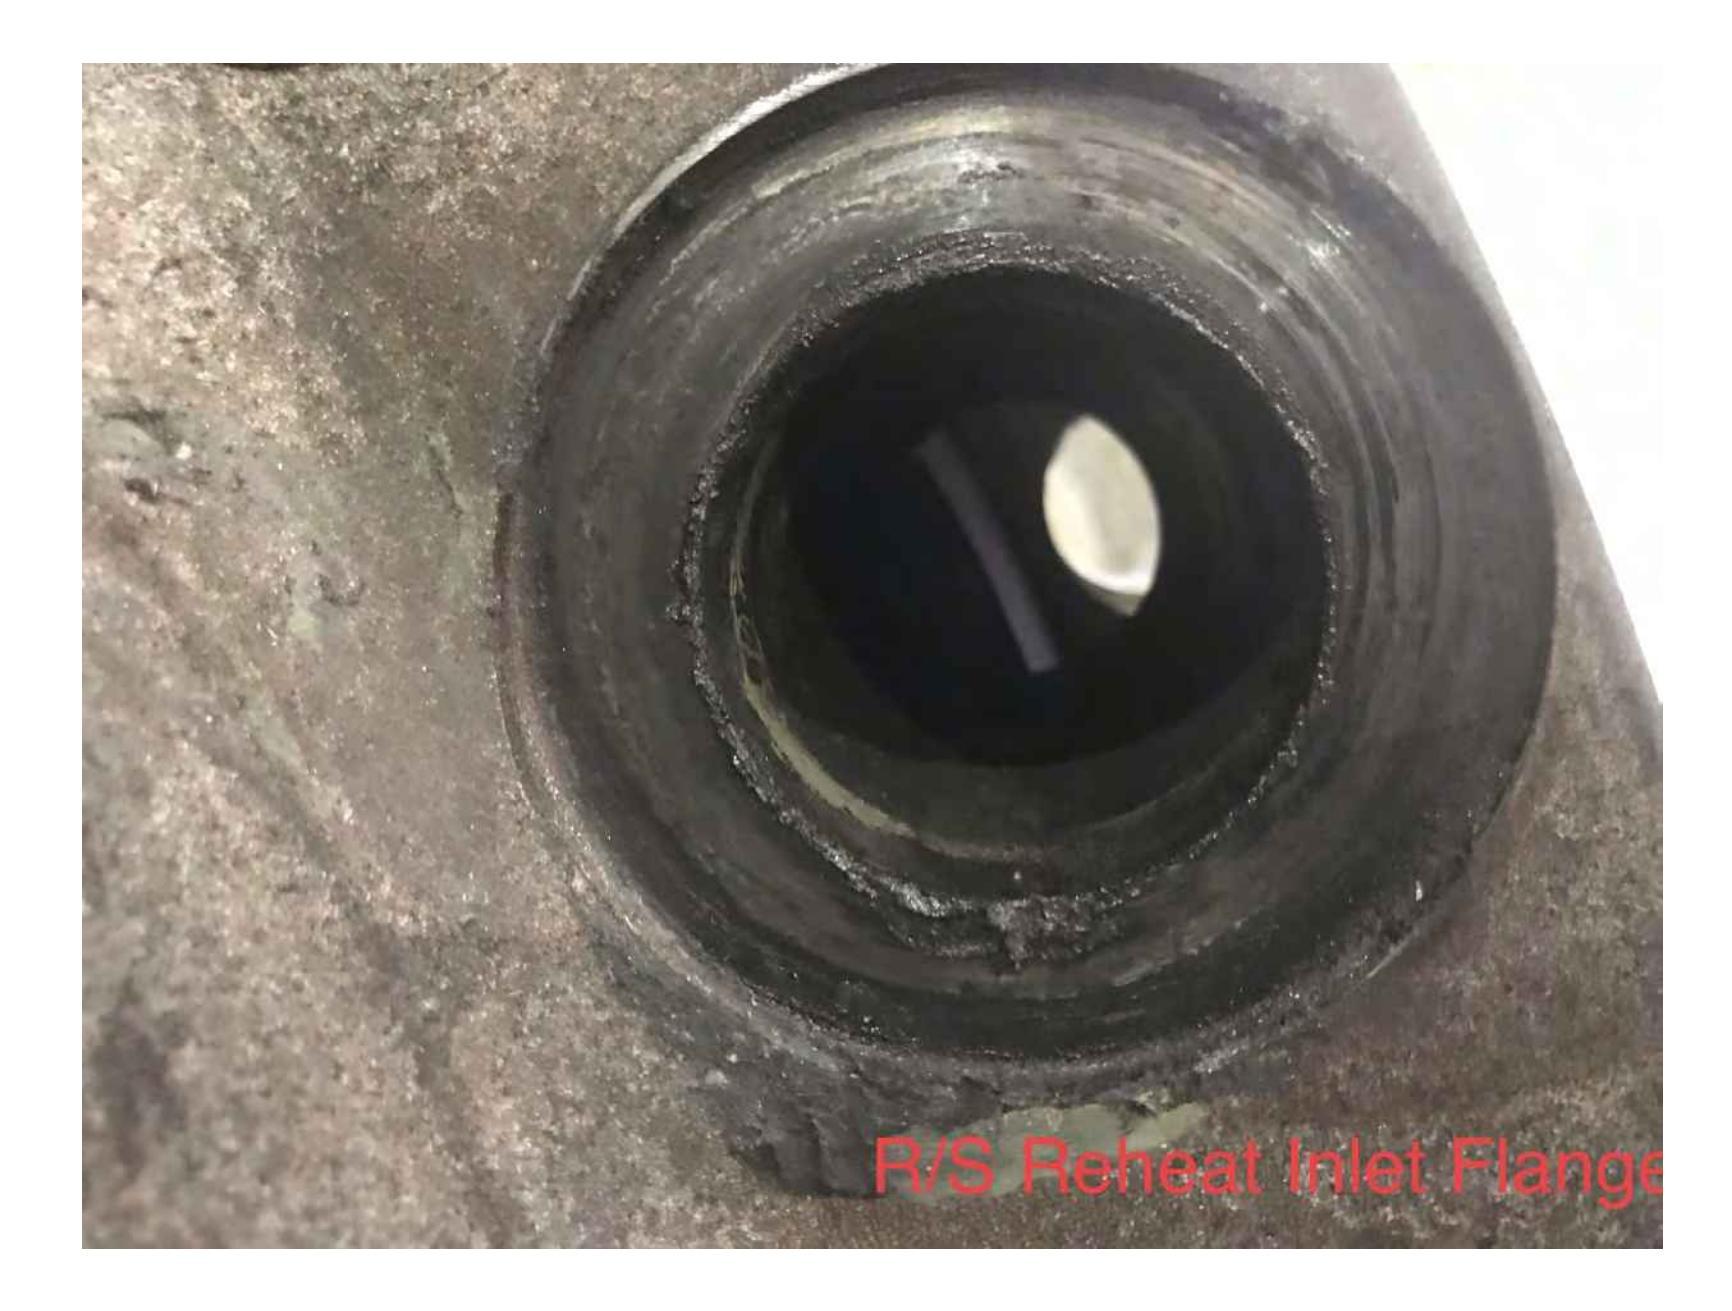
Reheat Inlet Flange Alignment

The inlet flanges were found to be considerably indexed to one another. The right side flange was found to be off approximately half of a bolt hole. A great deal of effort was required align the flanges well enough to remove and reinstall the bolting.

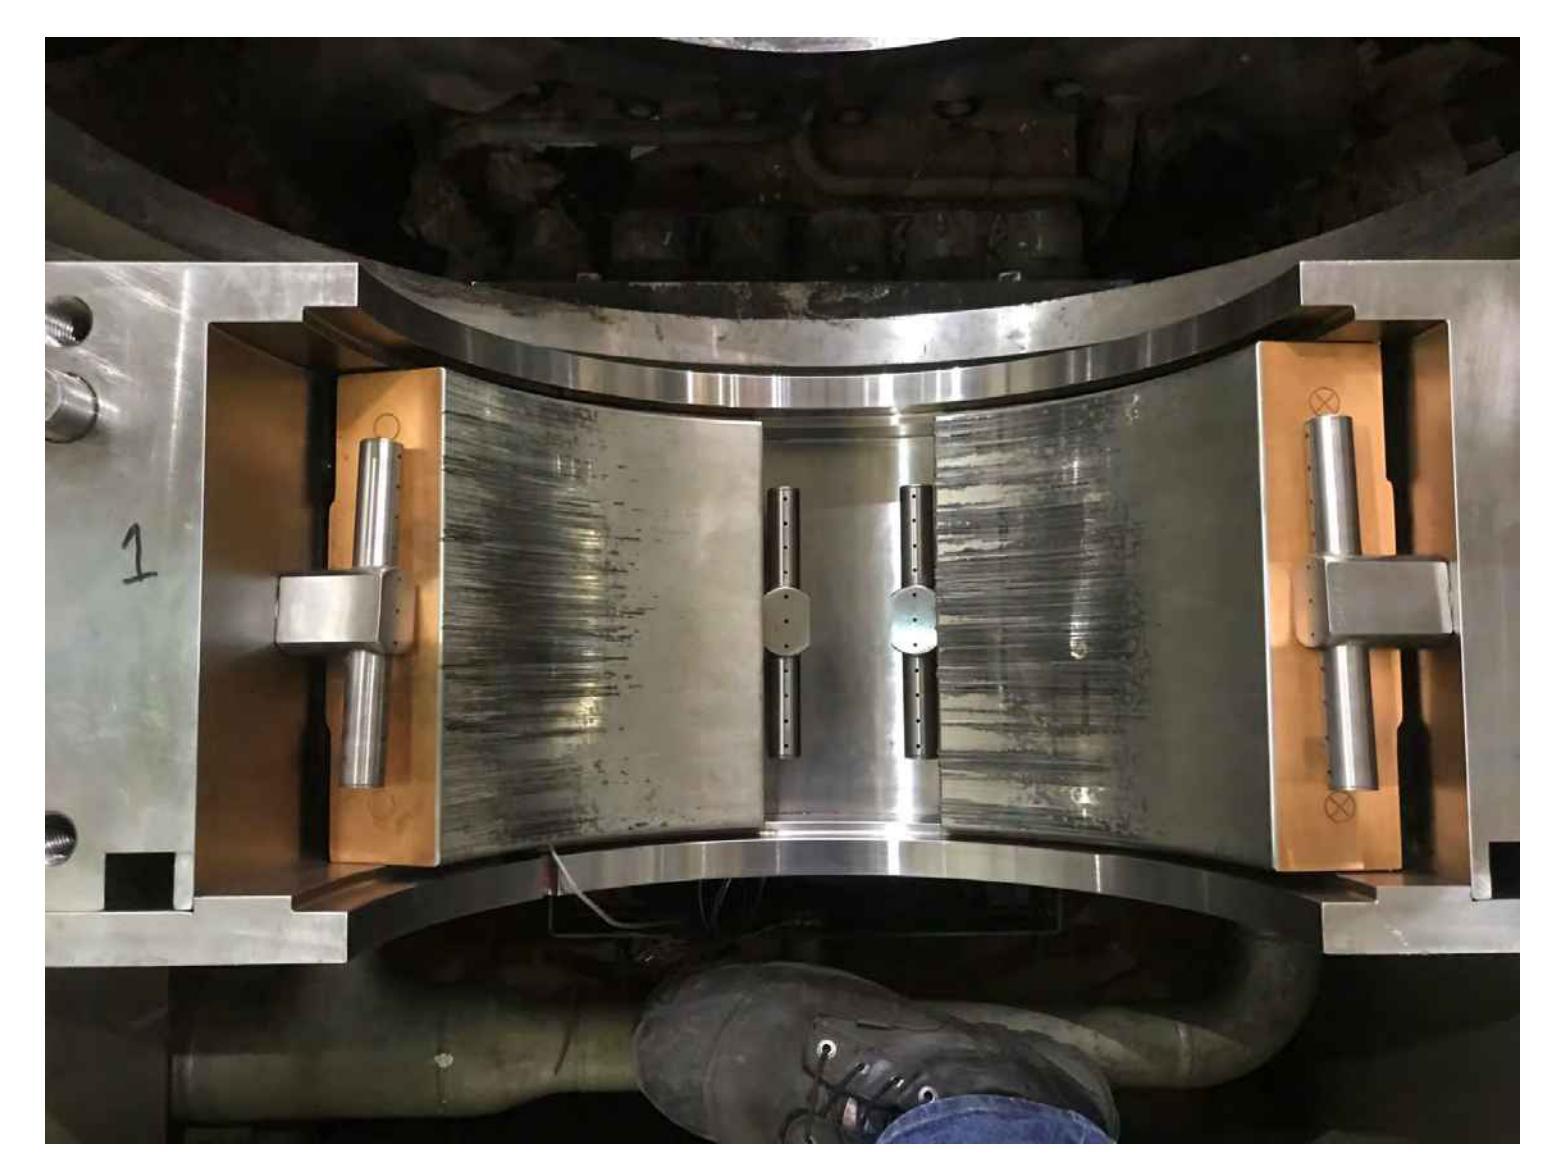
Bearings #1 and #2 were found with significant scoring from hard particle emission in the lube oil supply. Ultrasonic and dye penetrant inspections did not indicate any areas of disbond. One of the top pads of the #2 bearing had an area of porosity on the corner. This area of porosity had been found during the first year warranty inspection and does not appear to be getting worse. Scoring was found on the #6 bearing lower half pads. All other bearings were found to be in good condition.

#1 Bearing Lower Half – At Assembly

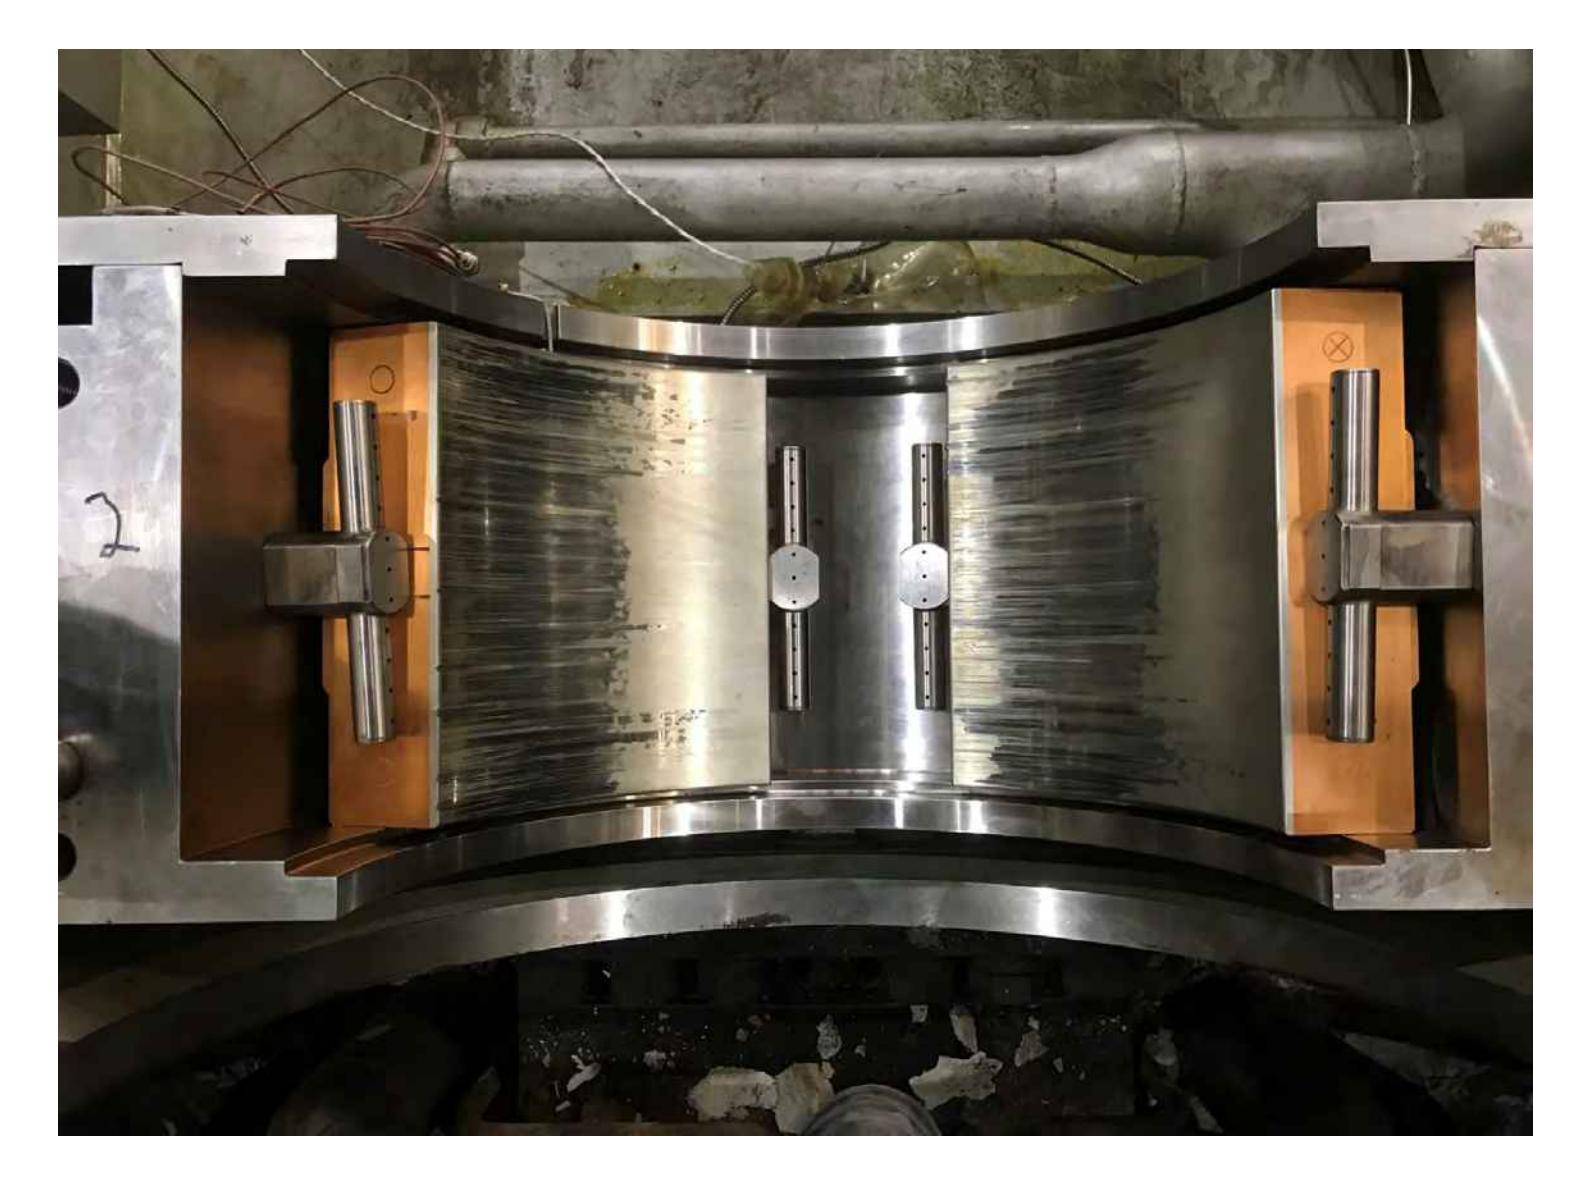
#2 Bearing Lower Half – At Assembly

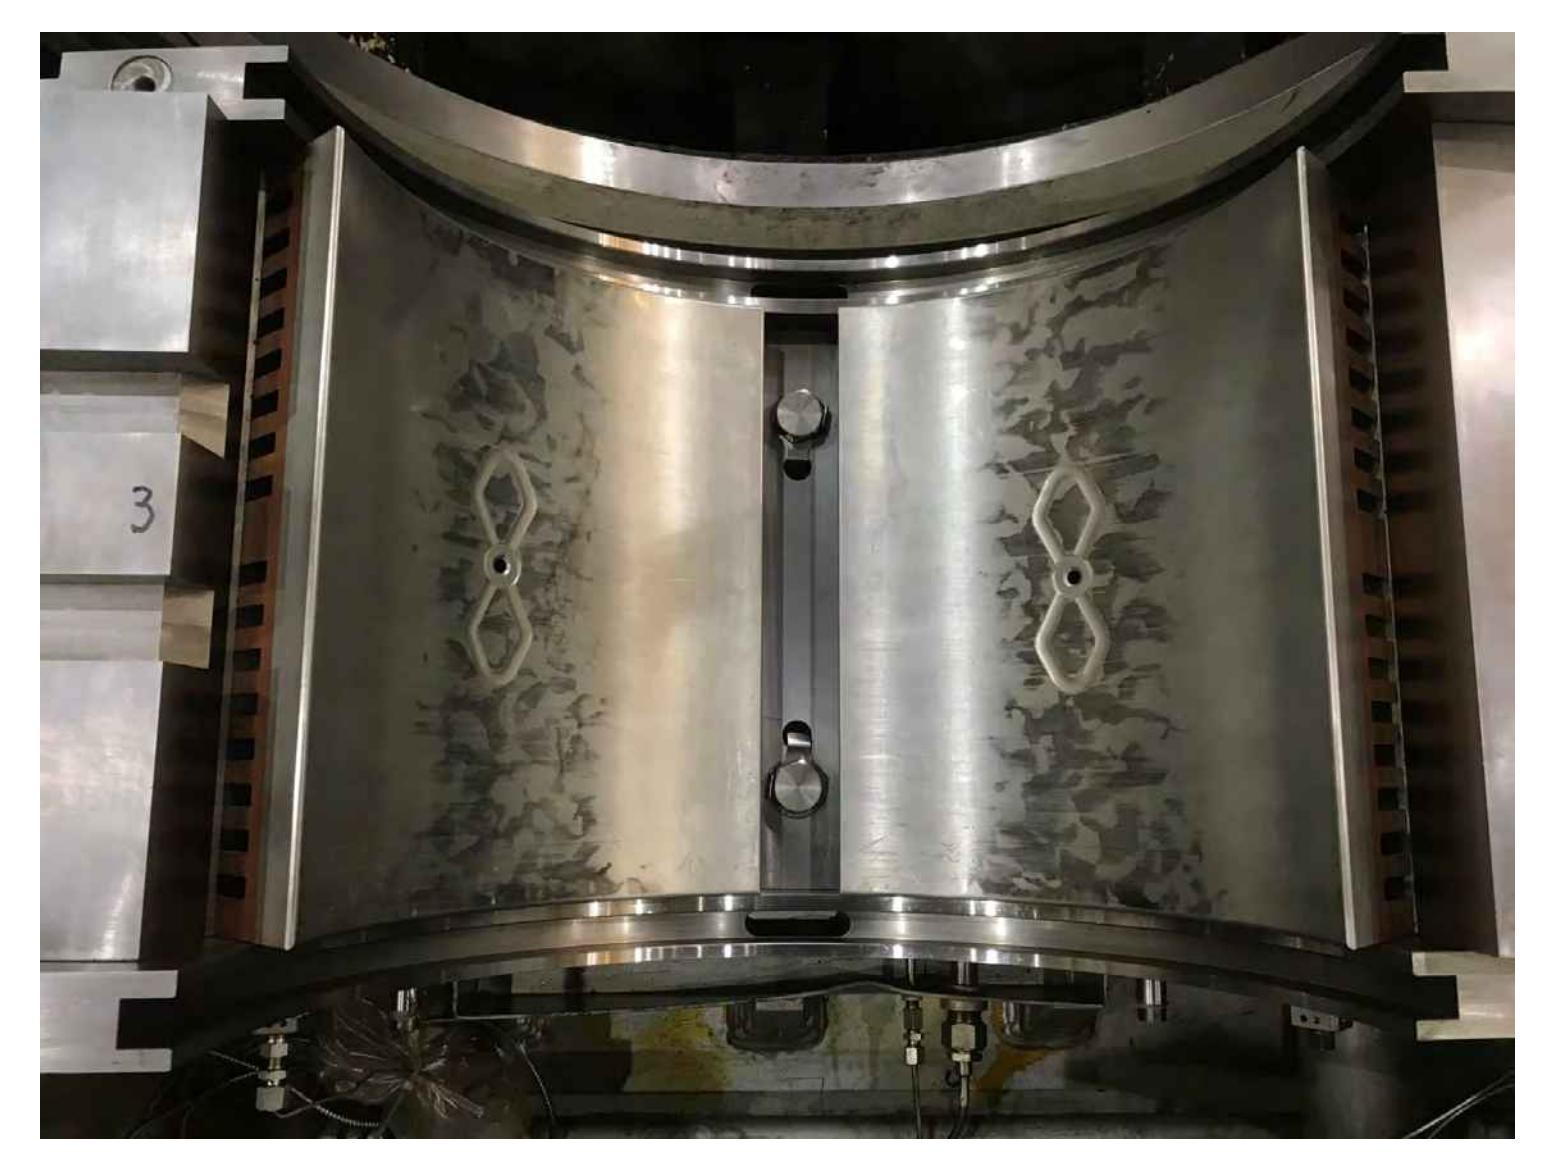
#3 Bearing Lower Half – At Assembly
