Comanche Unit 3 -Spring 2020 Outage

Full Train Major, Main Steam Valves & Generator

COMANCHE (CO) Steam Turbine ESN: SY0093272 Generator ESN: SY0350139 Job Start Date: 13 Jan 2020 Oracle Project ID: FSP-285469 | C-10344497

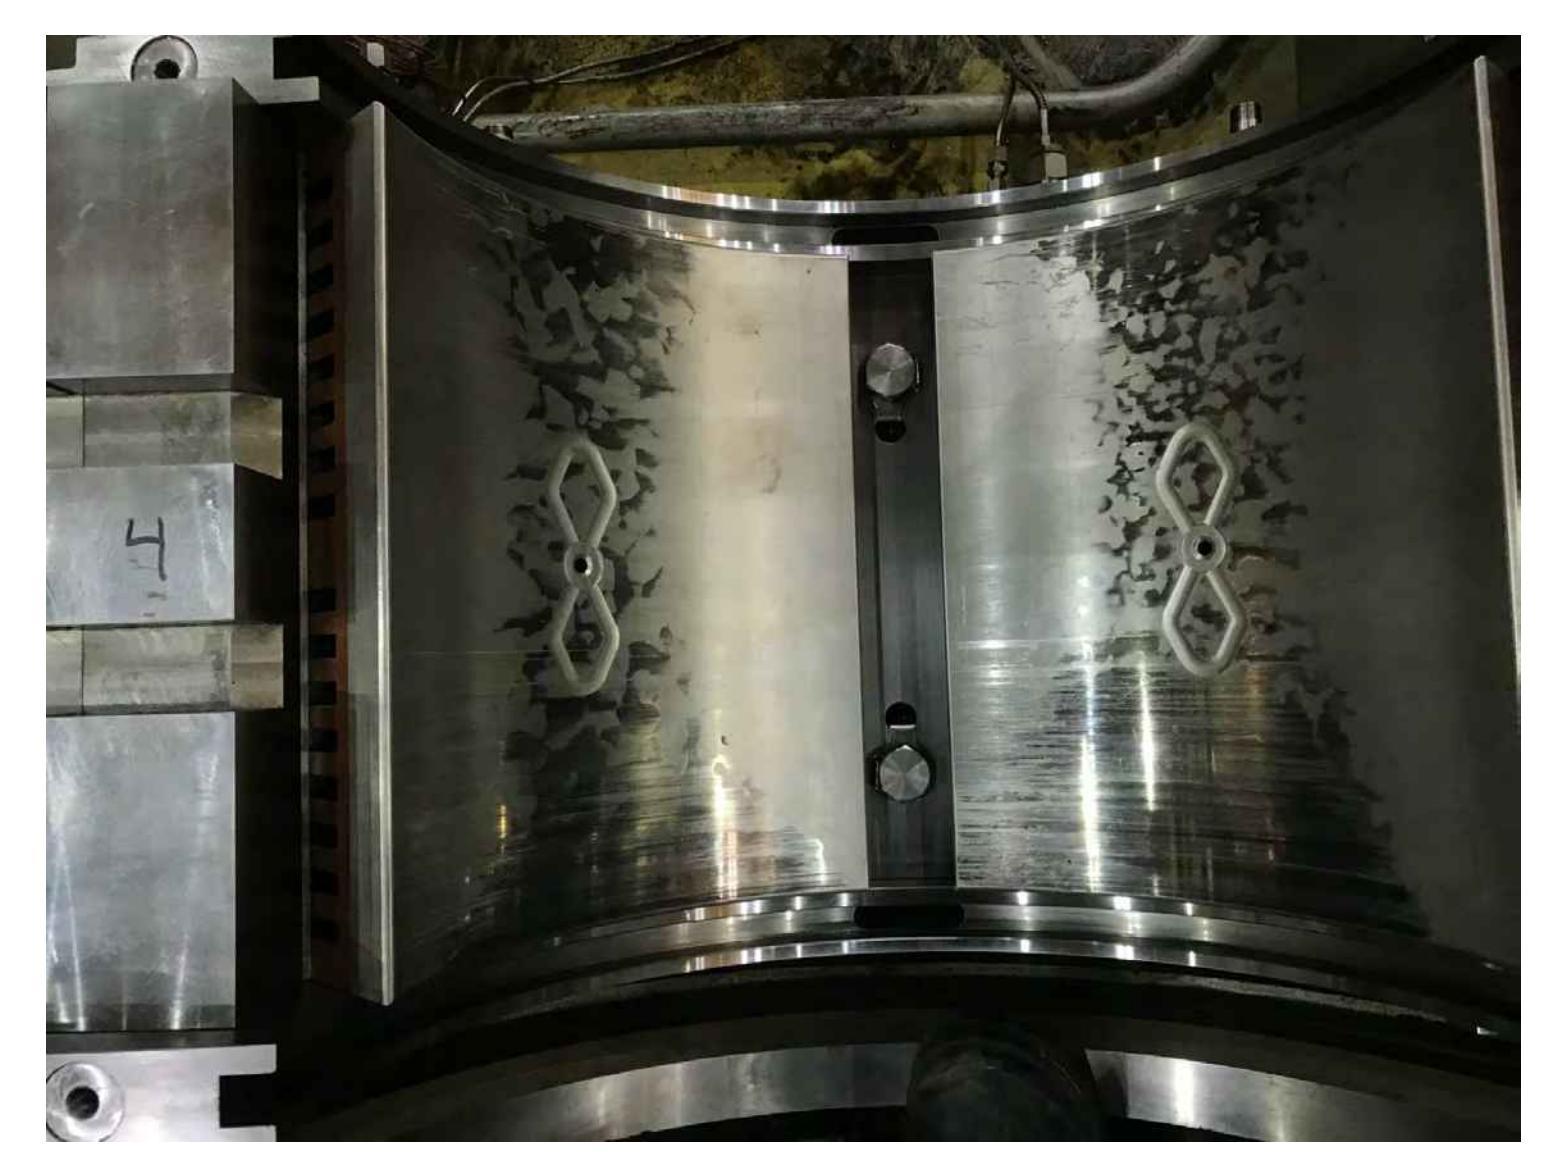
#4 Bearing Lower Half – At Assembly

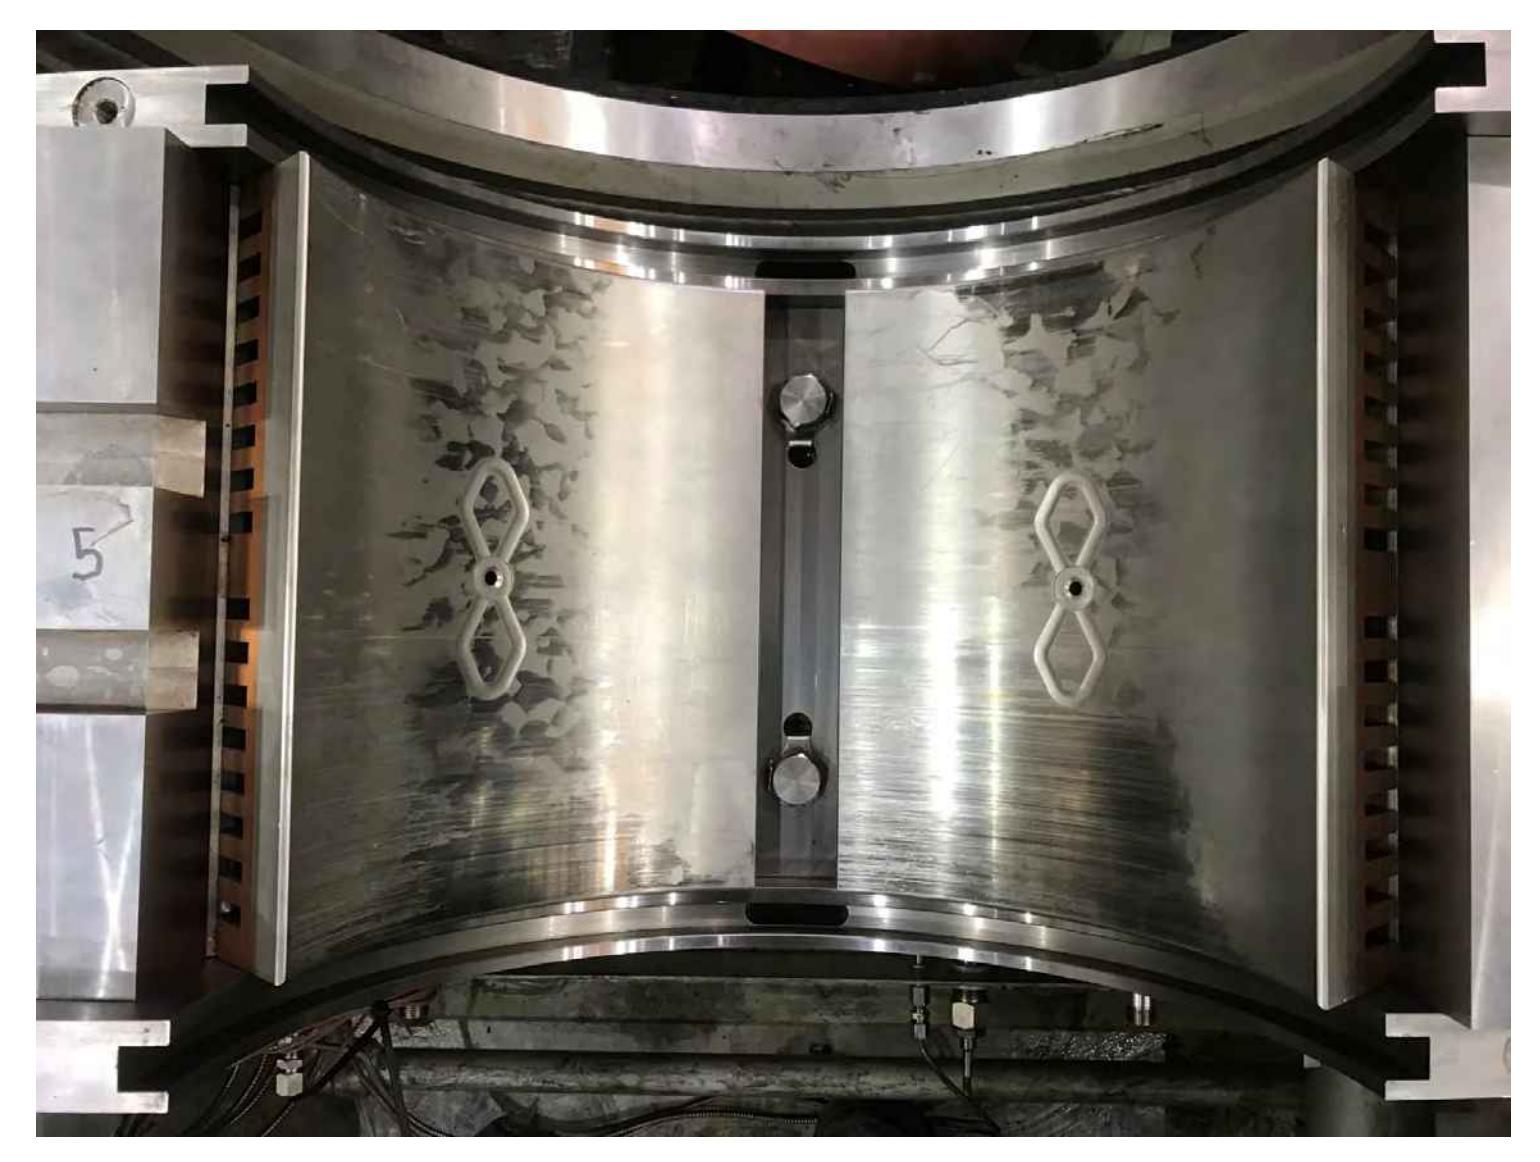
#5 Bearing Lower Half – At Assembly

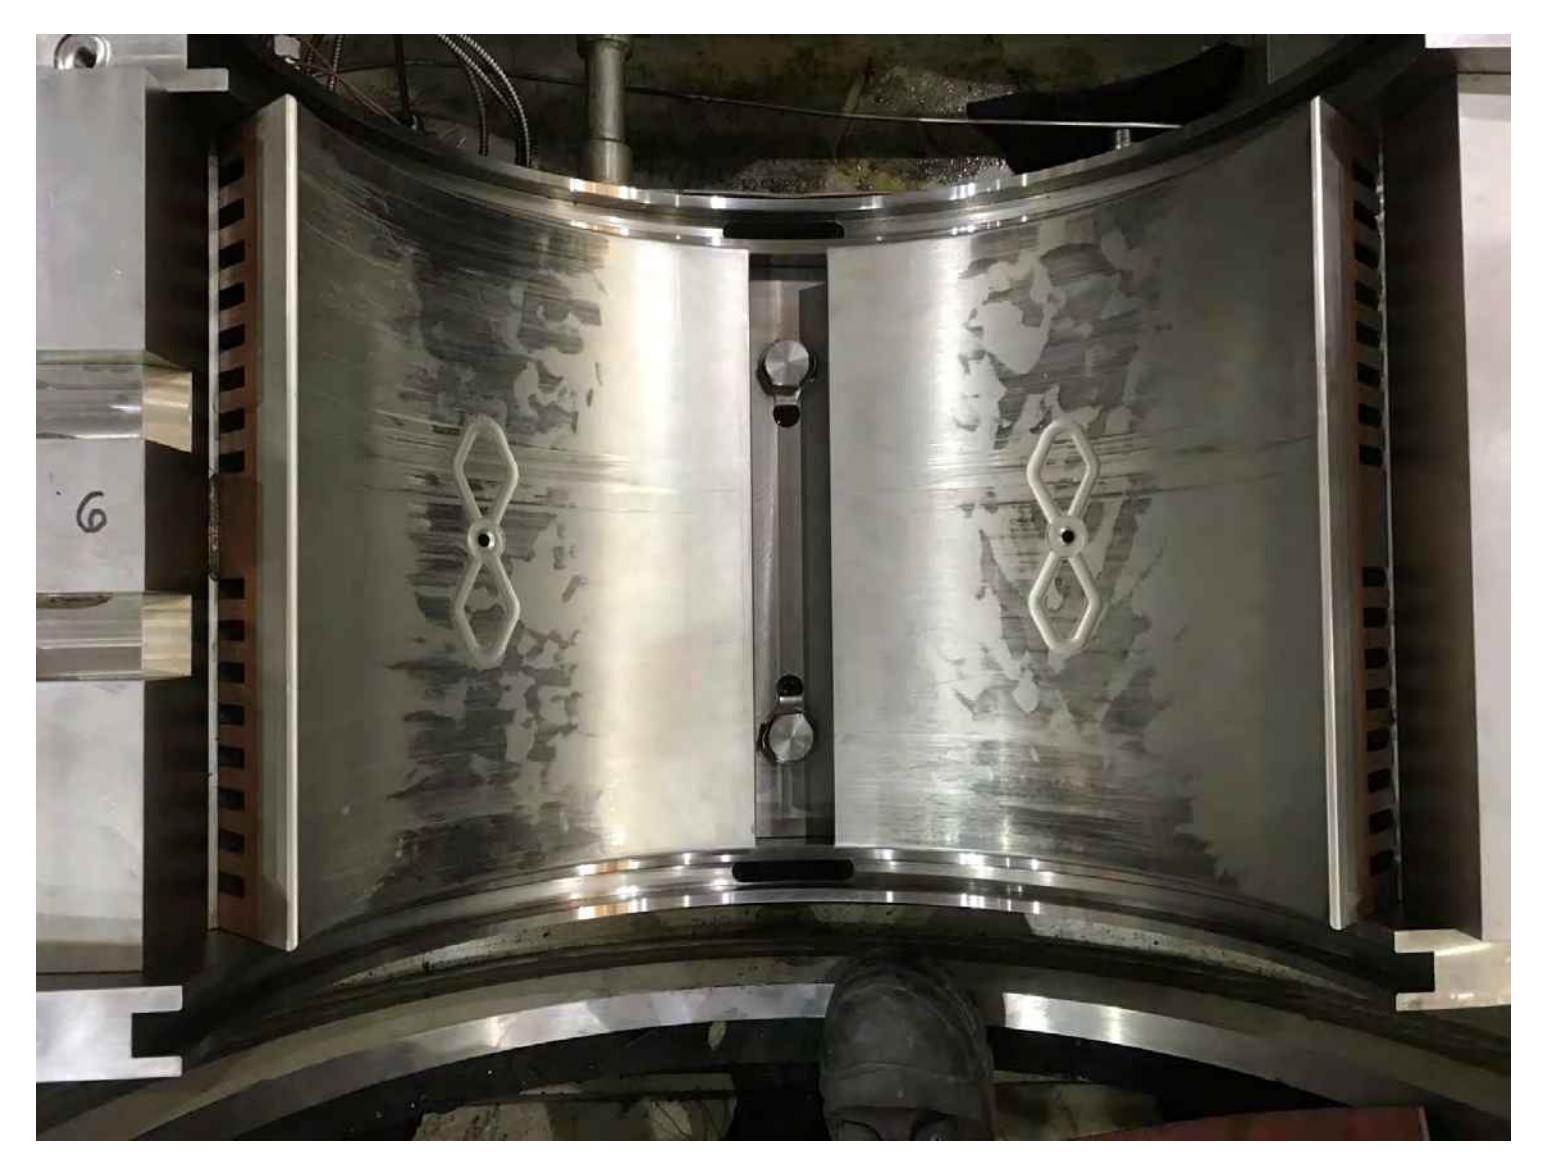
#6 Bearing Lower Half – At Assembly

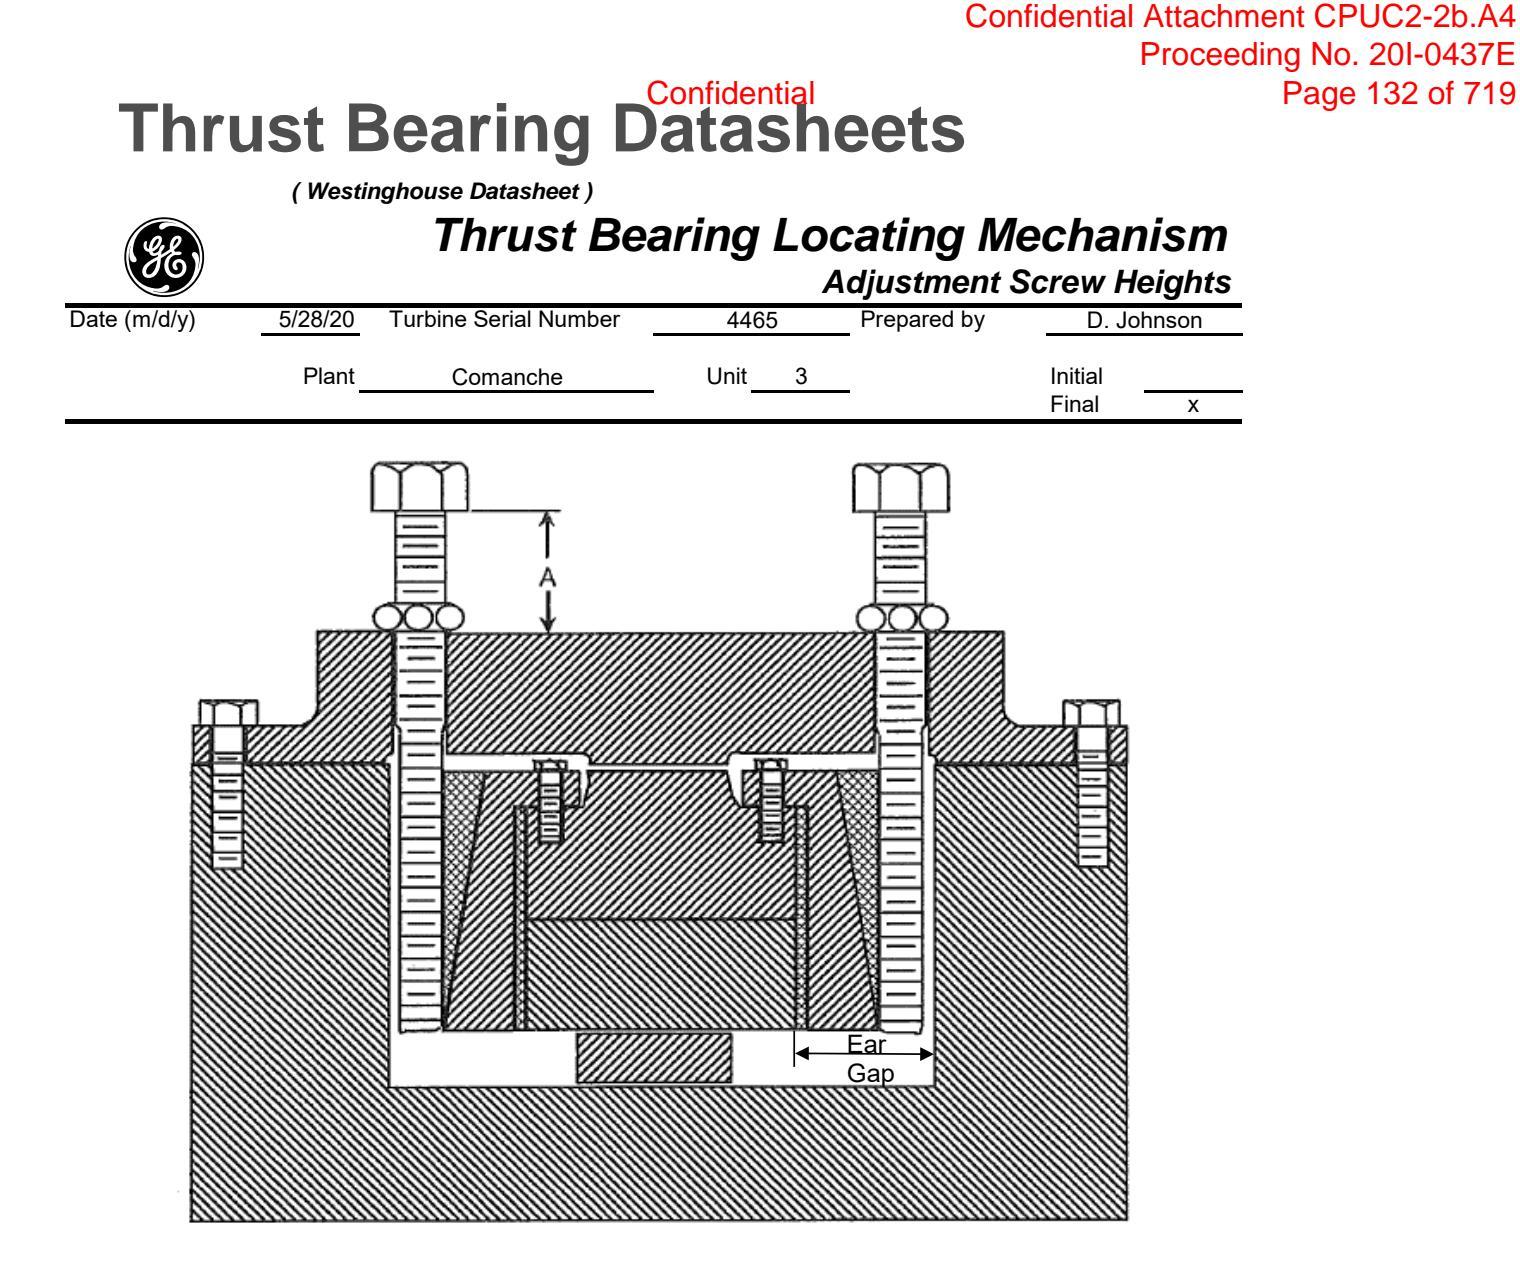
Screw Height A	Ear Gap	Shim Thickness
Right	Gov End	3-11/64"	3.124	0.242
Side	Gen End	1-7/32"	3.181	0.146
Left	Gov End	3-1/2"	3.128	0.244
Side	Gen End	1-59/64"	3.176	0.133

The screw heights of the thrust bearing locating mechanism should be adjusted so to maximize the available axial adjustment. This can be achieved by changing the thicknesses of the "ear" shims.

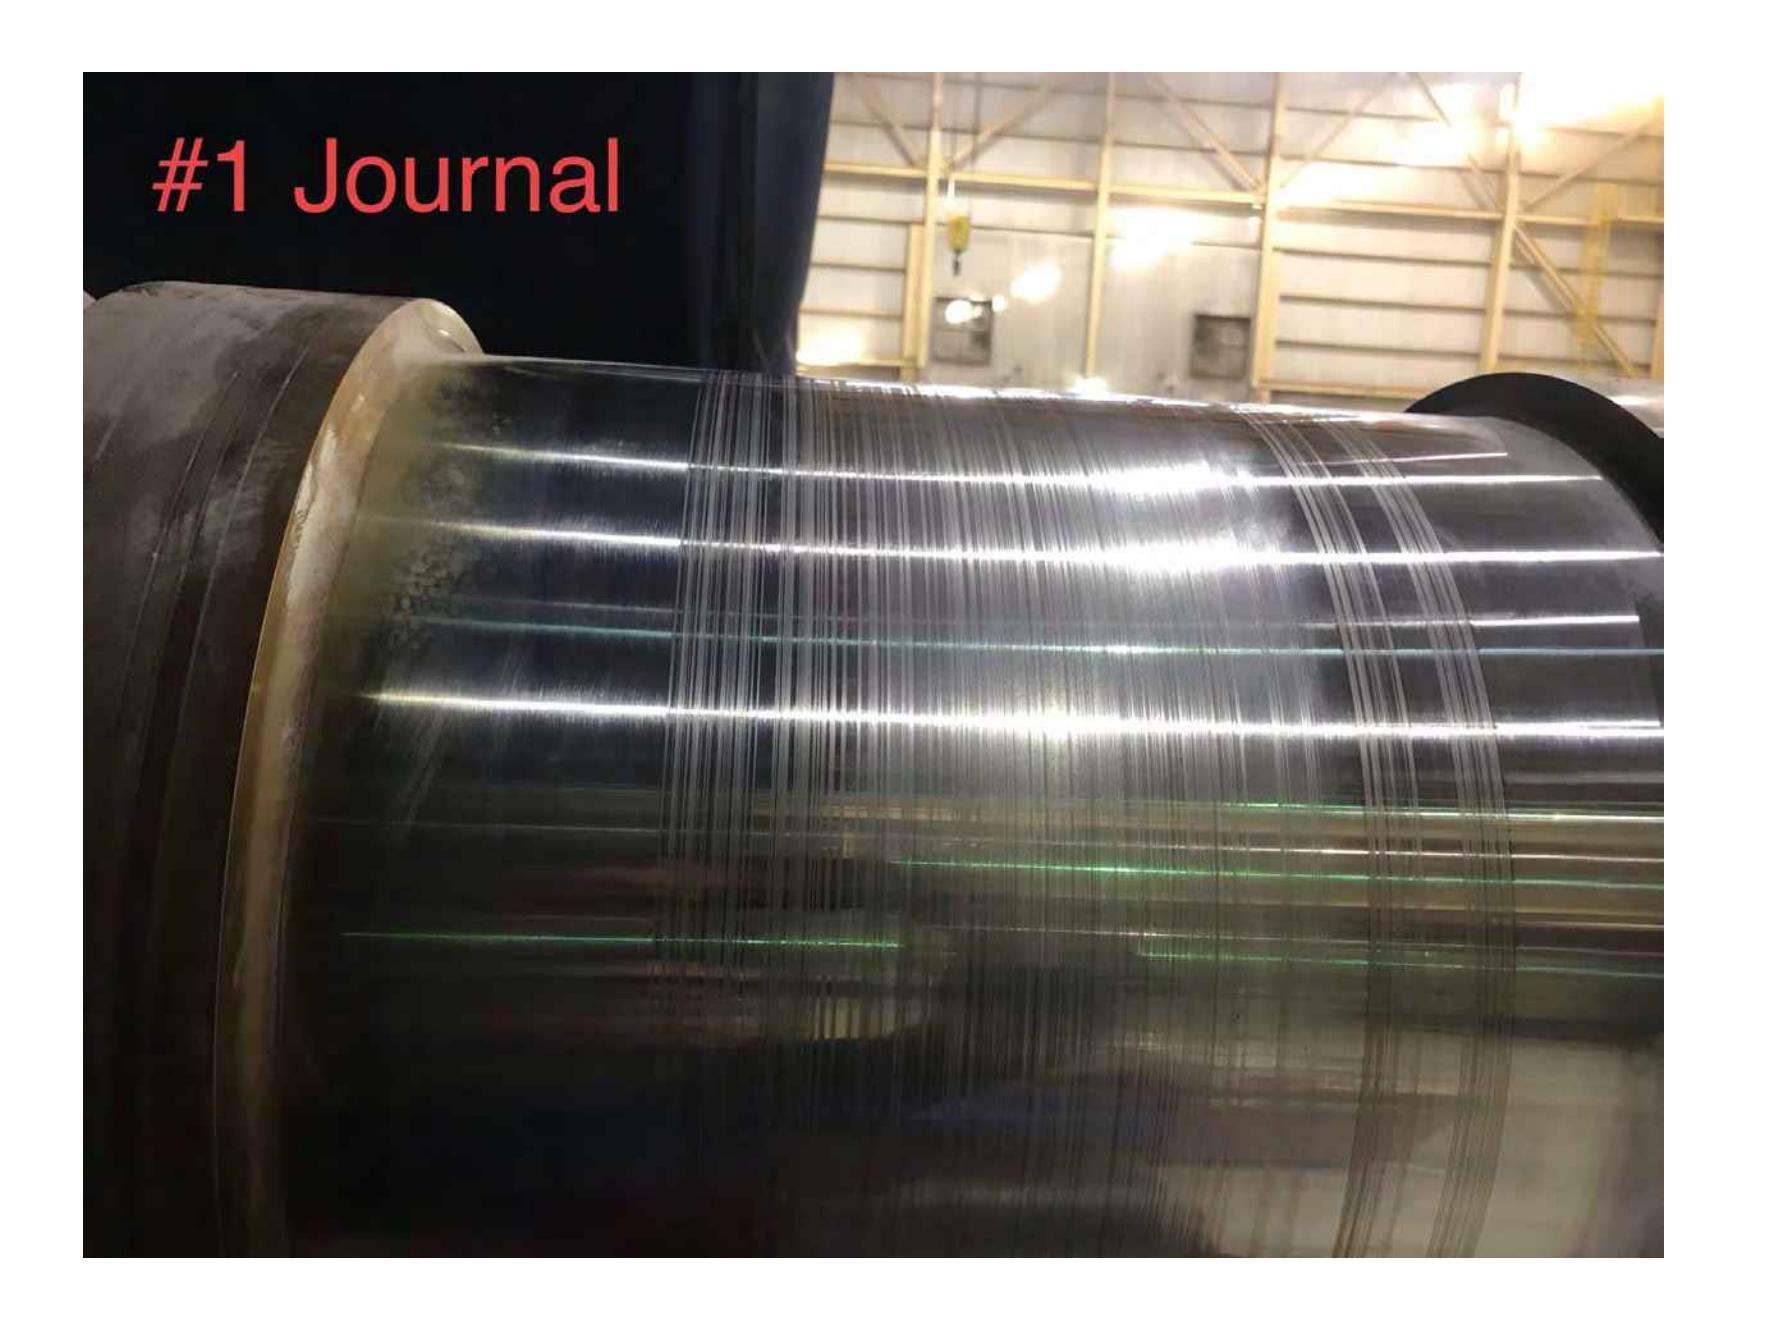
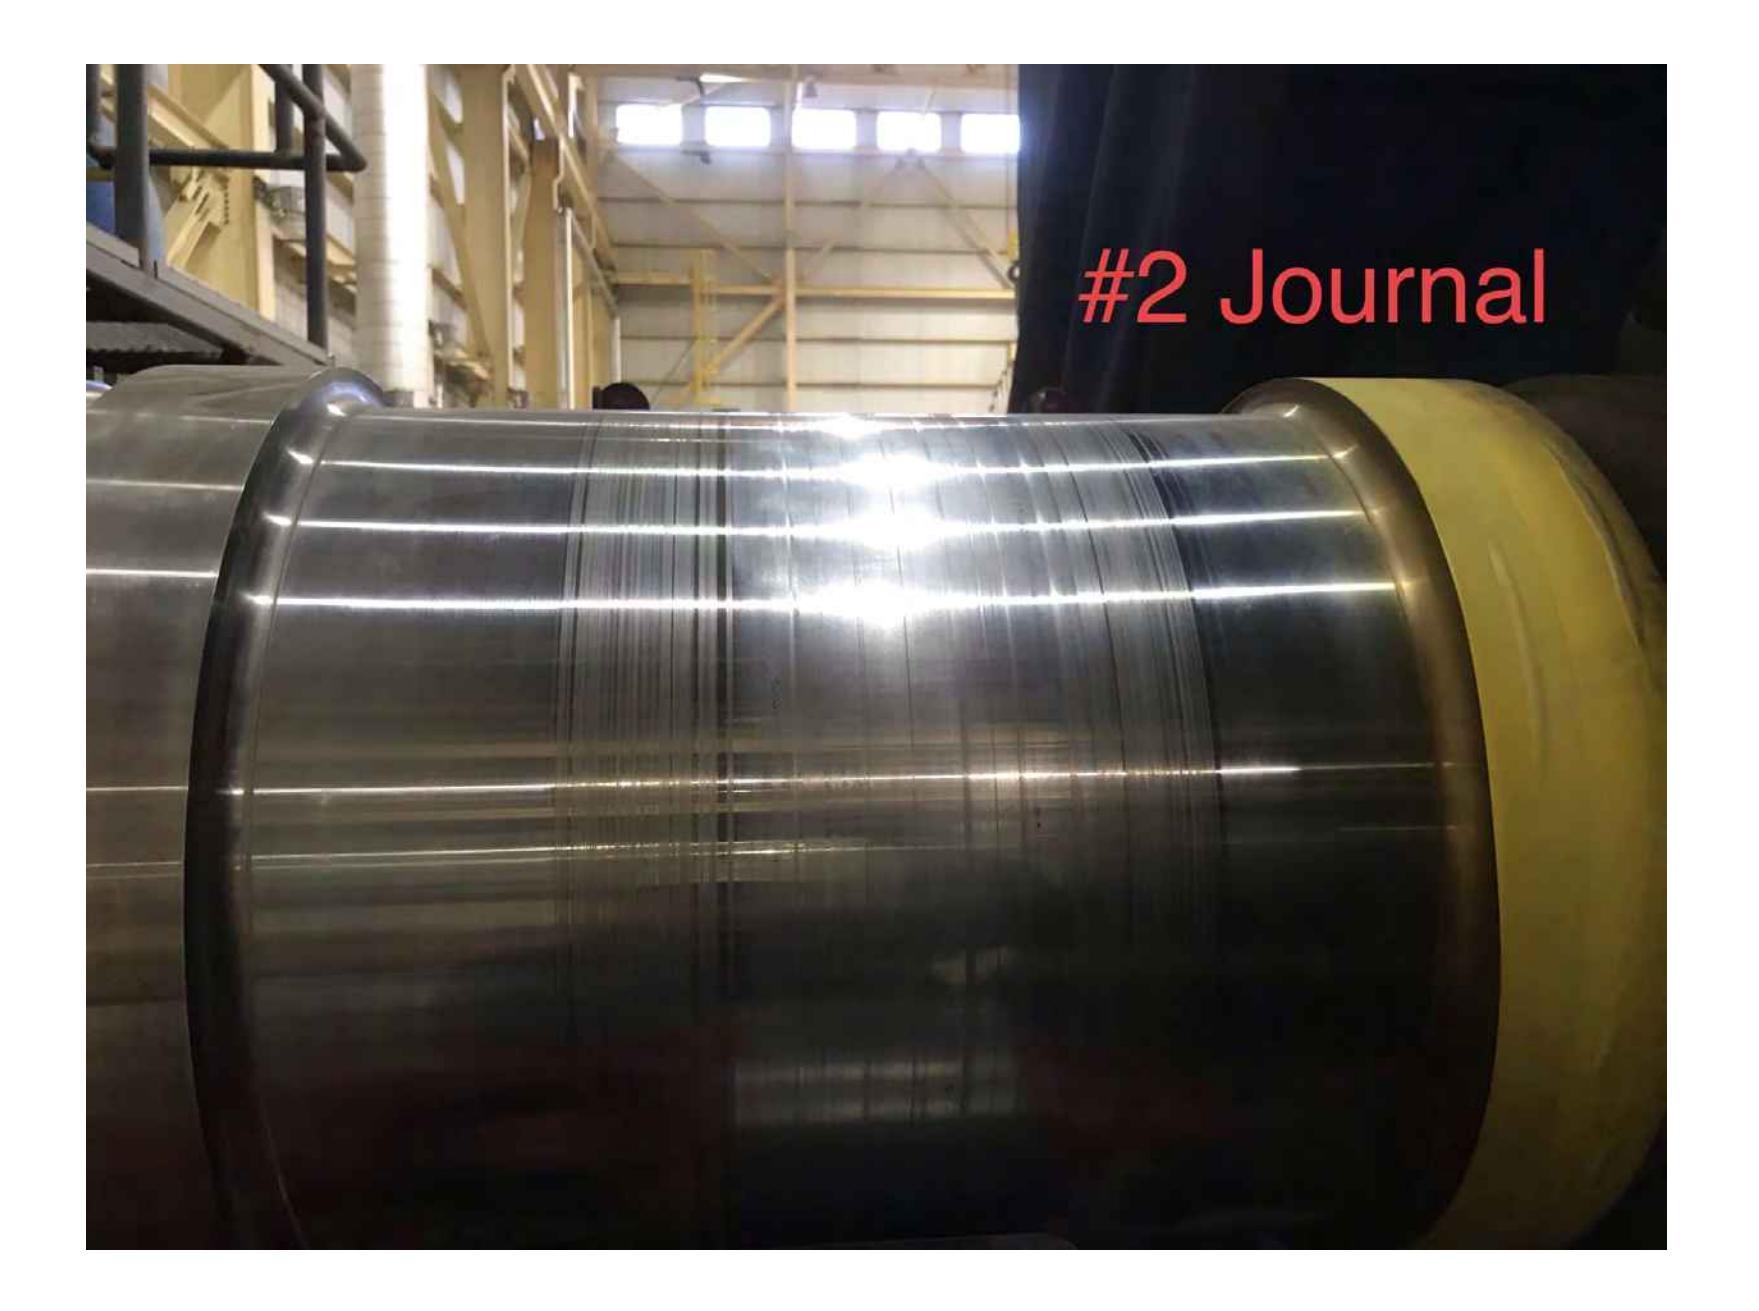
Journal Pictures

Each of the rotors have two journals that ride in babbited bearings. Once the rotors were removed the journals were cleaned and the outer diameters were measured. Some minor scoring was found on the HP-IP rotor at journals #1 and #2. At reassembly, the journals were strap lapped with 220 grit emery paper to remove surface imperfections.

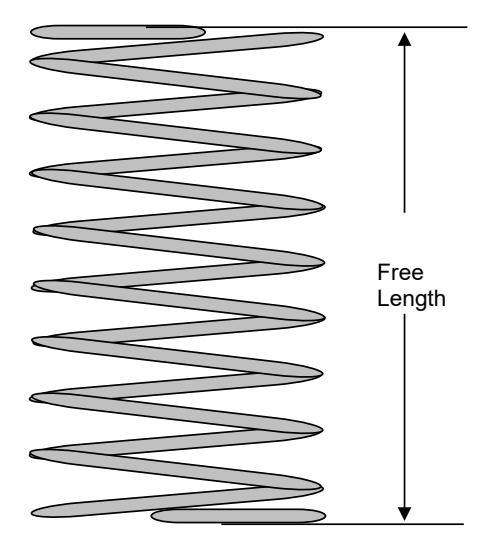
(Westinghouse Datasheet) Throttle Valve Spring Dimensions

At disassembly the spring pilot spring compression was measured. The left side valve was found to have zero spring compression. Further disassembly revealed that the spring seat (item 10) of the left valve was seized in the valve stem. Efforts were made to free the spring seat from the left side valve stem, but, it could not be removed, and the entire stem spring pilot assembly was replaced(items 10,15 & 6). The runout of the right side stem was found to be beyond acceptable limit and it was replaced (item 6). The right side pilot valve was found eroded at disassembly and was replaced (item 8). The right side spring guide to main bushing contact was found to be unacceptable. It appears that the holes in the stem had steam cut the spring guide surface and the spring guide was replaced (item 20). The left side pilot valve nut peening lip was found to be in unacceptable condition for continued service and it was replaced (item 9). Both of the valve stem end plugs were replaced and machined to size for acceptable spring pilot travel (item 22). The spring pilot spring of the right side valve was replaced, since the spring found in service did not have the proper free length (item 15).

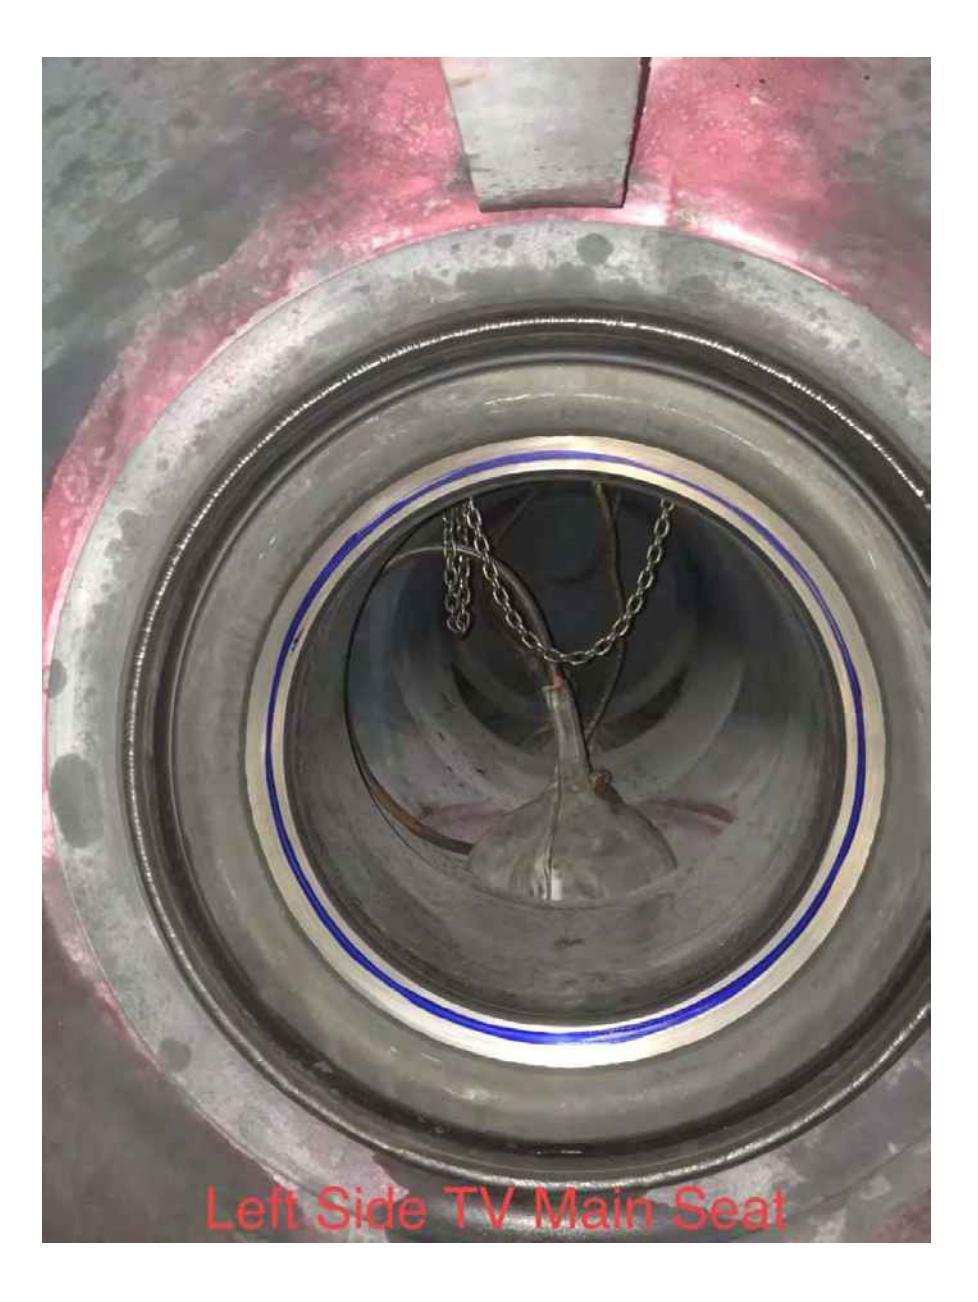
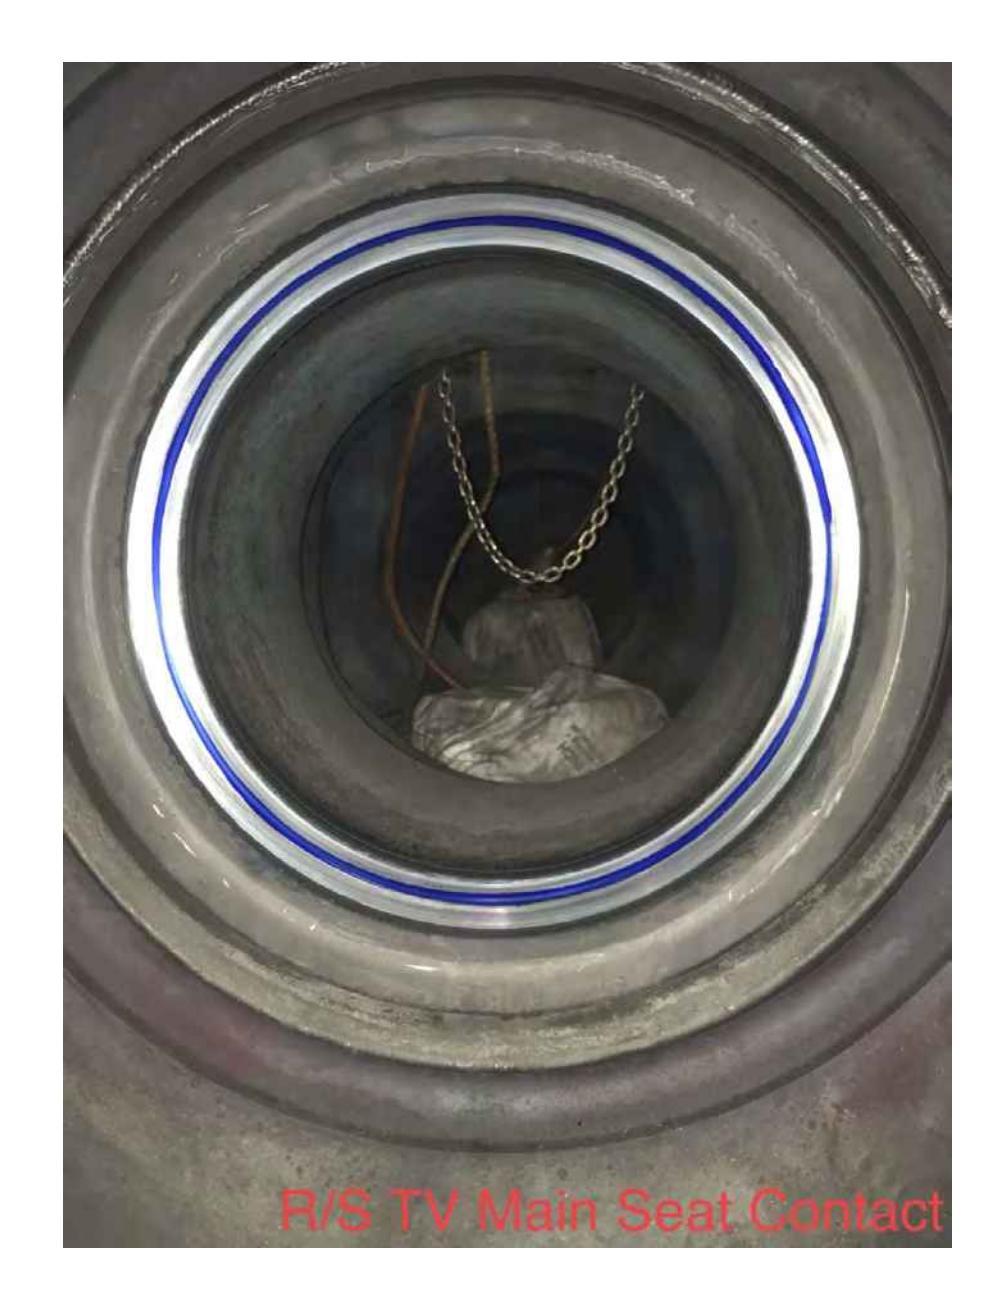
Throttle Valve Pictures

A crack-like linear indication was found across the right side main valve seat. The customer decided to undertake no action at this time and the indication will be monitored for propagation during future outages. Several of the main bonnet studs showed inconclusive result through ultrasonic testing. The customer's non-destructive testing expert tested the studs in question and deemed them suitable for continued service.

The indication on the right side throttle valve seat should be monitored during future outages. Pre-outage planning should include provisions for seat replacement. This would include

Since the exact cause of the steam cuts on the spring guide of the right side valve is unknown, a new spring guide should be on-hand prior to the next outage.

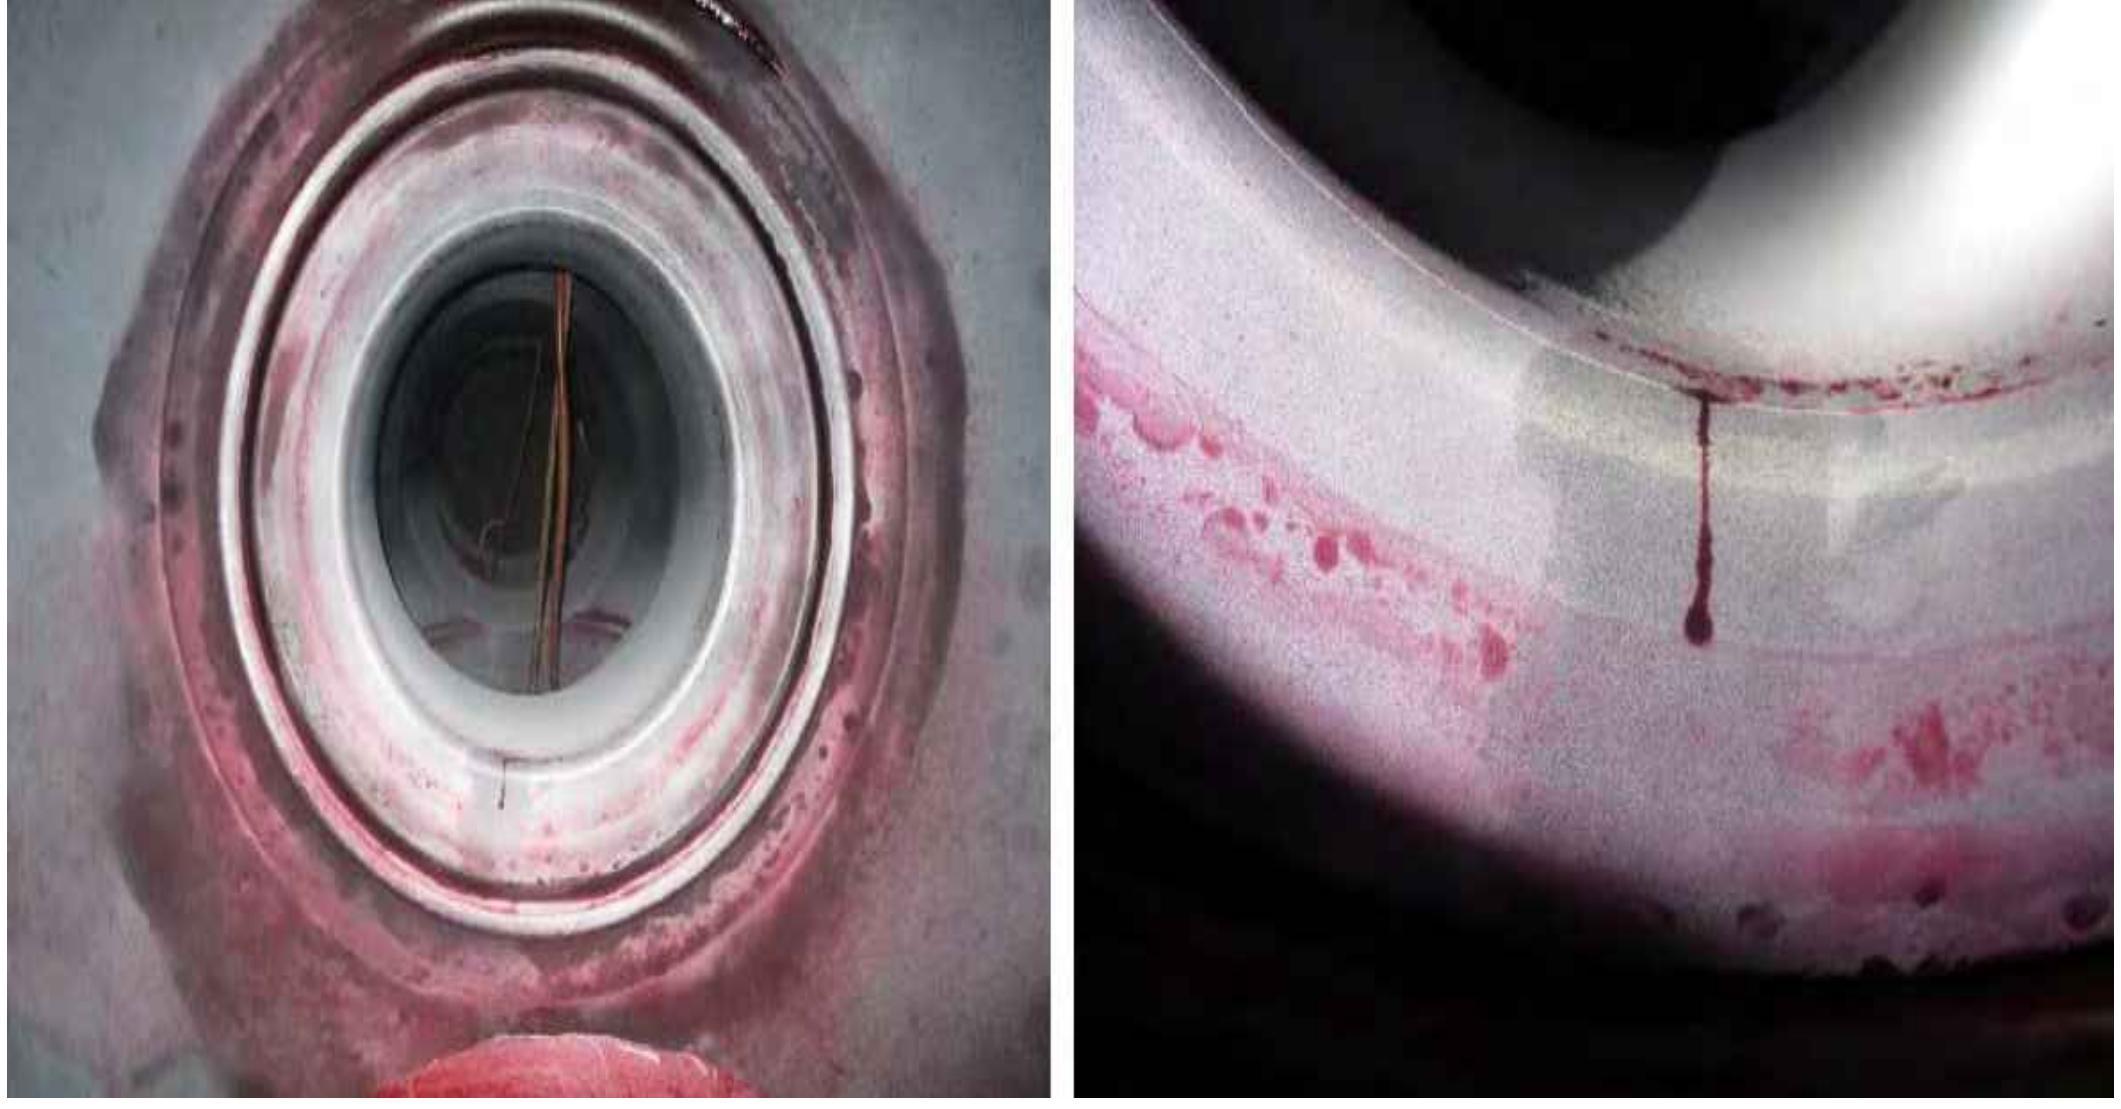
Right Side Throttle Valve Seat Indication

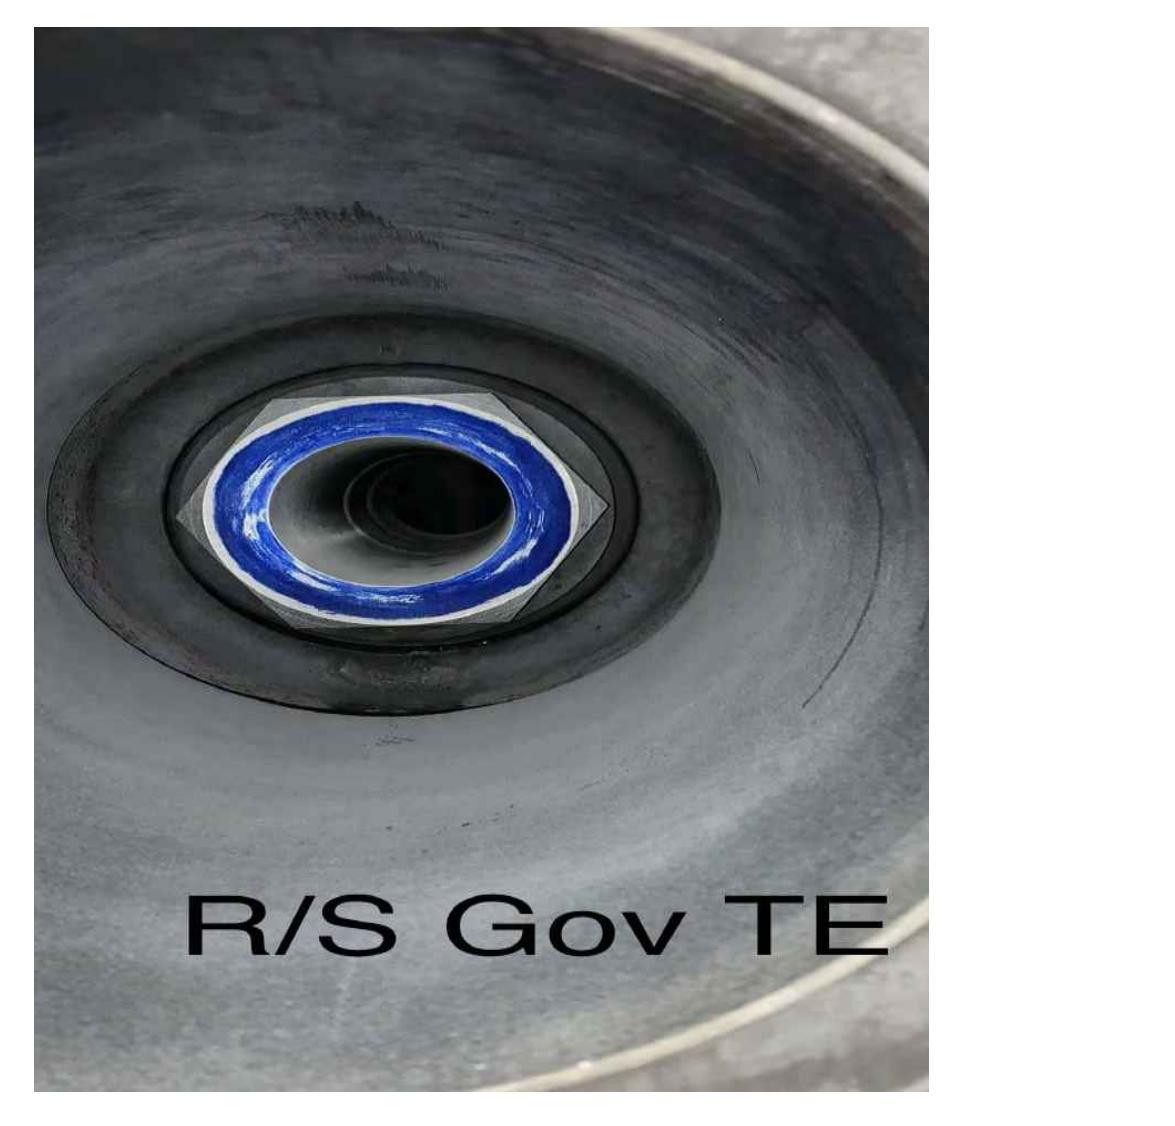
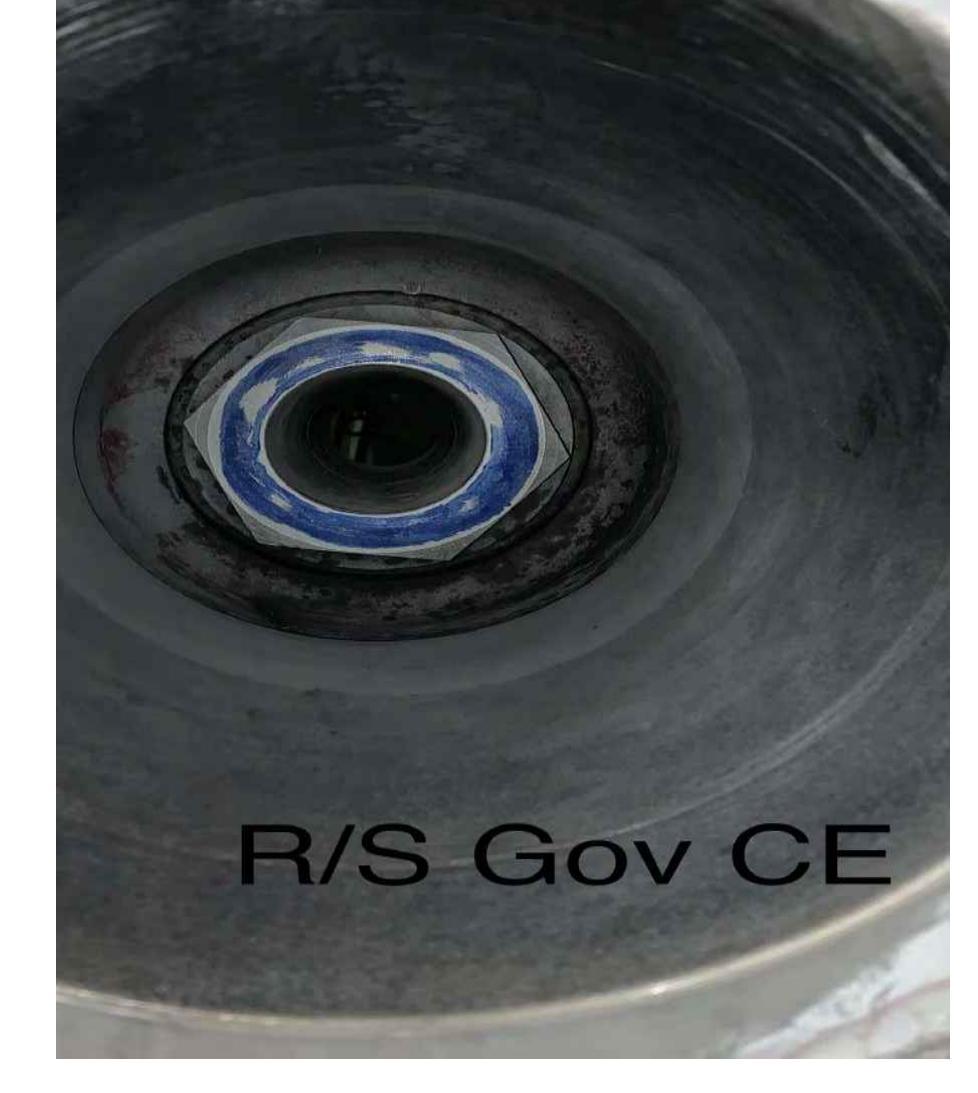
Governor Valve Backseat Contact

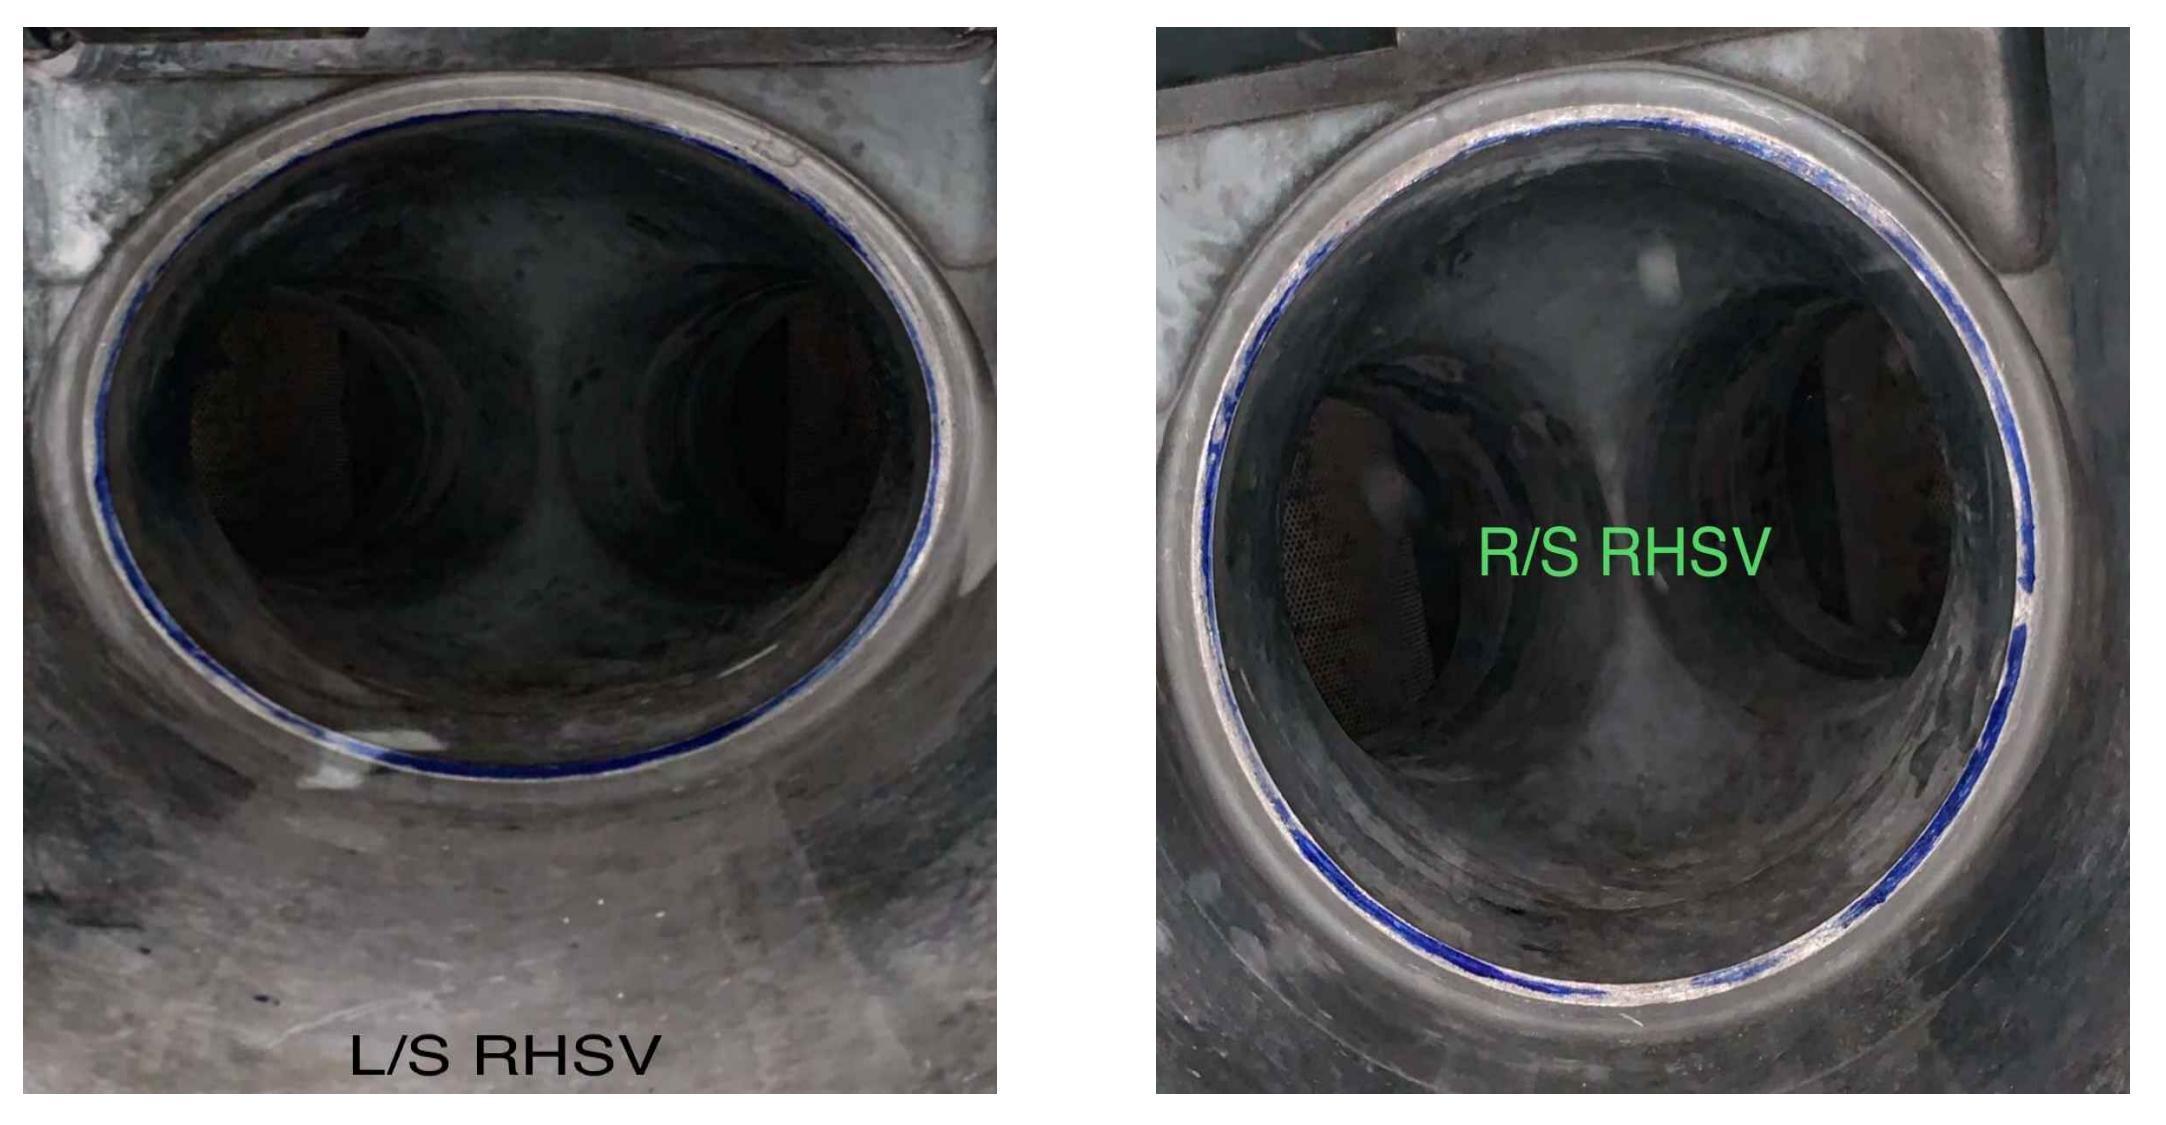
Reheat Stop Valve Main Seat Contact
