Comanche Unit 3 -Spring 2020 Outage

Full Train Major, Main Steam Valves & Generator

COMANCHE (CO) Steam Turbine ESN: SY0093272 Generator ESN: SY0350139 Job Start Date: 13 Jan 2020 Oracle Project ID: FSP-285469 | C-10344497

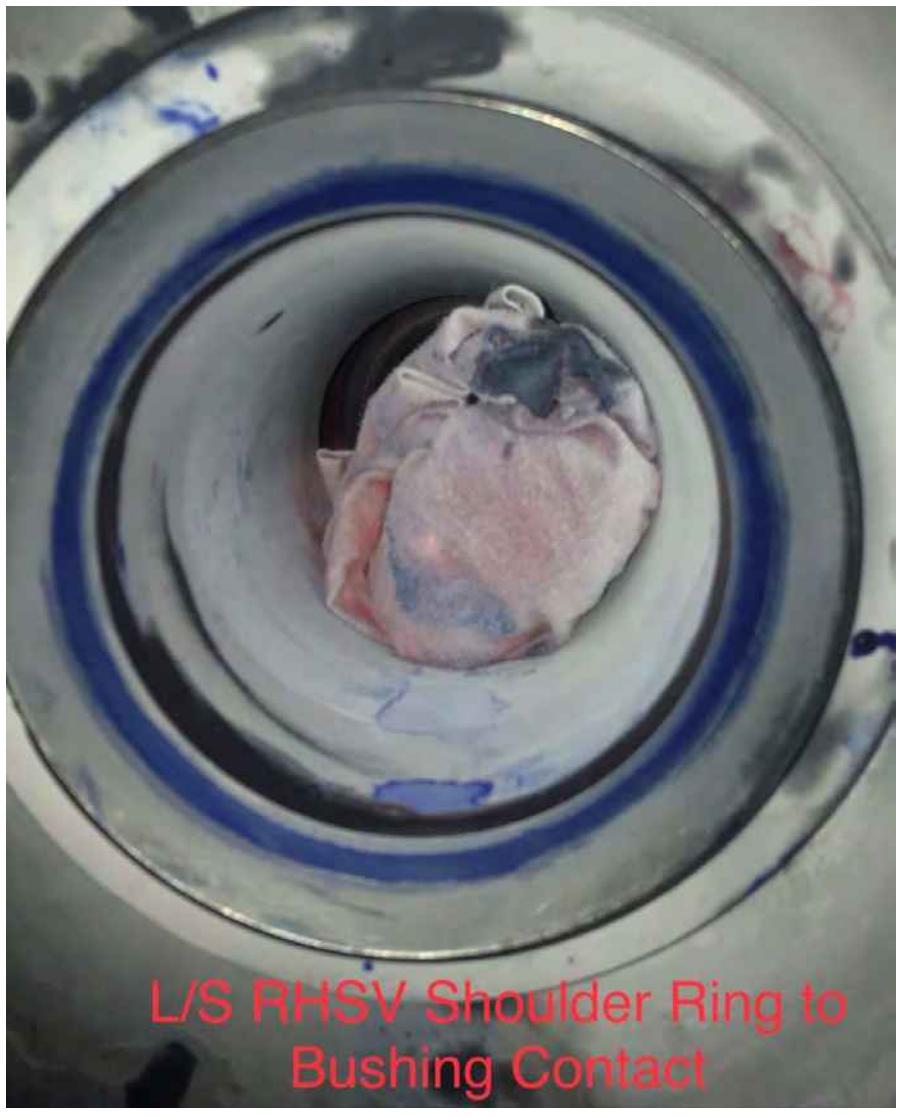
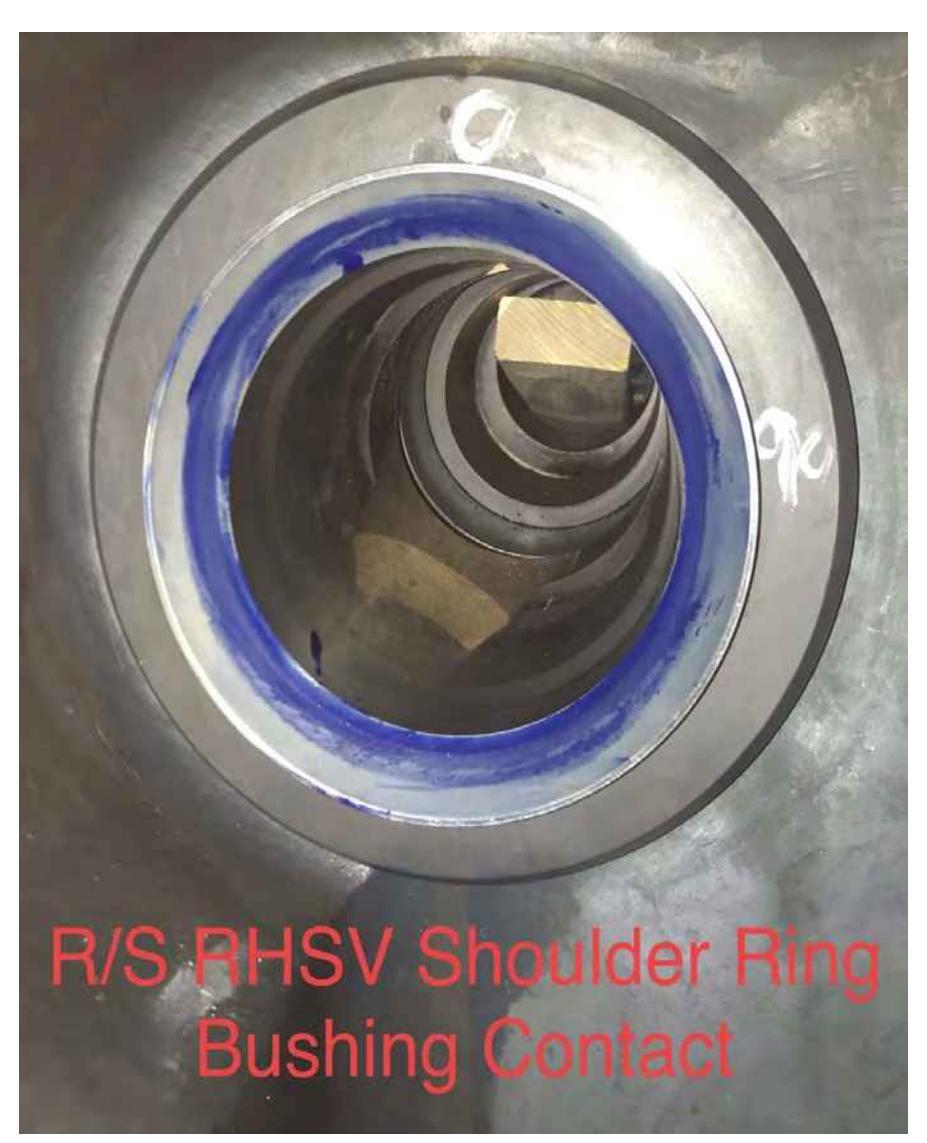
Reheat Stop Valve Shoulder Ring to Bushing Contact

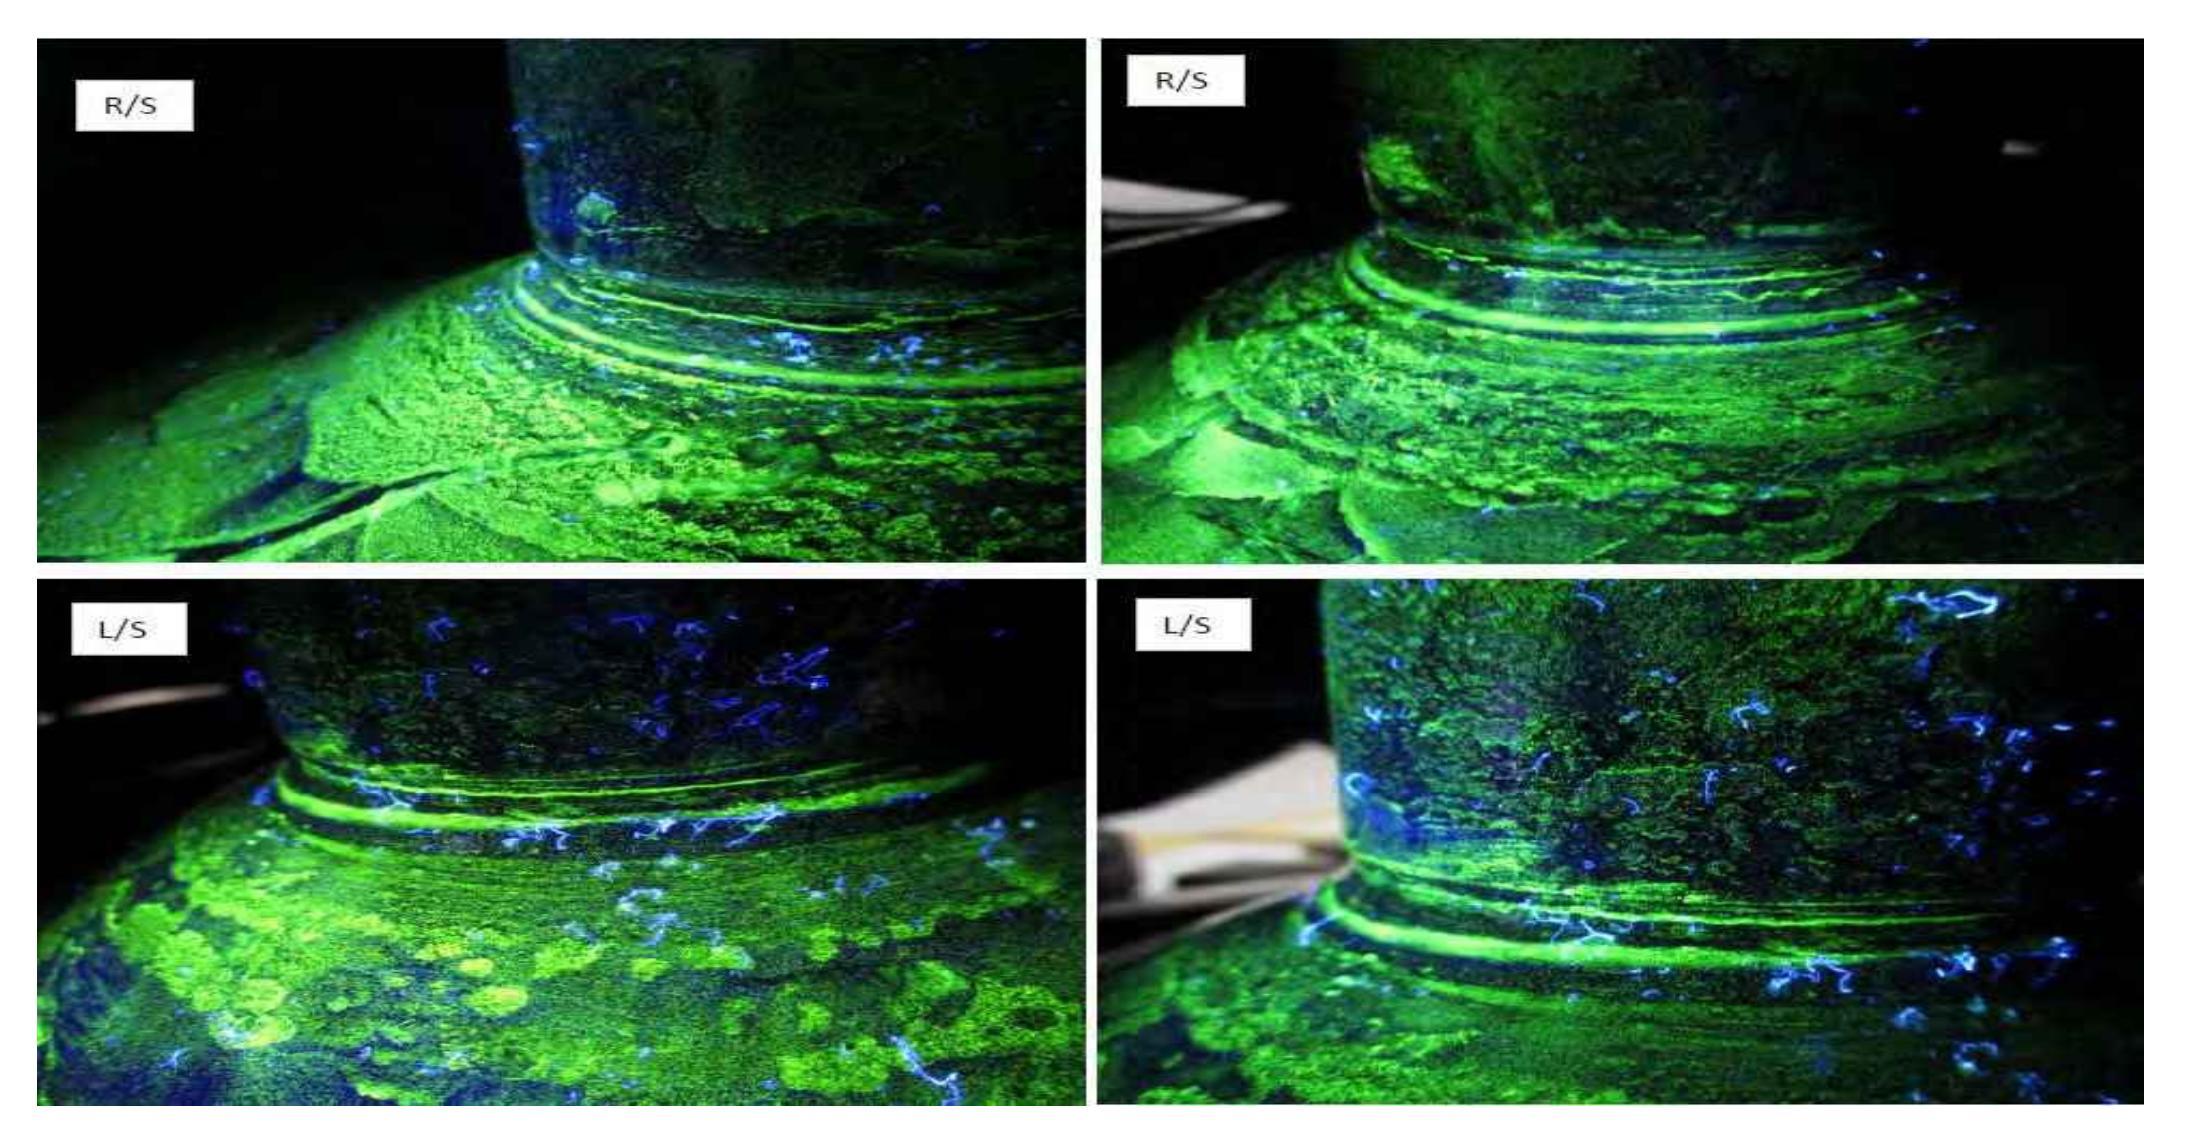
The center posts of both valve discs were found to have circumferential indications 360degrees around the interface point to the discs. The discs (item 2) and yokes (item 6) were shipped out for repair. New disc nuts (item 36) and pins (item 37) were shipped with the assemblies. The disc posts were repaired and contact checks were performed between the underside of the yoke to the discs and between the nut and the upper side of the yoke while offsite. The disc clearance was set and the new nuts were drilled for anti-rotstion pin

Reheat Stop Valve Disc Post Indications

Consideration should be given to adding a post to the valve covers that the disc post can seat against when the valve is fully opened. This would hold the disc rigidly against the seat of the yoke and not allow the disc to fret in operation. Similar valves incorporate this arrangement and it's abscence is the likely cause for the circumferential indications found on both discs.

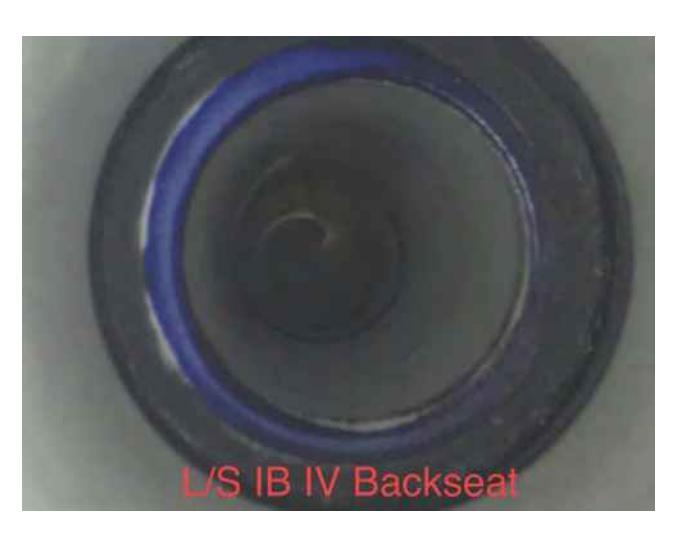
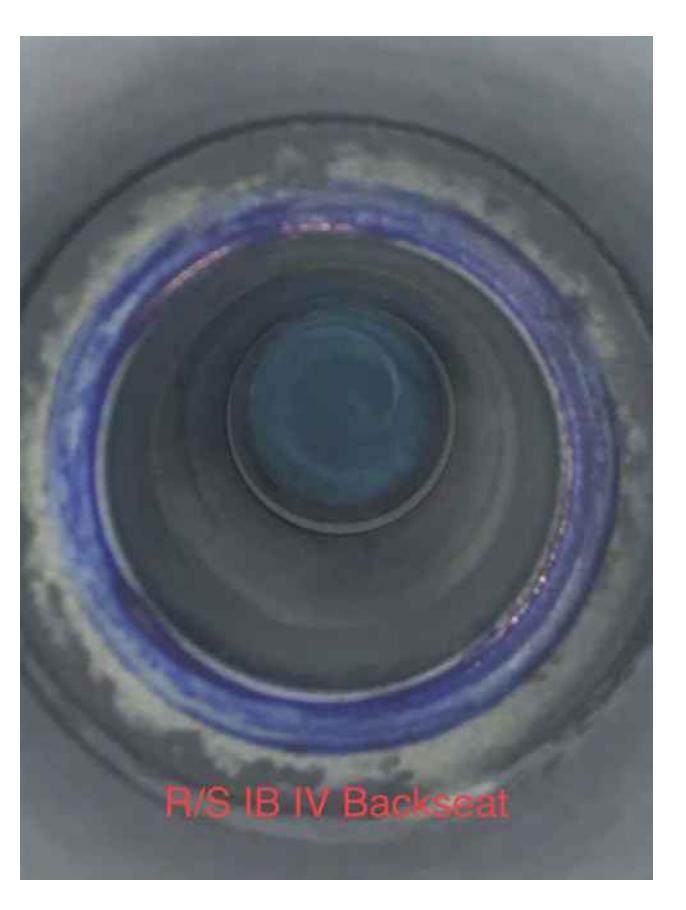
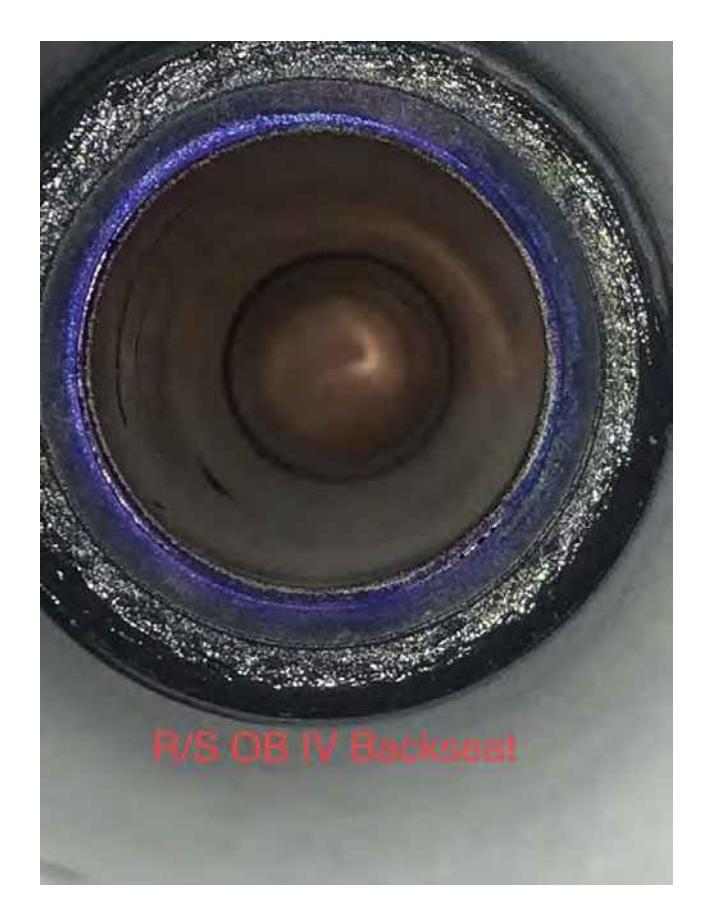
Right Side Inboard Intercept Valve Seat Damage

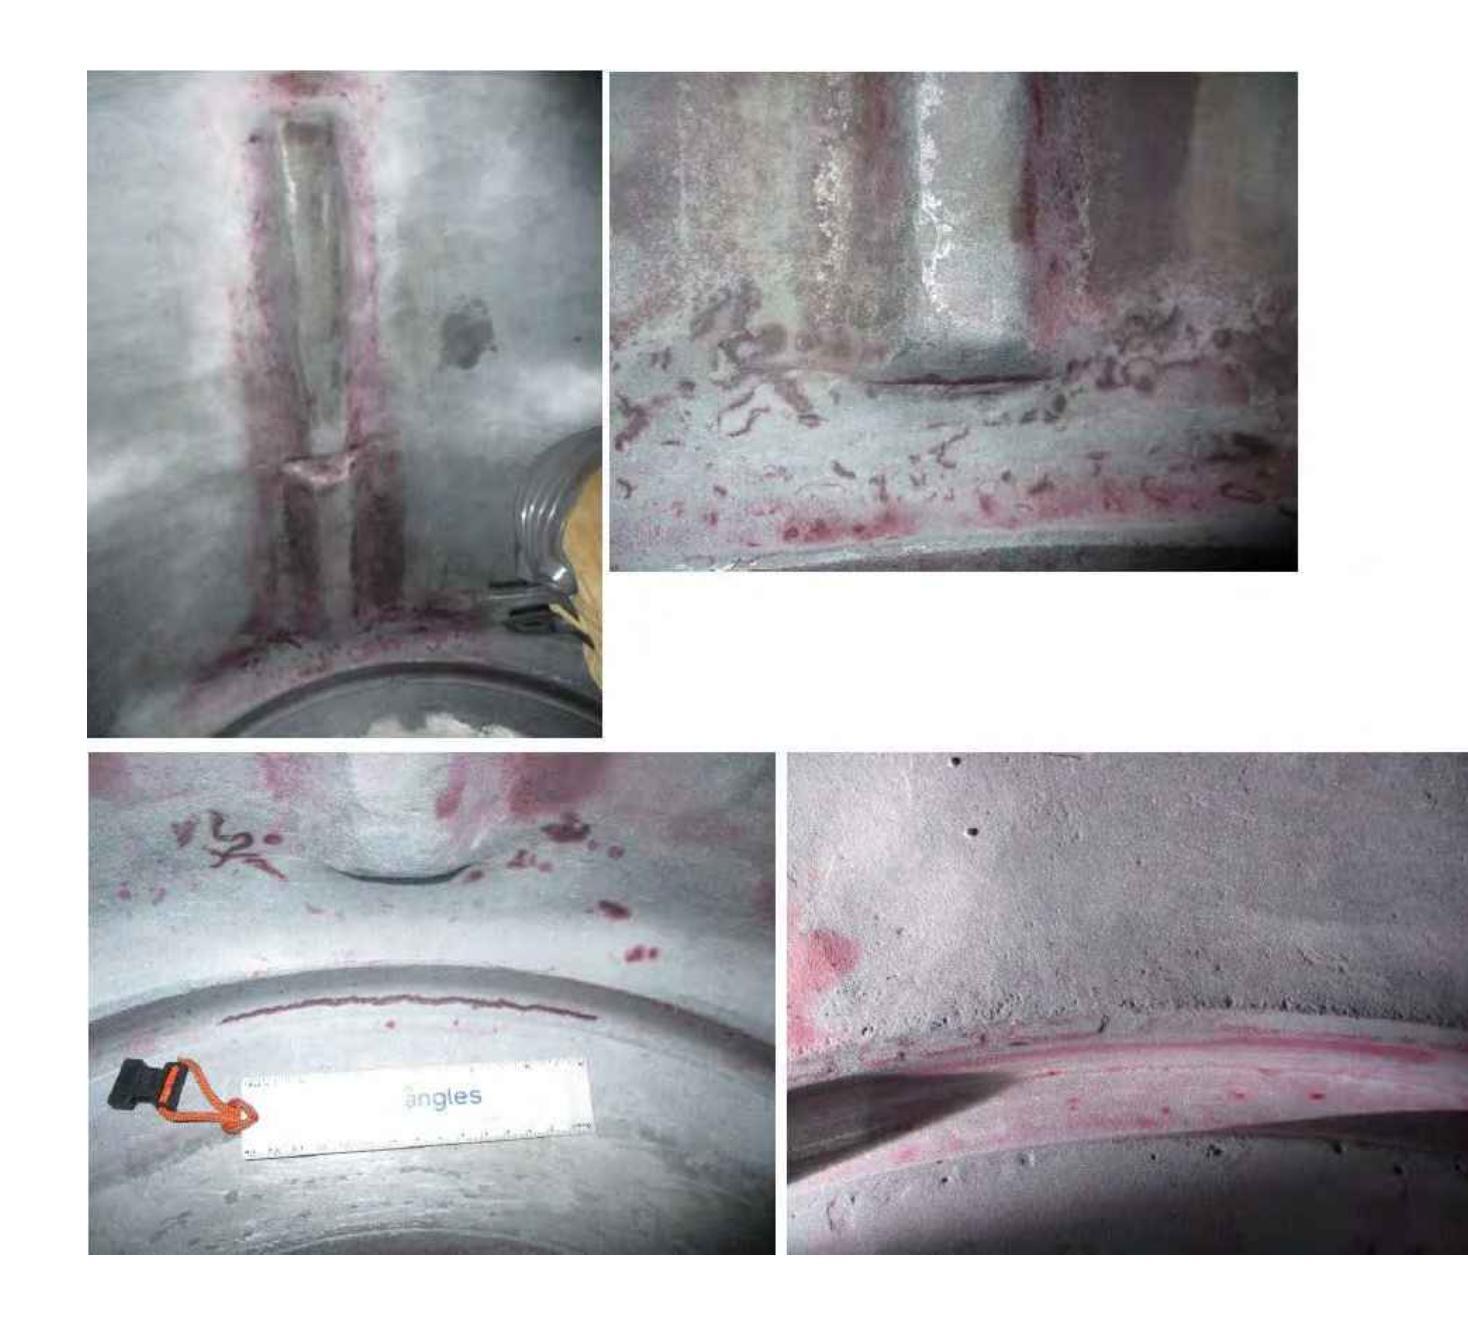
Right Side Outboard Intercept Valve Body PT Indications

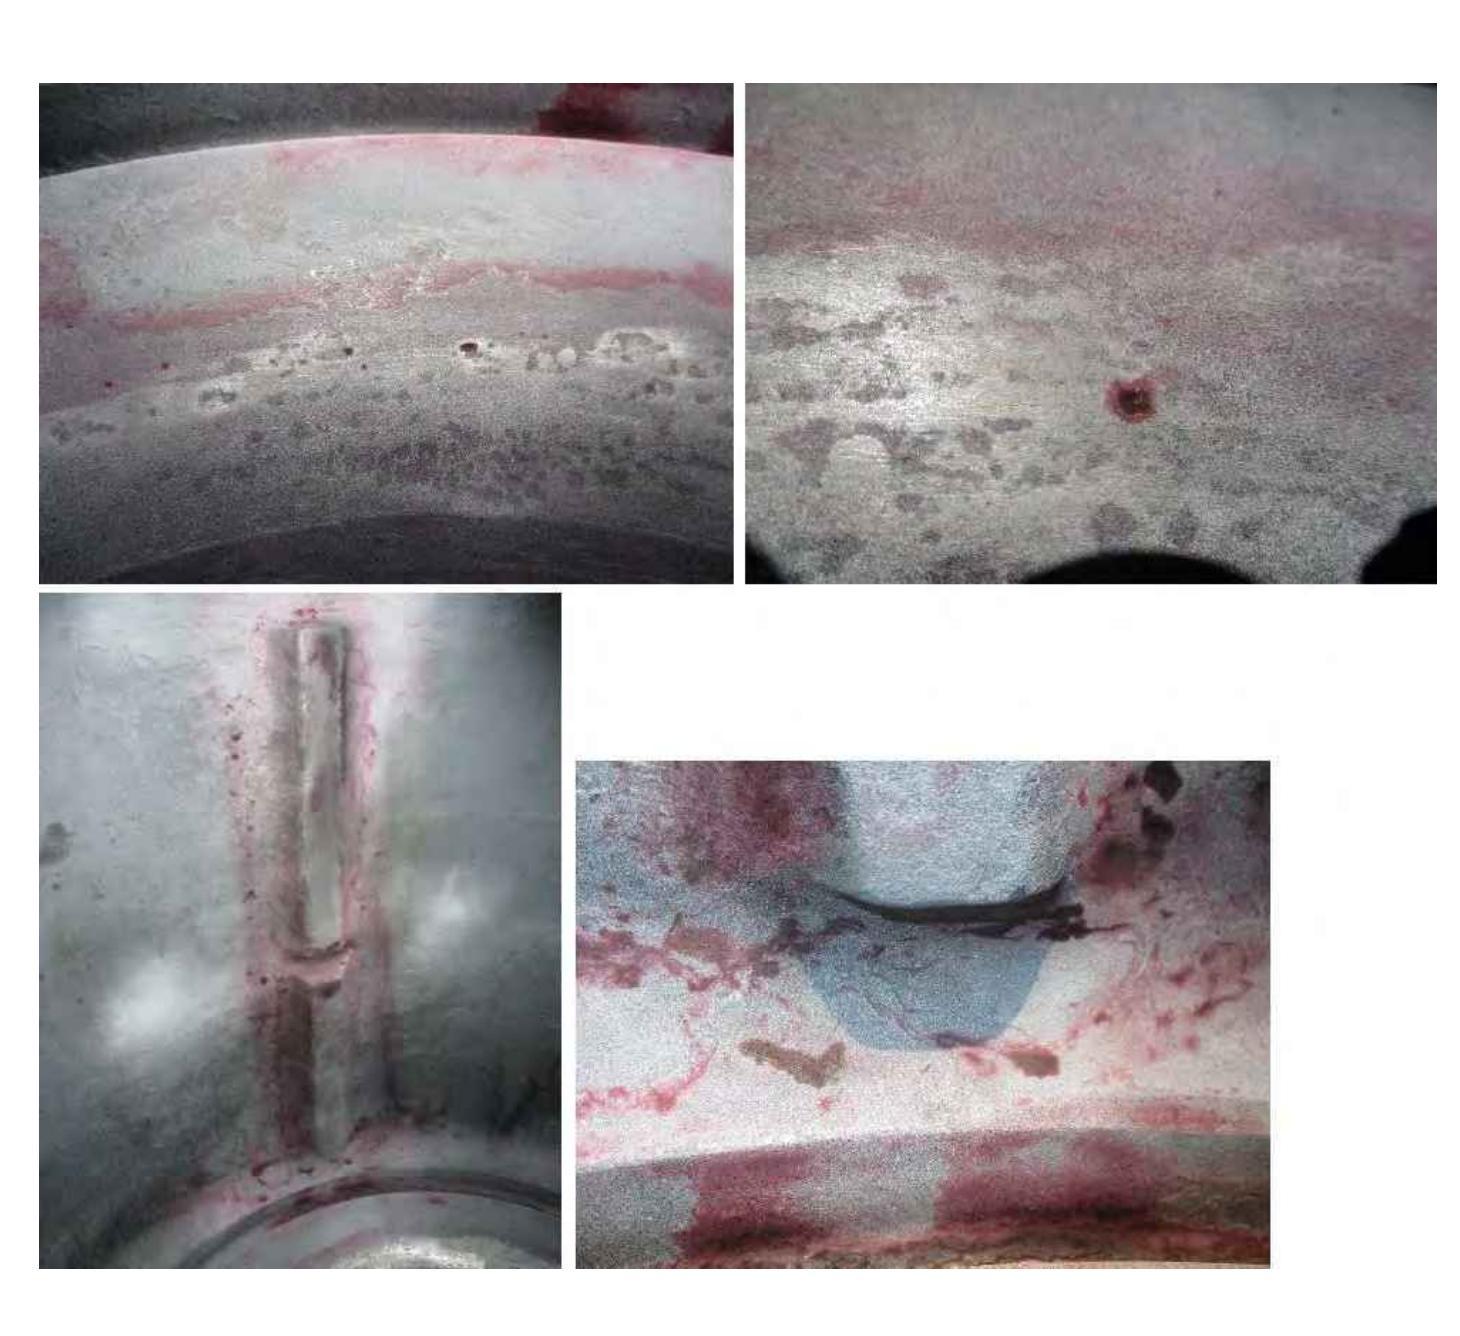
Right Side Inboard Intercept Valve Body PT Indications

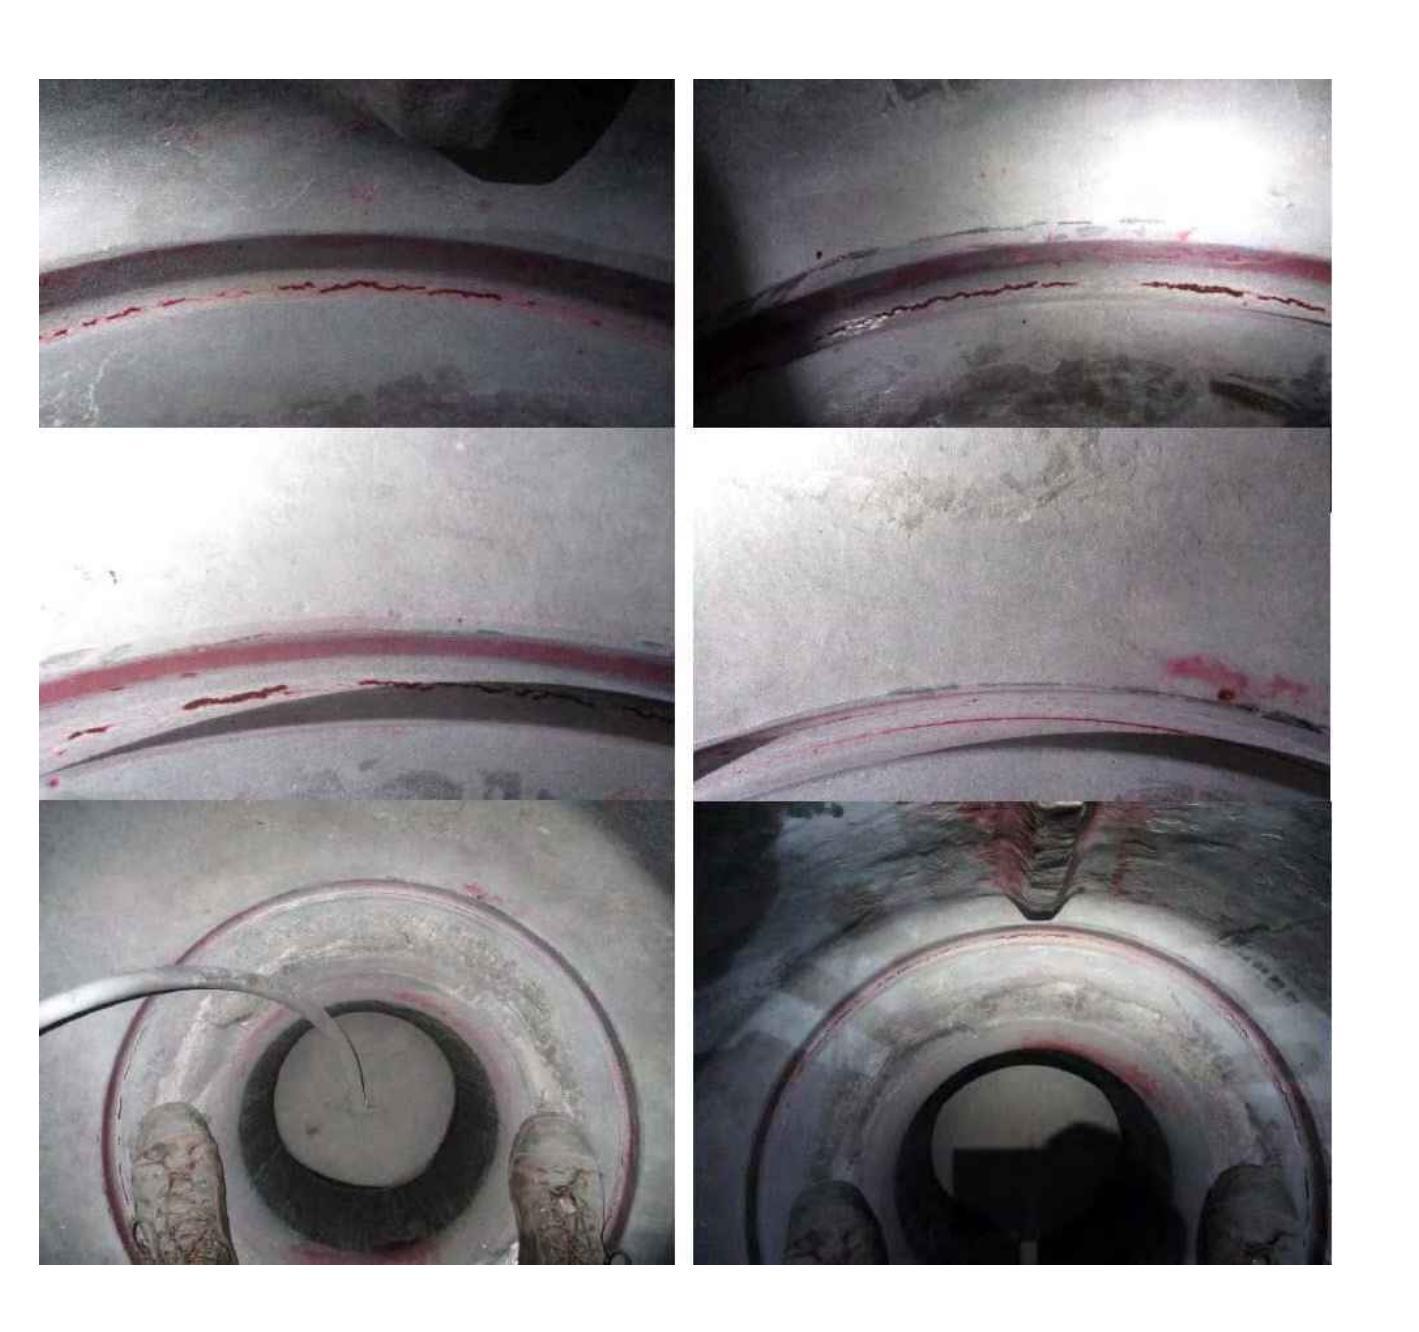
Right Side Inboard Intercept Valve Strainer Groove PT Indications

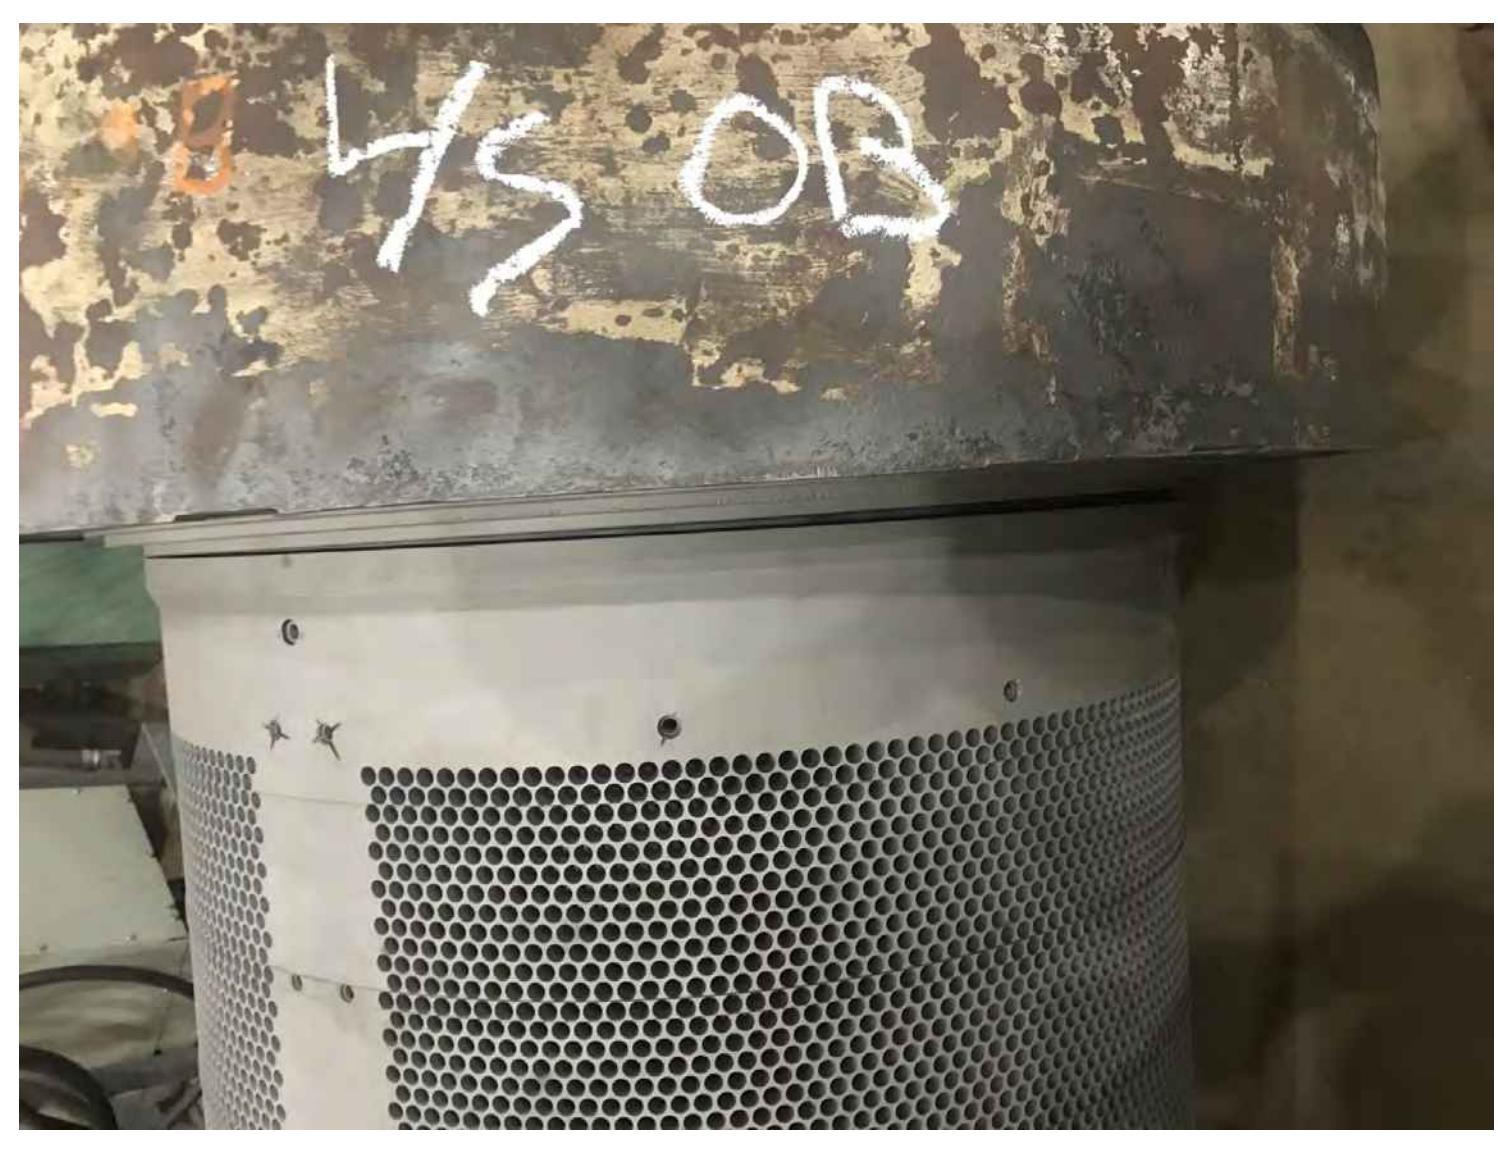
Left Side Outboard Intercept Valve – Strainer Gap

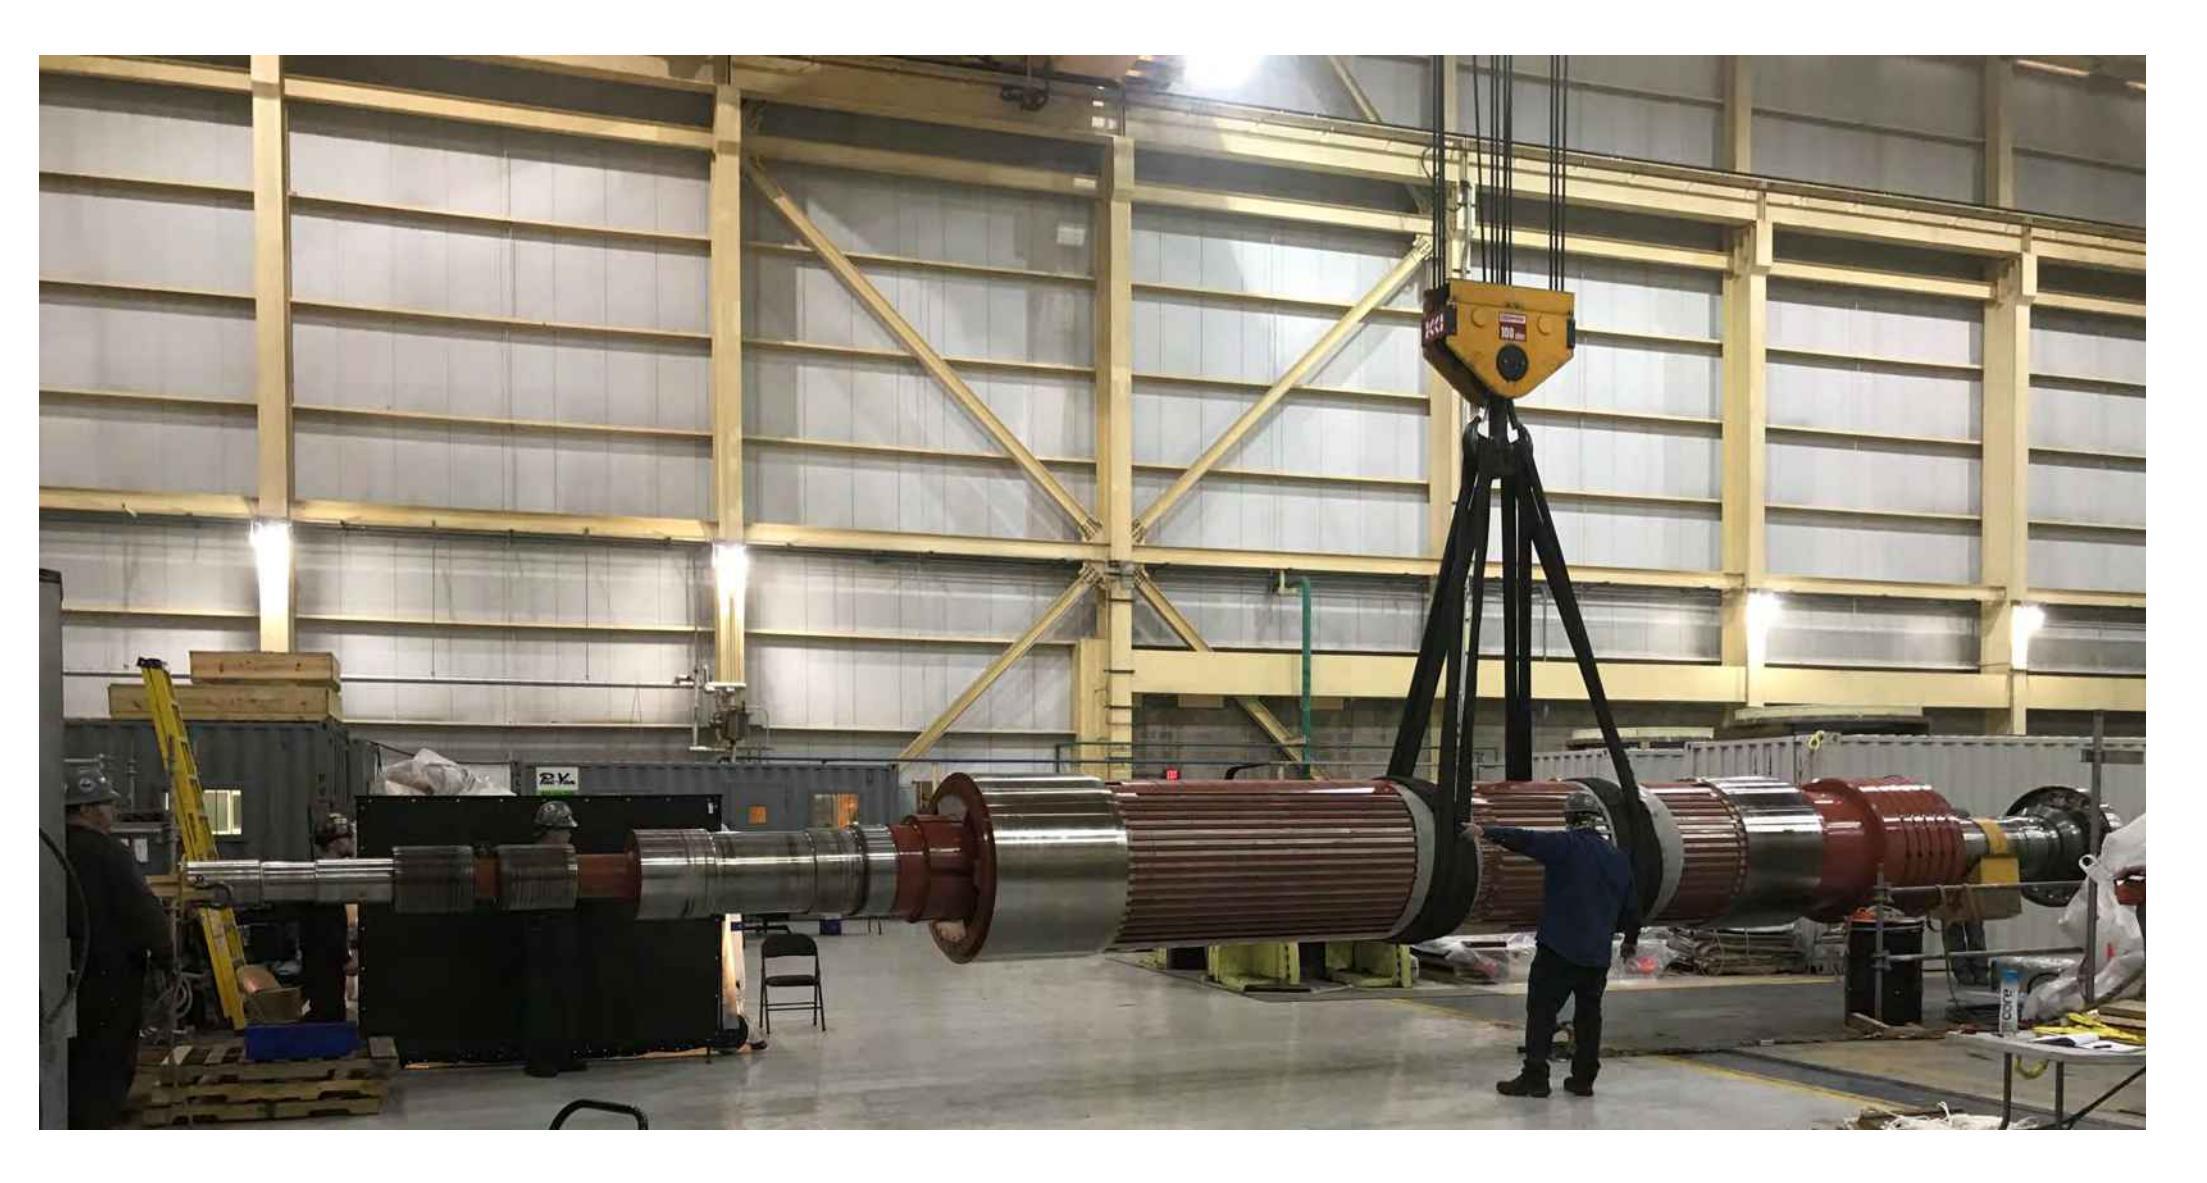
Generator Rotor

The rotor was removed from the stator, per OEM drawing A11B528. Several of the multipiece rotor body shoes, items T6 and T7, were found to be in poor condition and were replaced with segments fabricated and supplied by the customer.

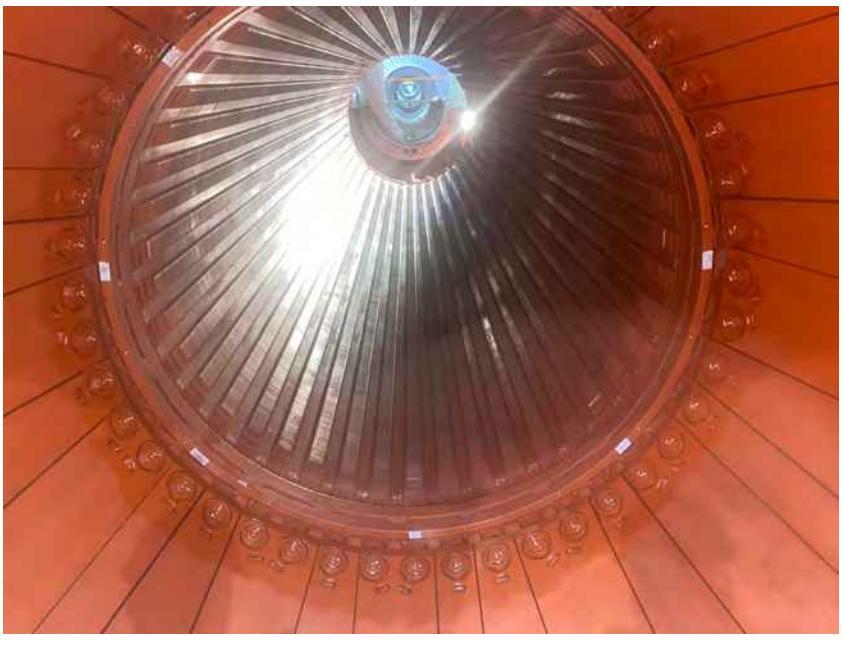
Upon visual inspection, the Stator Core appeared tight and free of smeared or damaged laminations. Core Compression Nuts were inspected for signs of greasing and Spring Bars were inspected for cracking via Borescope. There were no indications of greasing or movement present at the Core Nuts and no cracks were noted in the Spring Bars. An ELCID test was also performed to verify the integrity of the Core laminations. See ELCID test results under section 4.2 'Stator Tests'.

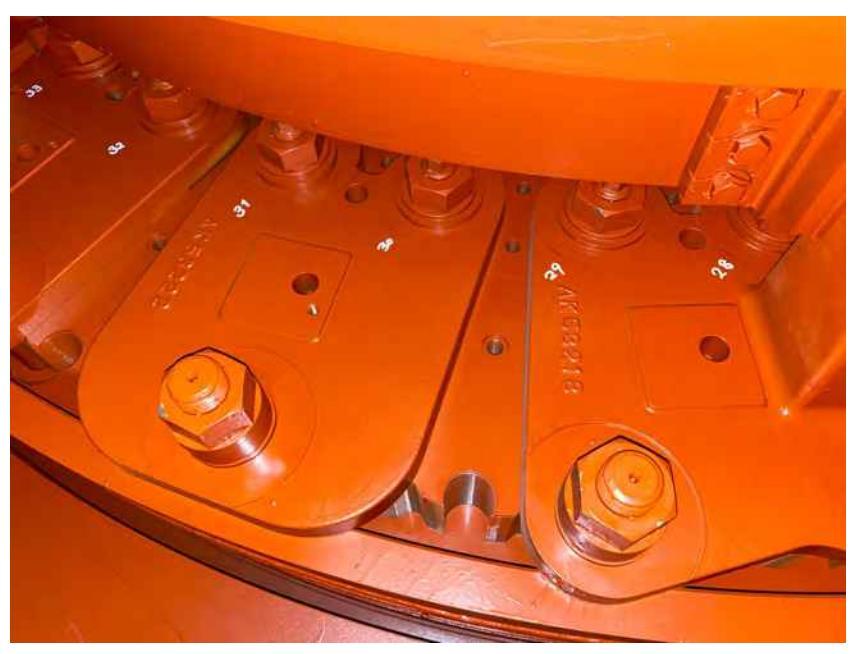
Core Compression Nuts were also subjected to a 500V Megger test. All passed at >100G:' within 1-minute.

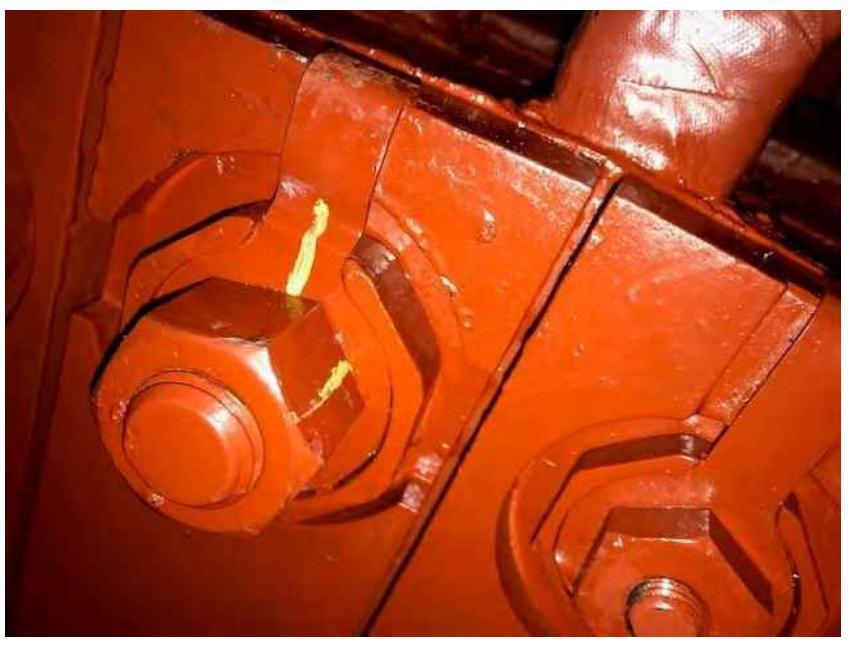
End Winding Insulation Bolts

The Stator End Winding was inspected for signs of dusting, greasing and overall movement/ vibration. There were no visual indications of loose blocking, ties or End Winding support hardware. Torque checks were also performed on the End Winding insulation and structural bolts, at the customer's request. For every nut that was checked, at least a 1/4 turn of movement was noted, with some allowing up to 3/4 of a turn. Based on this, the customer requested that we perform a full torque sequence on all End Winding insulation and structural bolts. Torque checks were performed satisfactorily.

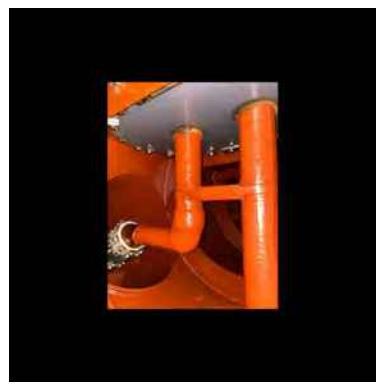
HVB Block & Tie (H2 Side)

The HV Bushing Box was inspected for signs of arcing and/or electrical heating at the Flex Link connections, greasing/dusting at block and tie locations, leaking gaskets, H2 embrittlement/corrosion of electrical surfaces and overall structural integrity. Aside from a minor amount of oily surface contamination, the integrity of all Bushing Box components was in good condition. All oil and surface contaminants were cleaned using lint-free rags and denatured alcohol. Bushings were also subjected to Hipotential testing at 68.9 KVDC. See results from Electrical testing under section 4.2 'DC Leakage & Hipot Test'.

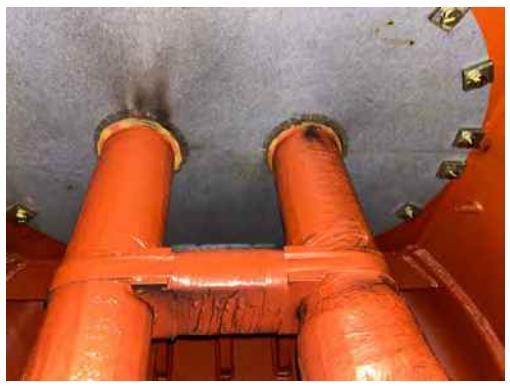
HVB Surface Contamination (H2 Side)

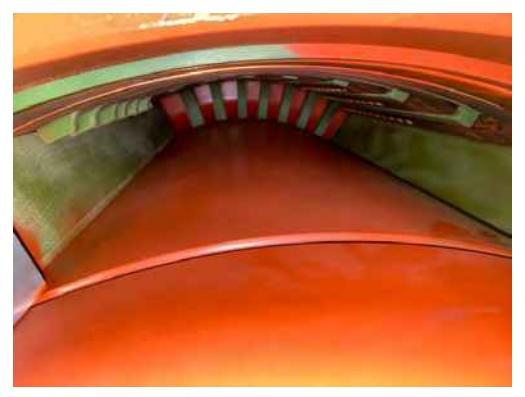
End Winding-1

A visual inspection was completed on the following Field components; Retaining Rings, Field Body, Body Wedges, Creepage Blocks & Vent holes, End Winding blocking and turn insulation, Main Leads, Pole to Pole & Coil to Coil jumpers and Collector Rings. The Field Body and Retaining Rings were cleaned using lint-free rags and denatured alcohol. The Collector Rings and ventillation holes were littered with carbon dust, so they were vacuumed and thoroughly cleaned with denatured alcohol. Collector Rings appeared to be in good condition with uniform wear. No other issues were noted during Field visual inspection.
